## Phase 2 Milne Rail Corridor Aquatic Habitat Assessment

**Crossing ID:** CV-89-1

**Baffinland Iron Mines  
Mary River Project**

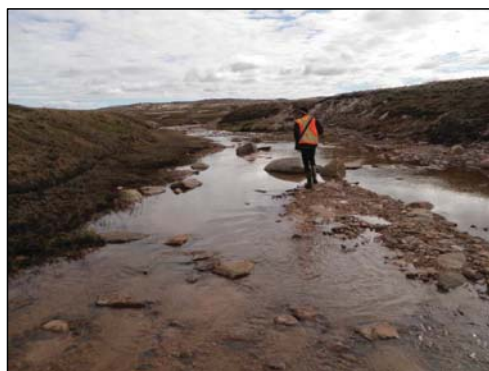
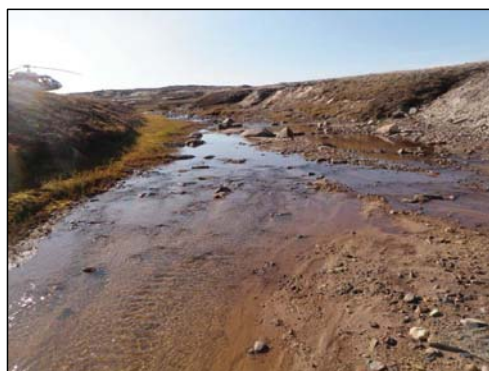
**Figure 5.** Summer (top) and fall (bottom) views of CV-89-1 at the 20 m downstream cross-section; (A) looking upstream; (B) looking downstream; and (C) looking across.

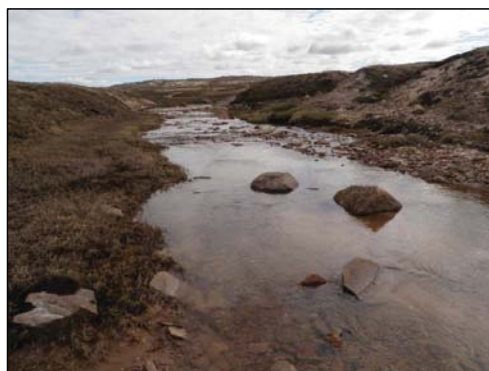
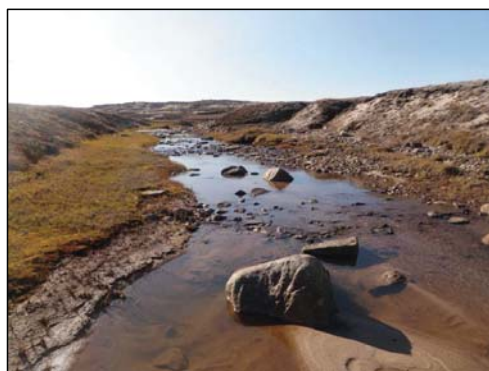
**Figure 6.** Summer (top) and fall (bottom) views of CV-89-1 at the rail crossing; (A) looking upstream; (B) looking downstream; and (C) looking across.

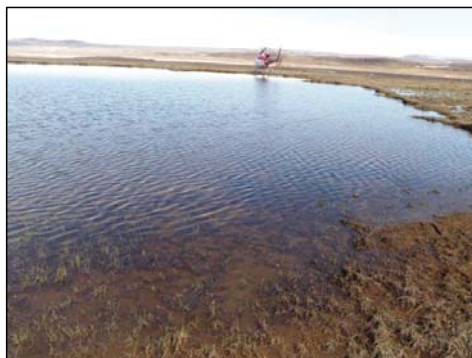
The crossing is an isolated pond with a maximum depth of 1.0 m. Fish were not captured or observed during surveys. There is no fish use of habitat at this crossing.

**Figure 1.** Views of CV-89-2 at the crossing during summer (A) and (B), and during fall (C).

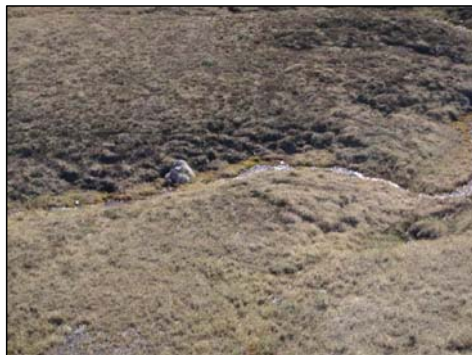
The crossing stream is small and flows into a fish-bearing lake downstream of the Tote Road. However, only about the lowermost 20 m downstream of the road culverts is usable by fish. A very steep gradient upstream of the road prevents fish use as noted during Tote Road surveys. There is no fish use of habitat at this crossing.

**Figure 1.** Views of CV-90-4 at the crossing during summer (A) and fall (B).

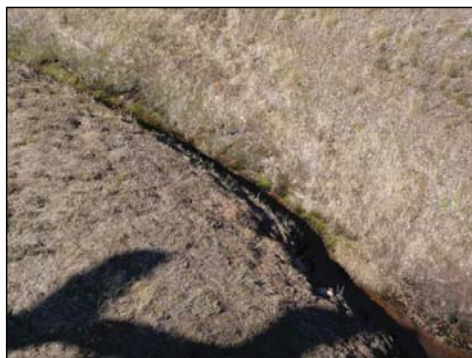
The crossing was nearly dry, was very steep and there is no access under all flow conditions. There is no fish use of habitat at this crossing.

**Figure 1.** Views of CV-91-1 at the crossing during summer (A) and fall (B).

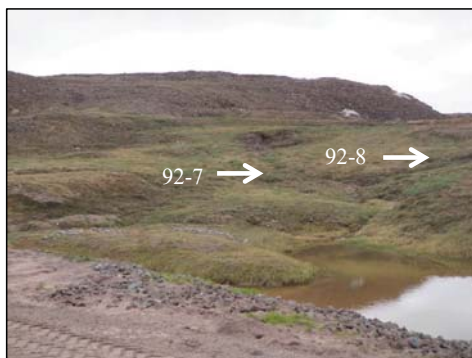
The crossings were nearly dry, very small, steep trickles on a hillside upstream of the Tote Road. There is no access under all flow conditions. There is no fish use of habitat at this crossing.

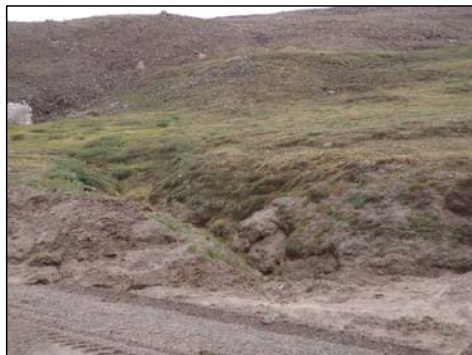
The crossing was a nearly dry, very small, steep trickle on a hillside upstream of the Tote Road. There is no access under all flow conditions. There is no fish use of habitat at this crossing.

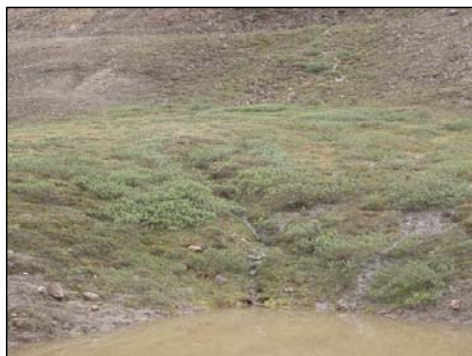
The crossing was a nearly dry, very small, steep trickle flowing into a fishless pond. There is no access under all flow conditions. There is no fish use of habitat at this crossing.

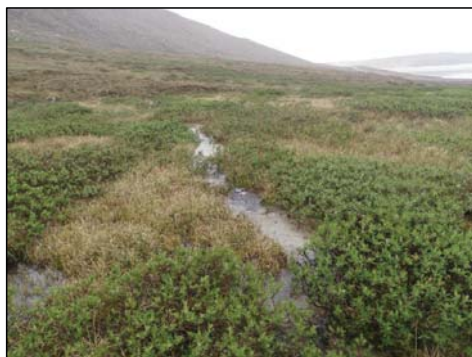
The crossing stream is a tributary of CV-93-4, which is known to be fish-bearing; however there is a vertical drop barrier at the confluence. The barrier prevents access under all flow conditions. There is no fish use of habitat at this crossing.

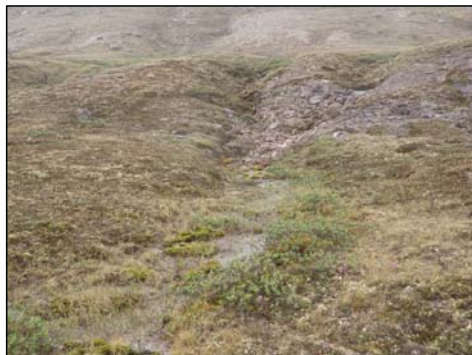
The crossing was nearly dry in summer and dry in fall 2018. The limited amount of water flowed under rocks at the crossing and dispersed over terrestrial vegetation downstream. There would be no access under any flow conditions. There is no fish use of habitat at this crossing.

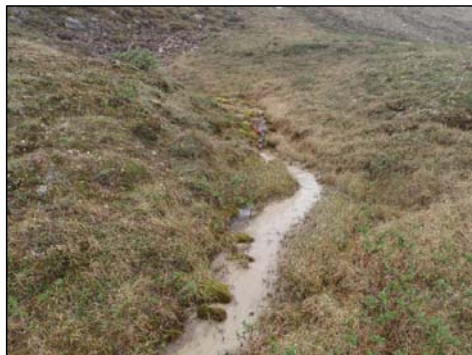
The crossing was a small trickle flowing from the hills into a small, isolated lake. There is a large, vertical drop at the confluence with the lake that is impassable under all flow conditions. There is no fish use of habitat at this crossing.

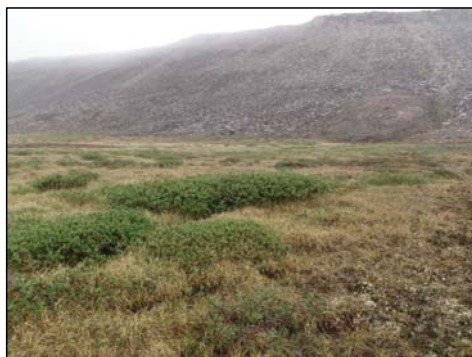
The crossing was a small, shallow trickle flowing across the tundra towards the CV-96-1 fish-bearing stream. However, there is a vertical barrier from 50-70 m downstream of the crossing and another at the confluence with 96-1 that are impassable under all flow conditions. There is no fish use of habitat at this crossing.

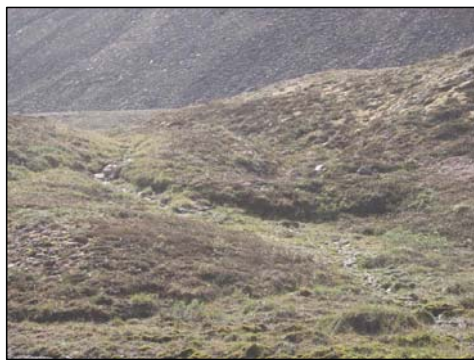
The crossing was a nearly dry to dry steep hillside trickle flowing into CV-96-1. There is no access under any flow conditions. There is no fish use of habitat at this crossing.

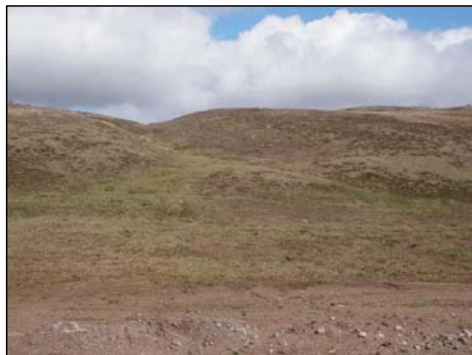
The crossing was dry in 2018. The steep gradient and consistently low flows have prevented access upstream of the Tote Road as observed during road monitoring. There is no fish use of habitat at this crossing.

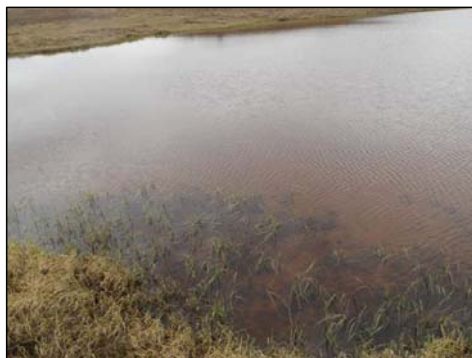
The crossing was a small, shallow pond with a maximum depth of approximately 2 m. No fish were captured or observed during an electrofishing survey of approximately half the shoreline and there was no evidence of their presence. There is no fish use of habitat at this crossing.
