NB102-181/63-1

MARY RIVER PROJECT

MINE SITE WATER MANAGEMENT PLAN

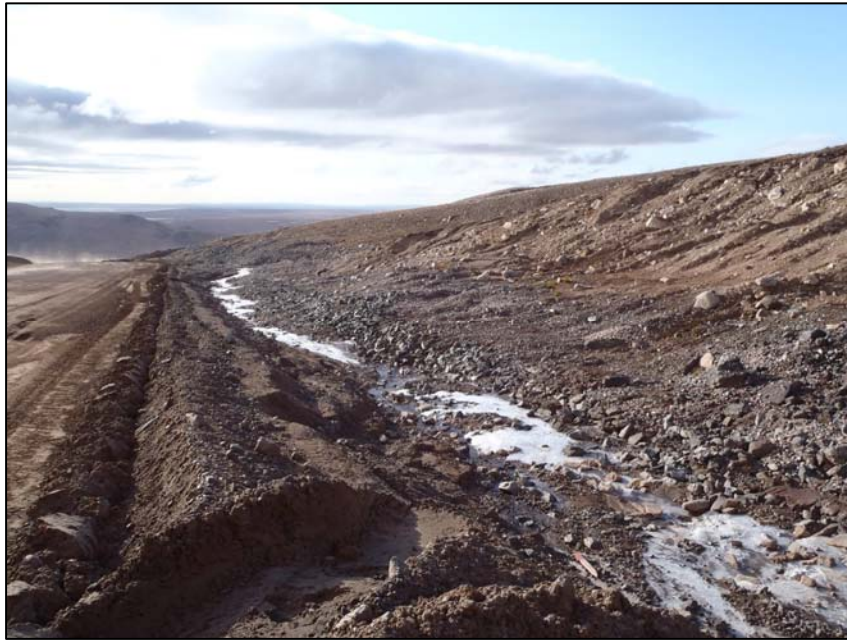
PHOTO 1 - Graded material and swale cut through material to ditch along Mine Haul Road (MHR).

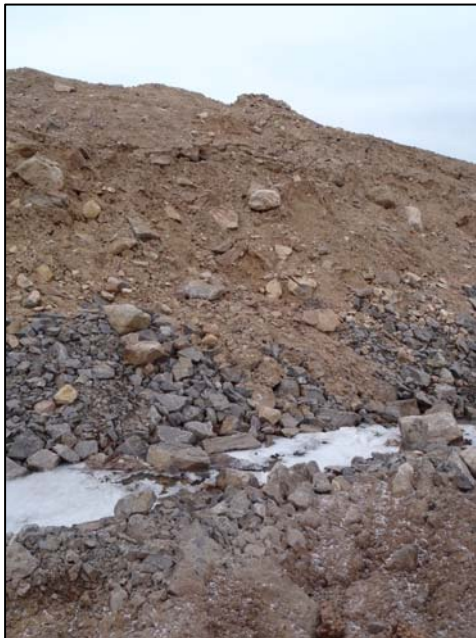
PHOTO 2 - Erosion of cut overburden slope along MHR.

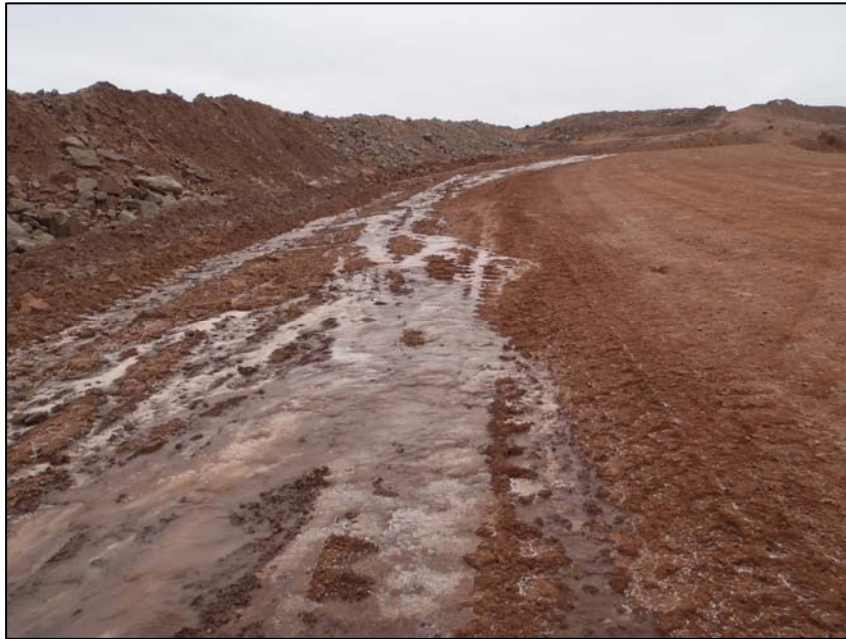
- Seepage daylighting on the MHR can cause ice conditions and contribute to sediment loading (Photo 3, Appendix B).
- Some culverts along the MHR have sediment buildup in and/or immediately upstream of the culverts. In addition, some culverts have been damaged during snow removal from upstream or downstream of the culverts in preparation for freshet.

PHOTO 3 - Seepage daylighting along MHR.

| Project Component | Consideration | Category | Proposed Measure/Action |
|---|---|--|---|
| | Seepage daylighting on the MHR can cause icy conditions and contribute to sediment loading. | Remedial measure | Address upgradient source(s) of seepage daylighting on the MHR by directing the drainage causing the seepage to the MHR ditch or installing a culvert to convey the drainage beneath the MHR. |

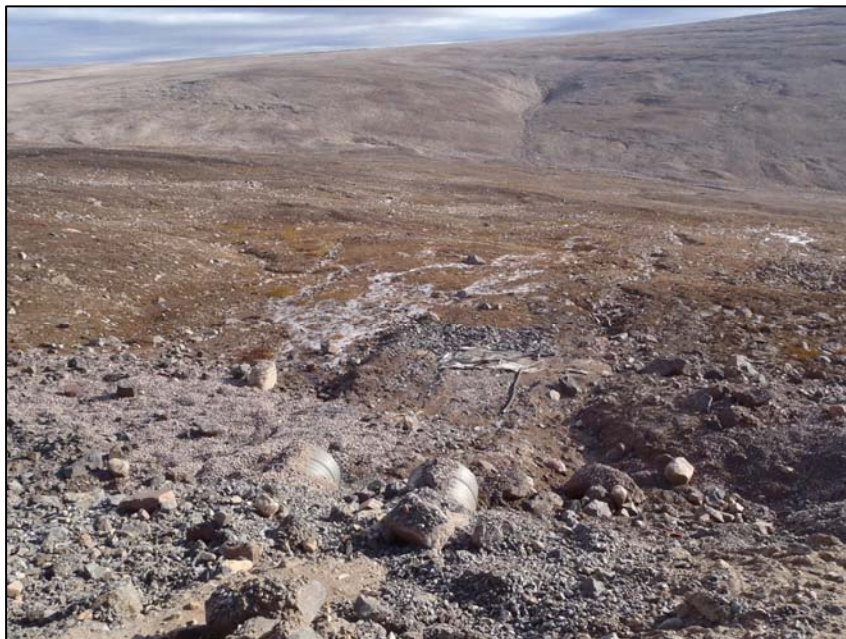
PHOTO 4 - Outlet of MHR culverts.

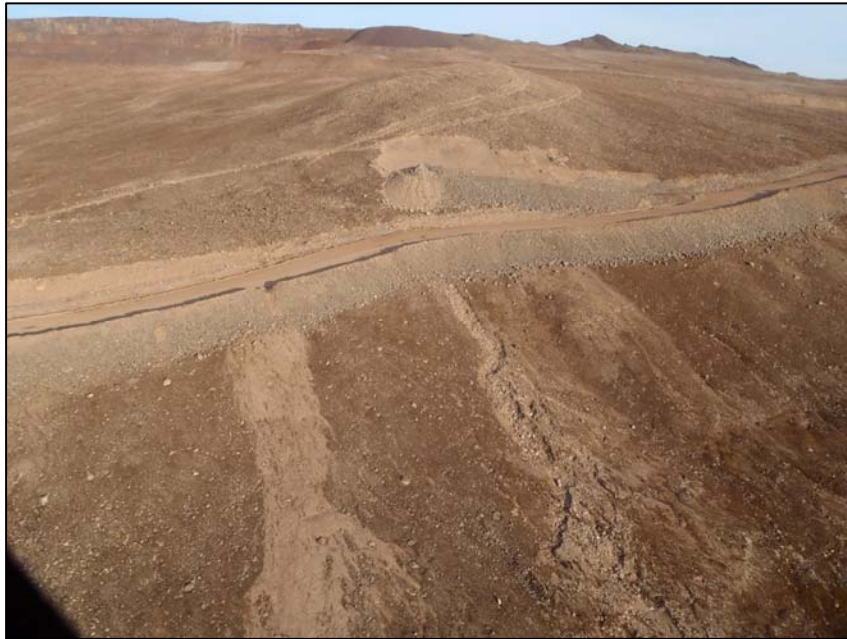
PHOTO 5 - Erosion of slope downstream of MHR culverts and cut in safety berm.

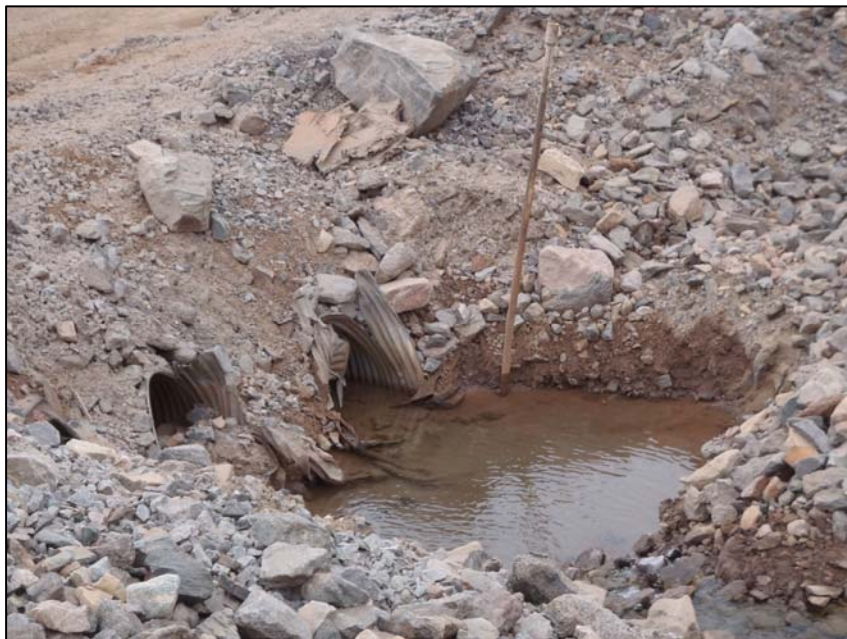
PHOTO 6 - Culvert inlet with steel rod and remnants of geotextile.

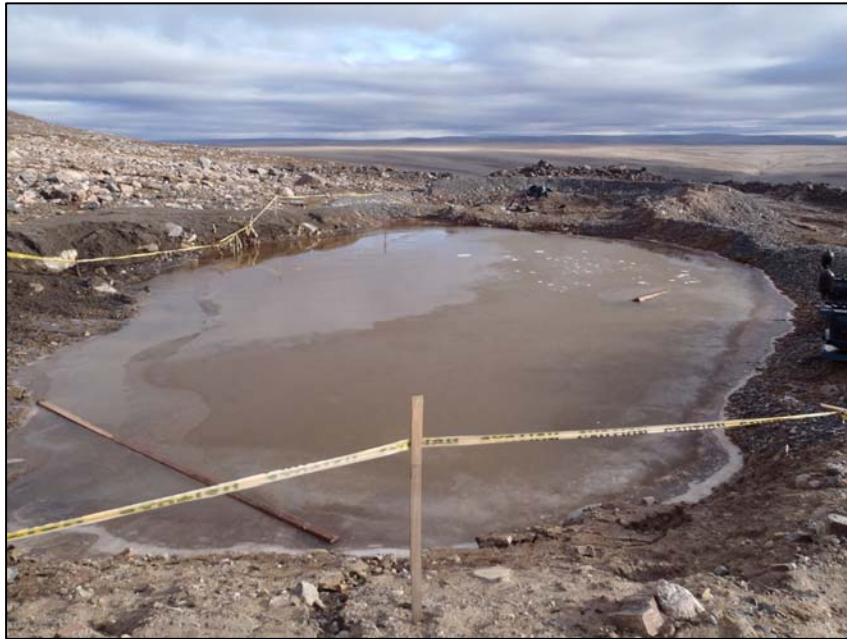
PHOTO 7 - Check Dam #1 along MHR.

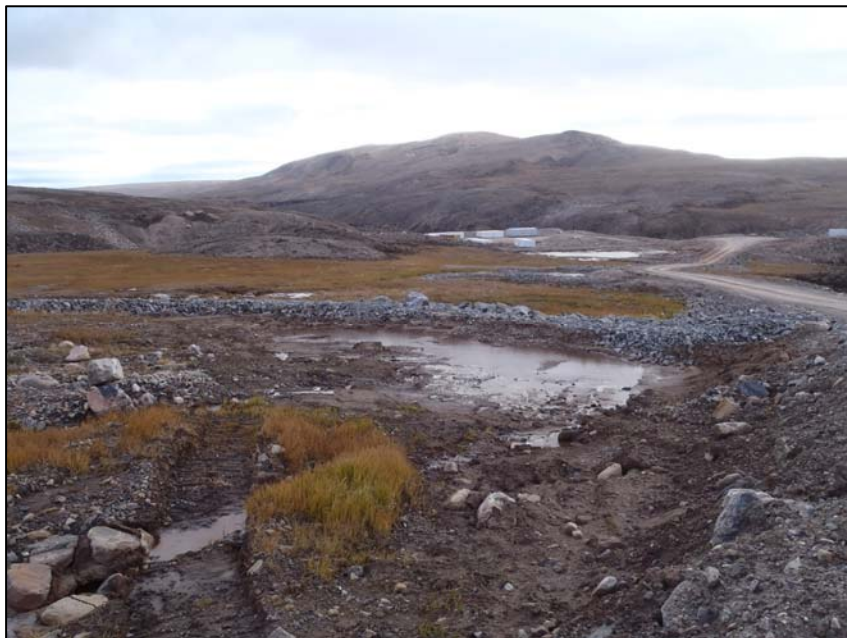
PHOTO 8 - Check dams by explosive magazine.

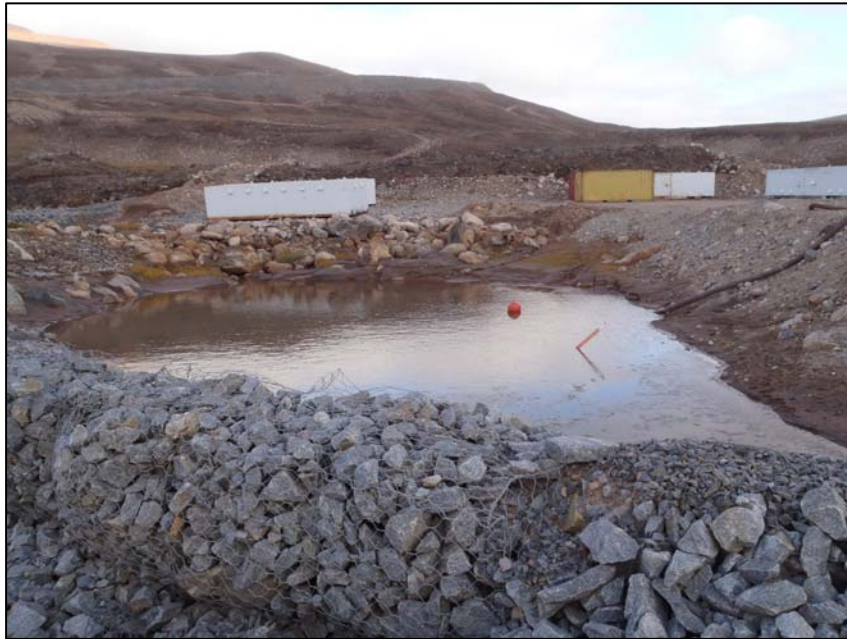
PHOTO 9 - Check dam in explosive magazine area.

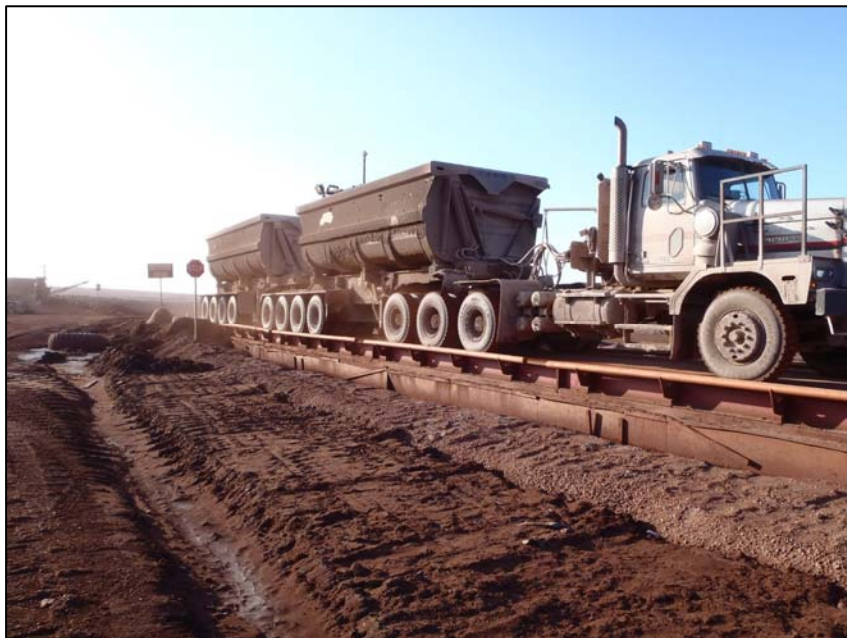
PHOTO 10 - Truck weigh scale and trench for drainage.

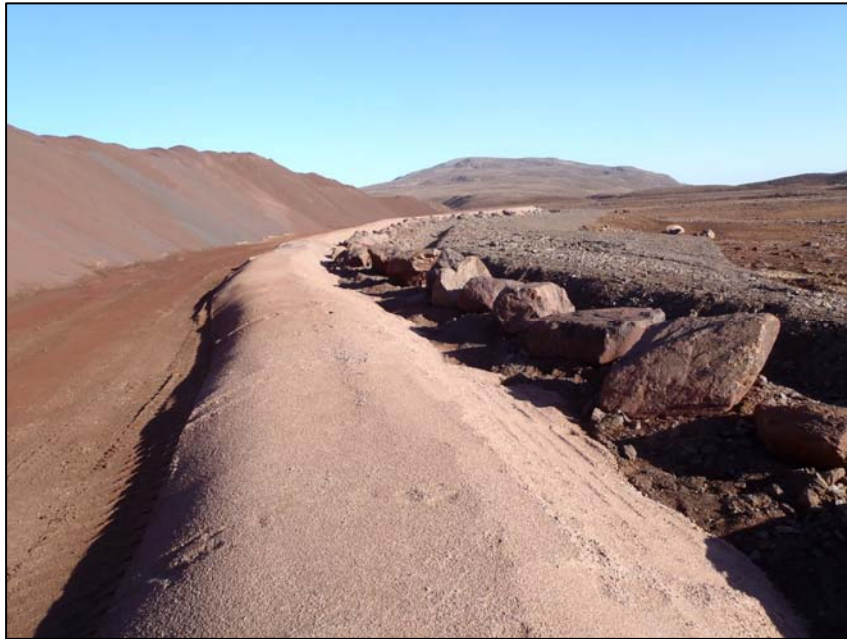
PHOTO 11 - Berm and perimeter ditch around Crusher Facility.

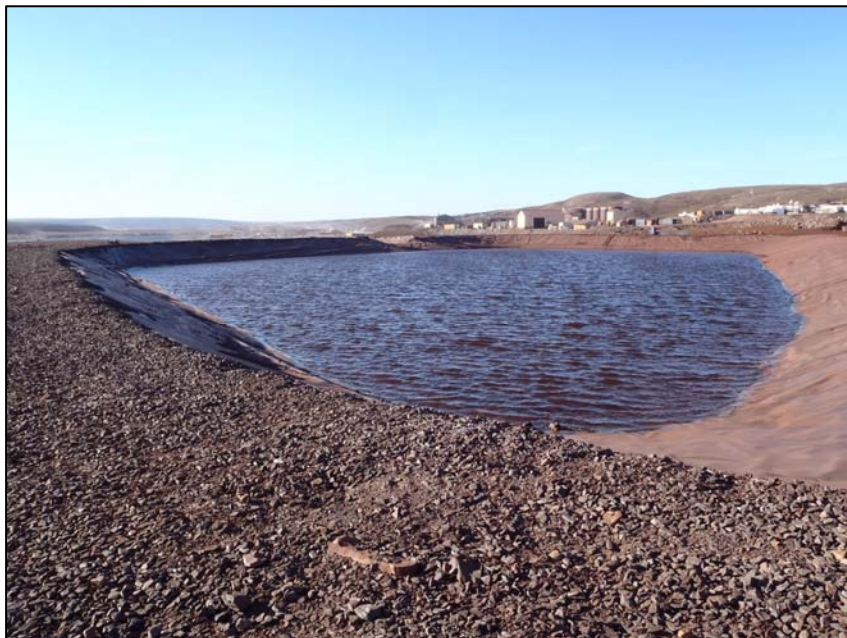
PHOTO 12 - Crusher Facility Surface Water Management Pond.

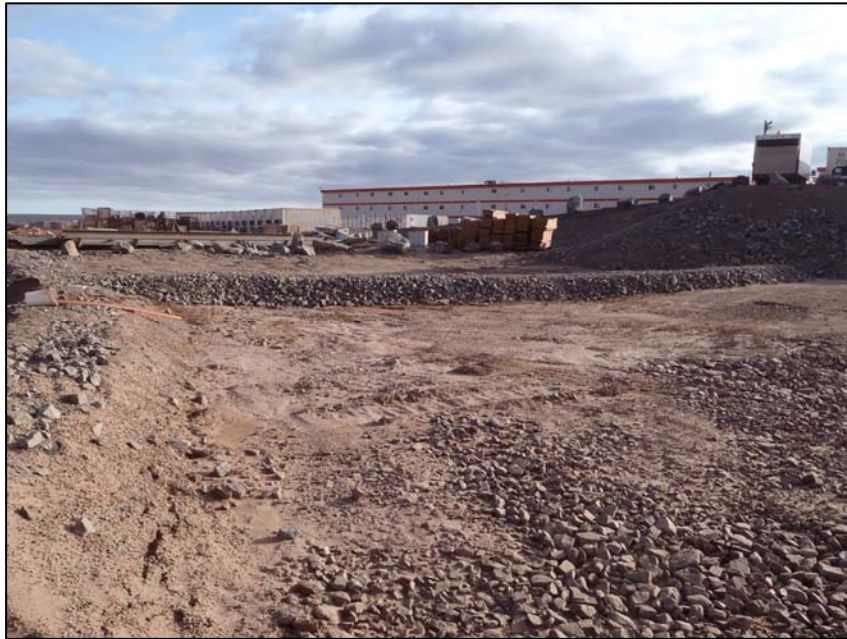
PHOTO 13 - Sailivik Camp laydown area check dams.

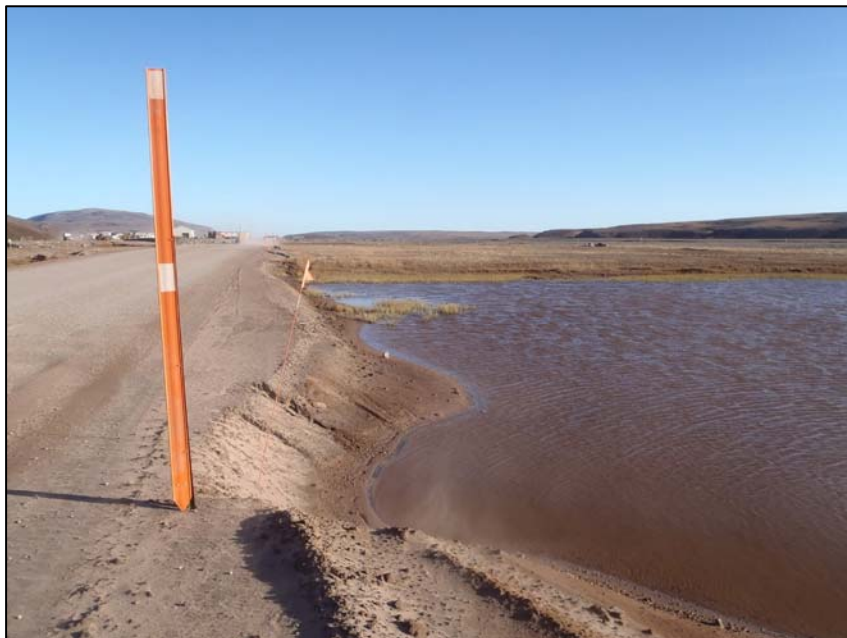
- Several culvert inlets and/or outlets were not visible along the Mine Site roadway because finer grained material had covered them (Photo 14, Appendix B). As mentioned previously, some of the culverts are damaged due to snow removal from upstream or downstream of the culverts in preparation for freshet.

PHOTO 14 - Finer material on bank of the Mine Site Road in culvert area.

| Project Component | Consideration | Category | Proposed Measure/Action |
|--|---|---|--|
| Mine Site Road | The presence of finer grained material on Mine Site Road banks and over culverts results in erosion of road material, blockage of culverts and possible sediment being washed downstream of the culverts. | | Replace or extend culverts and armour culvert inlets and outlets and road banks with riprap. Implement localized remediation measures along the road near fish habitat areas (i.e., silt fence, small check dams, armouring of road embankments and ditches). Road bank slopes need to be flattened at some locations. |

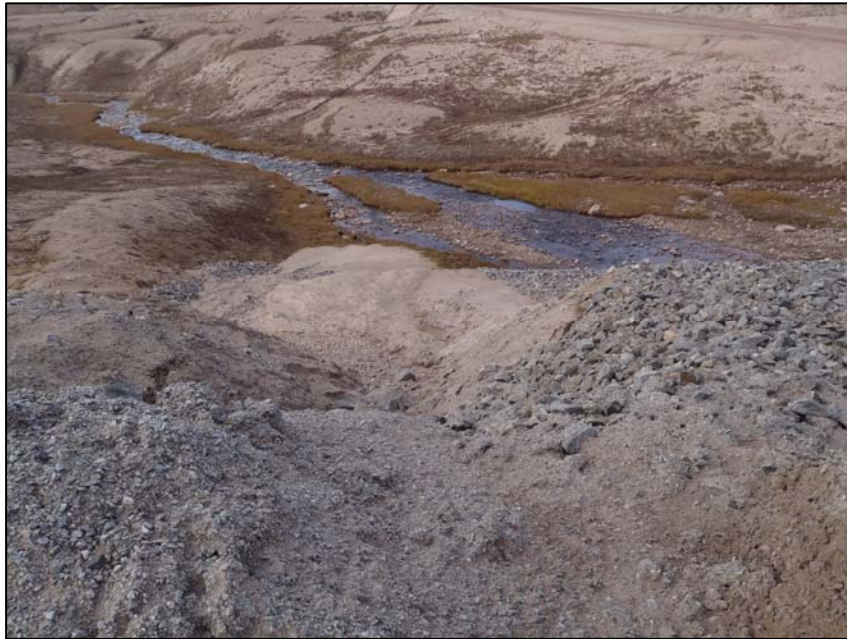
PHOTO 15 - Eroded material downslope of airstrip area.

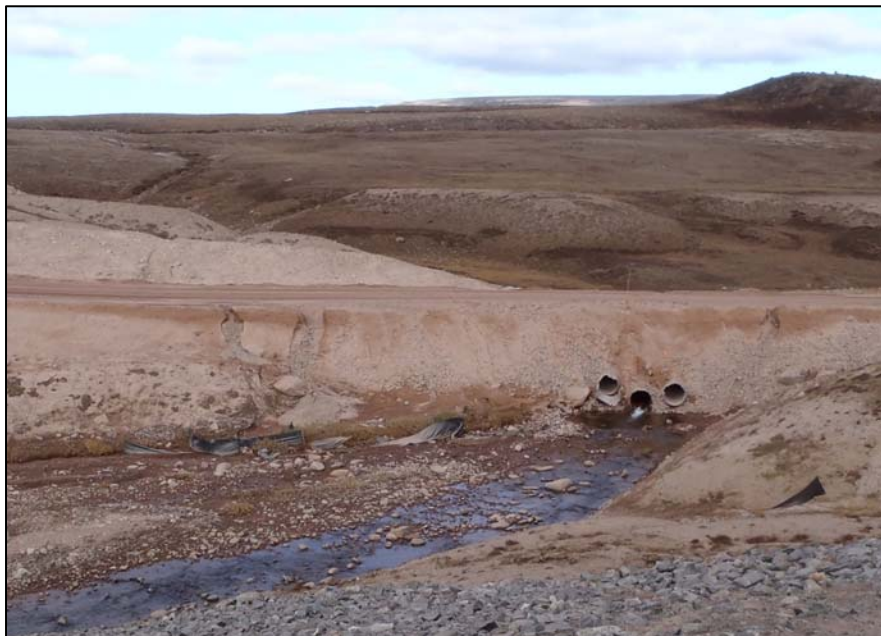
PHOTO 16 - Erosion along Mine Site Road at Tributary 3 to Camp Lake.

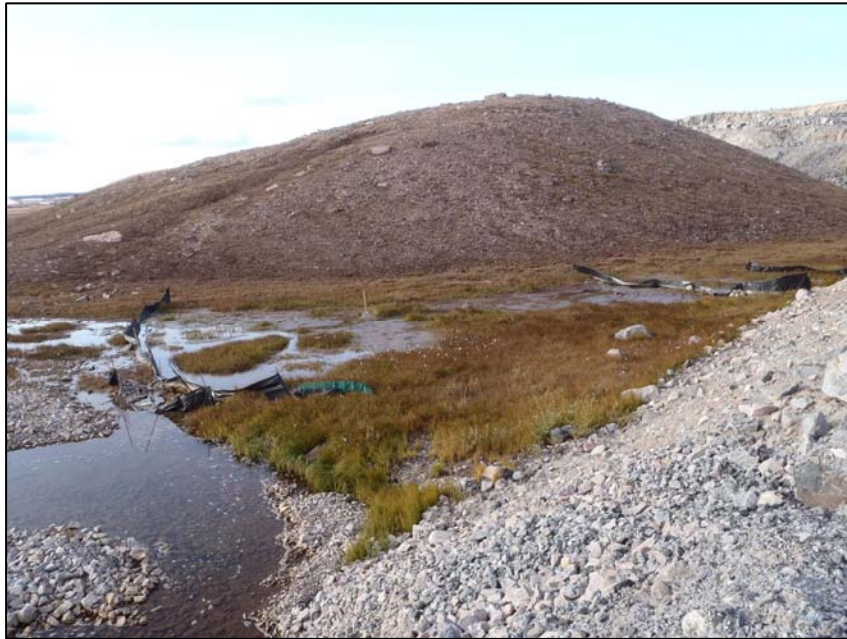
PHOTO 17 - Silt fences downstream of Quarry QMR2.

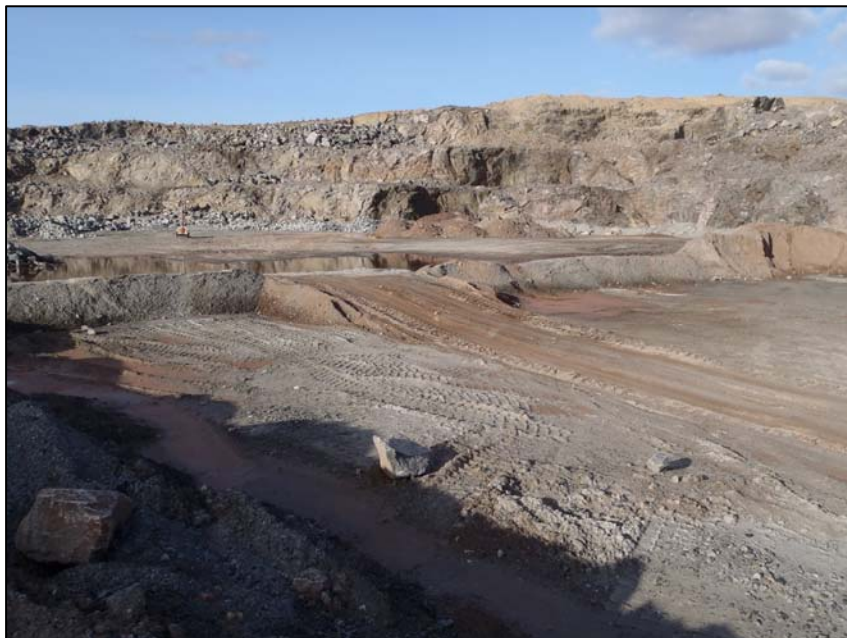
PHOTO 18 - Quarry QMR2 and berm.

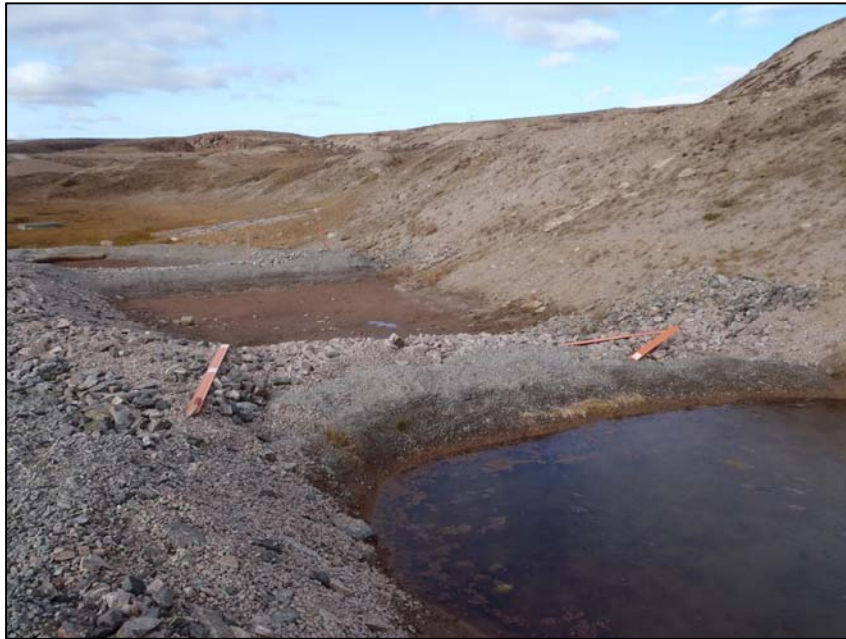
PHOTO 19 - Check dams and sediment traps by Water Jetty.

| Project Component | Consideration | Category | Proposed Measure/Action |
|--|---|---|--|
| | Existing check dams and sediment traps by the Water Jetty are undersized for the amount of runoff reporting to them. | | Divert or collect and pump runoff to a new sedimentation pond proposed south of the camp and thereby increase the water management capacity of existing structures. |

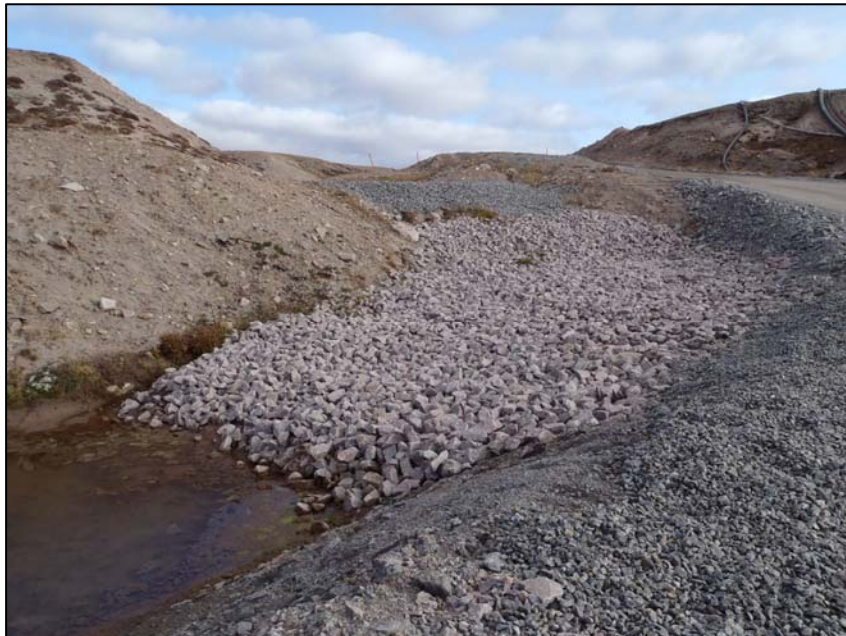
PHOTO 20 - Check dams near Water Jetty.

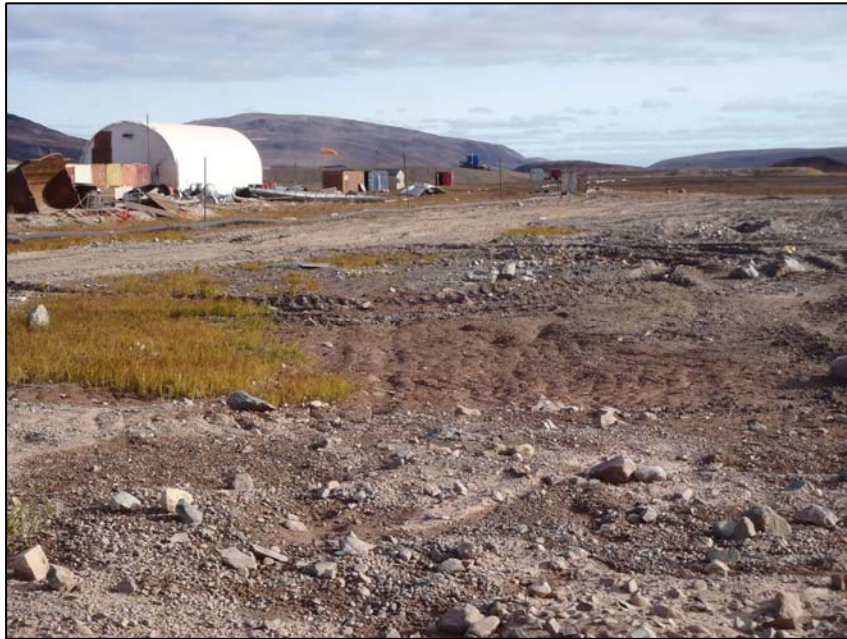
PHOTO 21 - Remnants of snow stockpile near Weatherhaven Camp.
