# Railway Construction Access Road Watercourse Crossing Assessments

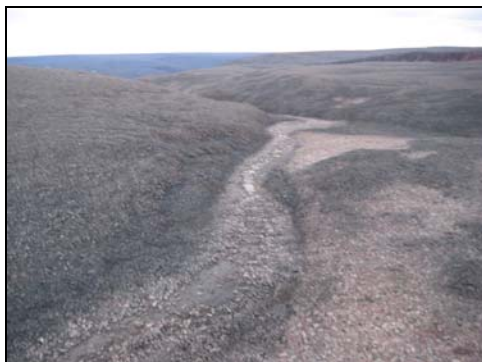
Figure 1: Aerial view of area near crossing R1

Cockburn Lake is ~2 km downstream of the crossing site. Cascades between Cockburn lake and the crossing site act as barriers.

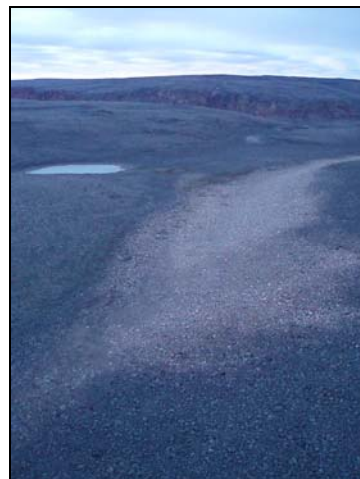
Figure 1: Aerial view of area near crossing R2

Cockburn Lake is ~2.5 km downstream of the crossing site. Cascades and a dry stretch between Cockburn lake and the crossing site act as barriers.

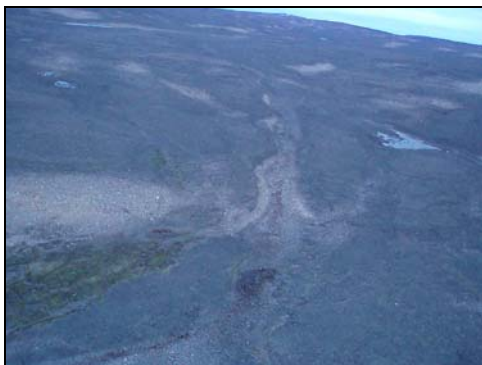
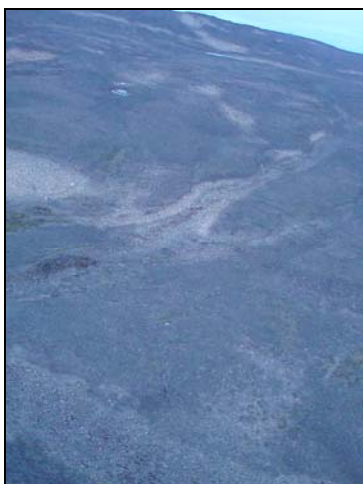
Figure 1: Aerial view of area near crossing R3

Cockburn Lake is several km downstream of the crossing site. A small river (flowing into Cockburn) is ~400 m downstream. All downstream areas are inaccessible.

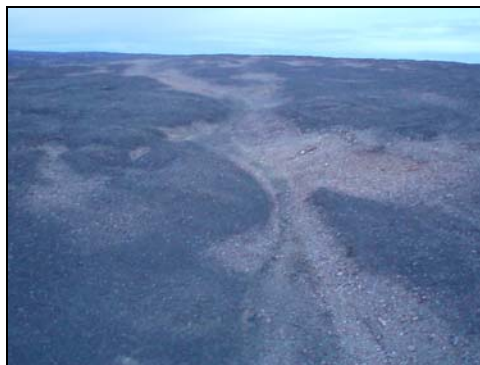
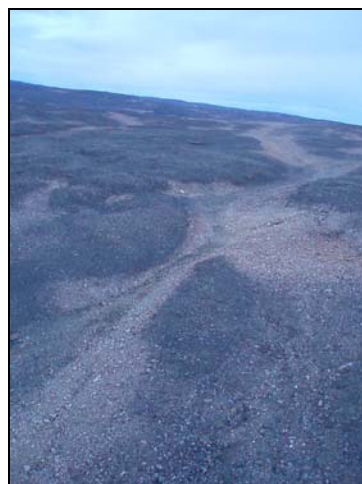
Figure 1: Aerial view of area near crossing R4

Cockburn Lake is several km downstream of the crossing site. A small river (flowing into Cockburn) is ~100 m downstream. All downstream areas are inaccessible.

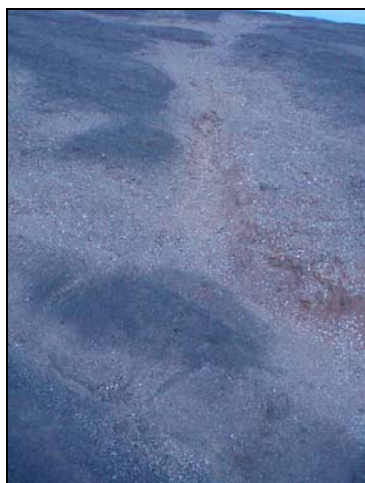
Figure 1: Aerial view of area near crossing R5

Cockburn Lake is several km downstream of the crossing site. A small river (flowing into Cockburn) is ~50 m downstream. All downstream areas are inaccessible.

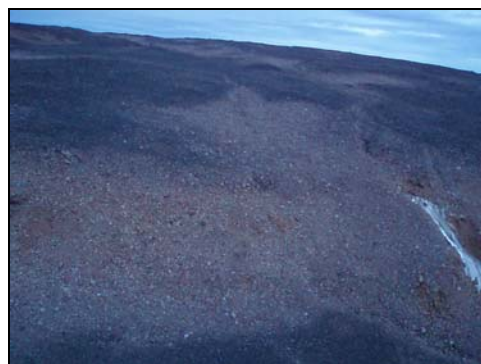
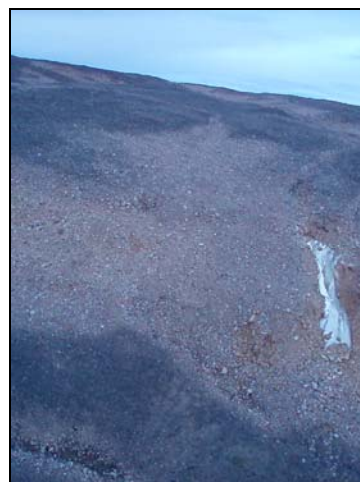
Figure 1: Aerial view of area near crossing R6

Cockburn Lake is several km downstream of the crossing site. A small river (flowing into Cockburn) is ~50 m downstream. All downstream areas are inaccessible.

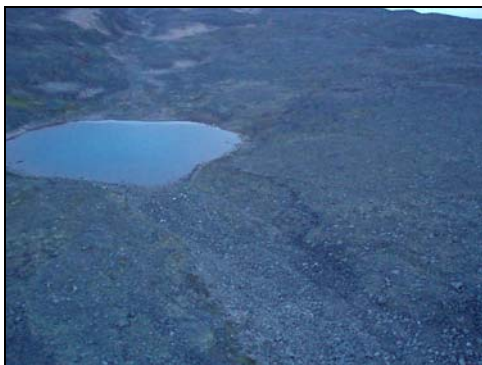
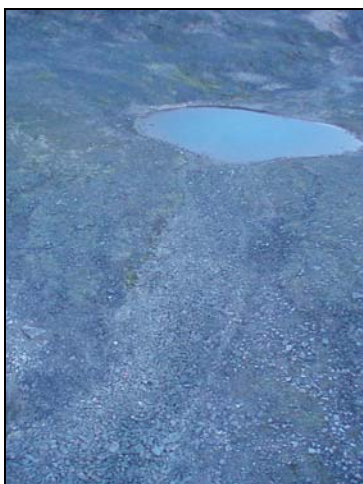
Figure 1: Aerial view of area near crossing R7

Cockburn Lake is several km downstream of the crossing site. A small river (flowing into Cockburn) is ~50 m downstream. All downstream areas are inaccessible.

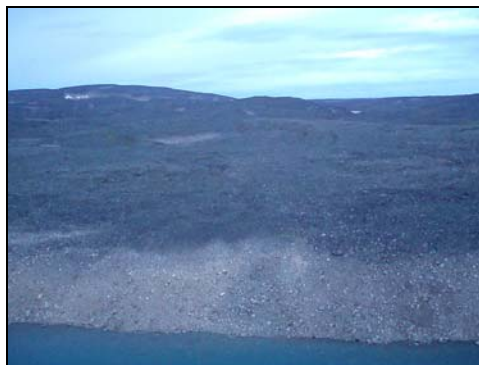
Figure 1: Aerial view of area near crossing R8

Cockburn Lake is several km downstream of the crossing site. A small lake (flowing into Cockburn) is ~50 m downstream. All downstream areas are inaccessible.

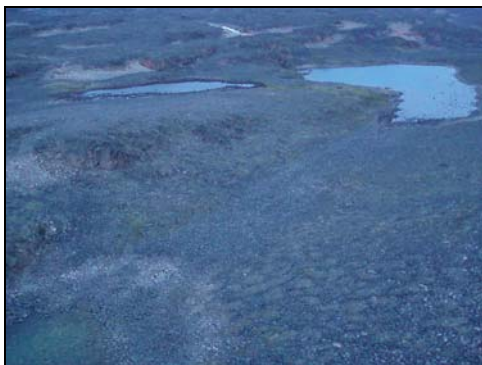
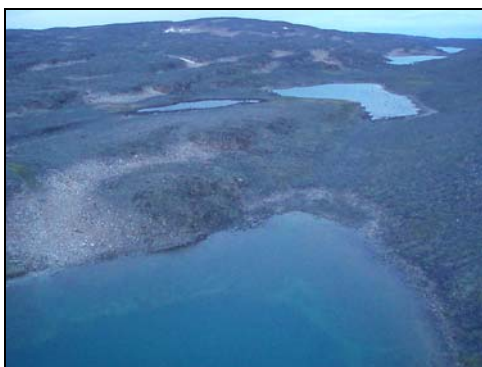
Figure 1: Aerial view of area near crossing R9

Cockburn Lake is several km downstream of the crossing site. A small lake (flowing into Cockburn) is ~100 m downstream. All downstream areas are inaccessible.

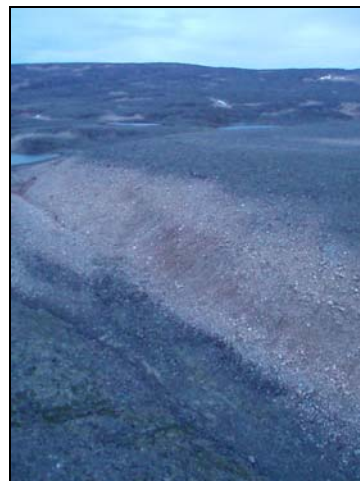
Figure 1: Aerial view of area near crossing R10

Cockburn Lake is several km downstream of the crossing site. There is an unnamed large lake ~700 m downstream of the crossing site. All downstream areas are inaccessible.

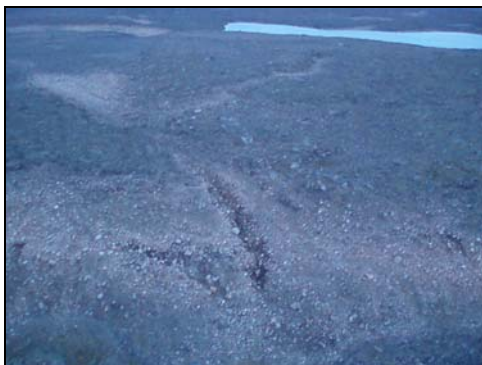
Figure 1: Aerial view of area near crossing R11

Cockburn Lake is several km downstream of the crossing site. There is an unnamed large lake ~300 m downstream of the crossing site. All downstream areas are inaccessible.

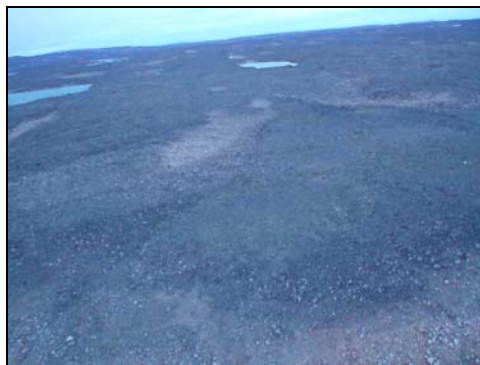
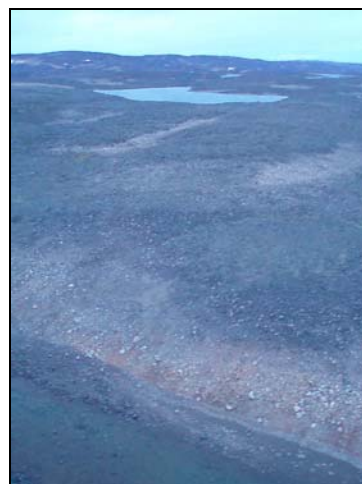
Figure 1: Aerial view of area near crossing R12

Cockburn Lake is several km downstream of the crossing site. There is an unnamed large lake ~50 m downstream of the crossing site. All downstream areas are inaccessible.

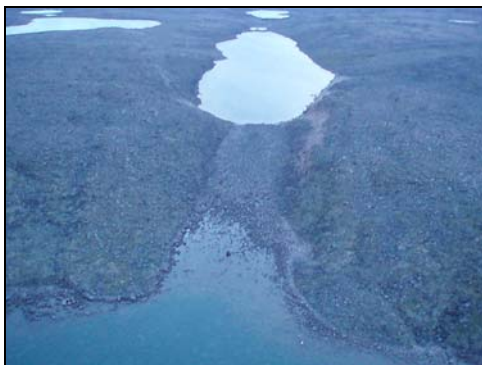
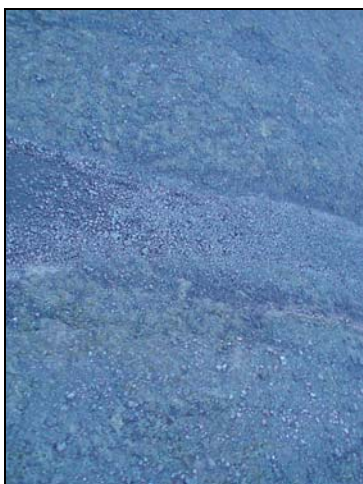
Figure 1: Aerial view of area near crossing R13

Cockburn Lake is several km downstream of the crossing site. There are unnamed lakes ~50 m upstream and downstream of the crossing site. Accessibility is limited.

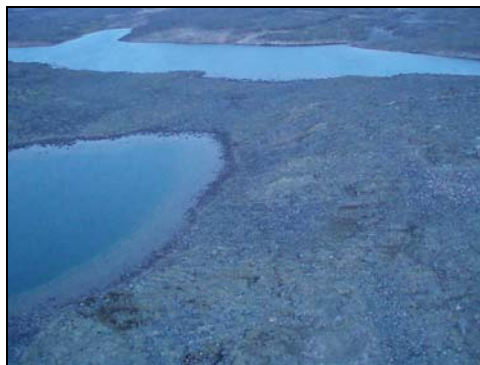
Figure 1: Aerial view of area near crossing R14

Cockburn Lake is several km downstream of the crossing site. There is an unnamed large lake ~50 m downstream of the crossing site. All downstream areas are inaccessible.

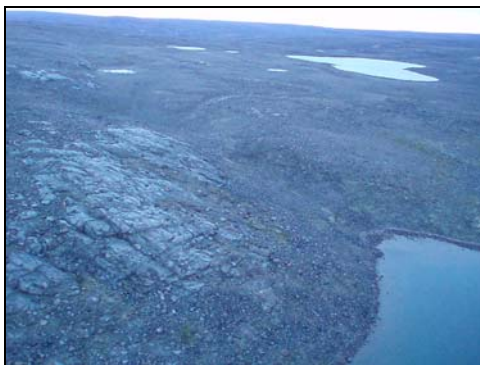
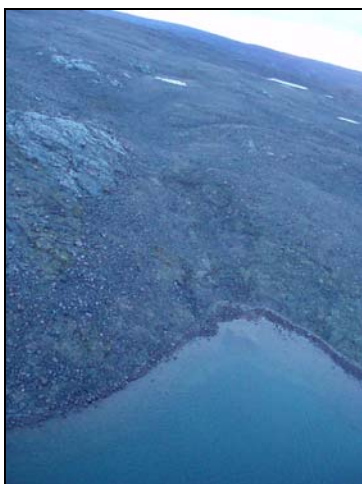
Figure 1: Aerial view of area near crossing R15

Cockburn Lake is several km downstream of the crossing site. There is an unnamed large lake ~50 m downstream of the crossing site. All downstream areas are inaccessible.

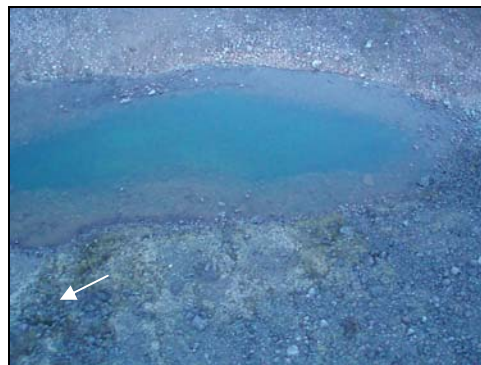
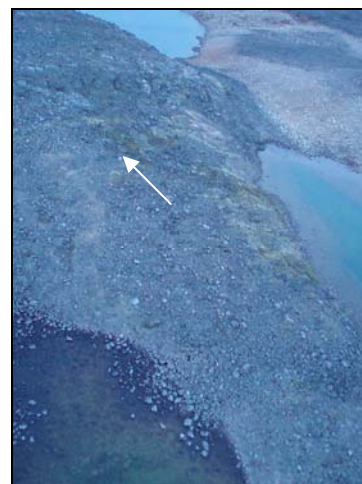
Figure 1: Aerial view of area near crossing R16 (white arrow)

Cockburn Lake is several km downstream of the crossing site. There is an unnamed large lake ~200 m downstream of the crossing site. All downstream areas are inaccessible.

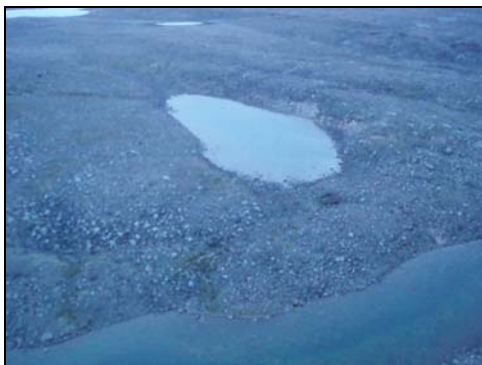
Figure 1: Aerial view of area near crossing R17

Cockburn Lake is several km downstream of the crossing site. There is an unnamed small lake ~50 m downstream of the crossing site. All downstream areas are inaccessible.

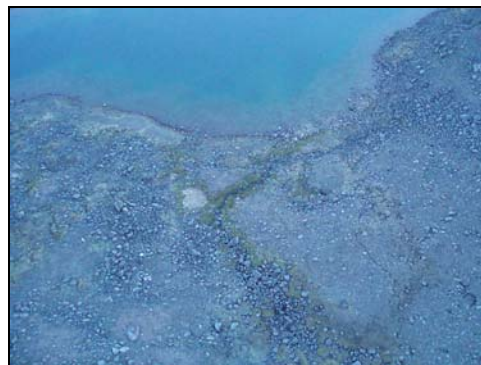
Figure 1: Aerial view of area near crossing R18

Cockburn Lake is several km downstream of the crossing site. There is an unnamed small lake ~50 m downstream of the crossing site. All downstream areas are inaccessible.

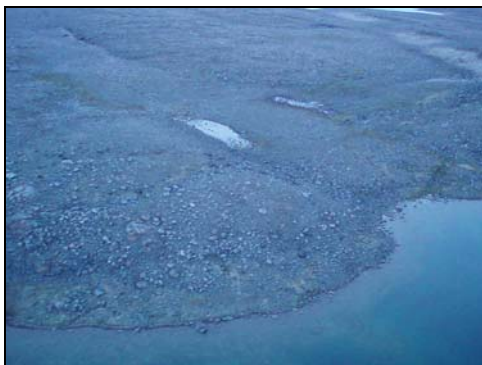
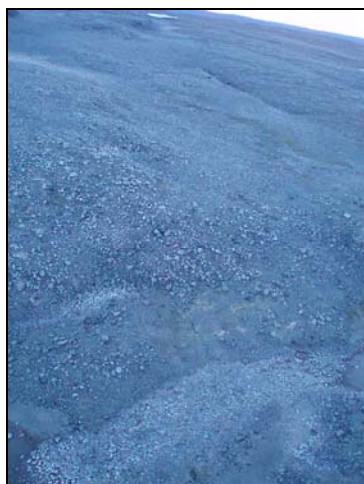
Figure 1: Aerial view of area near crossing R19

Cockburn Lake is several km downstream of the crossing site. There is an unnamed small lake ~50 m downstream of the crossing site. All downstream areas are inaccessible.

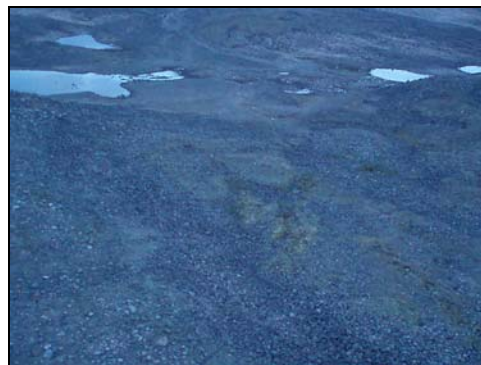
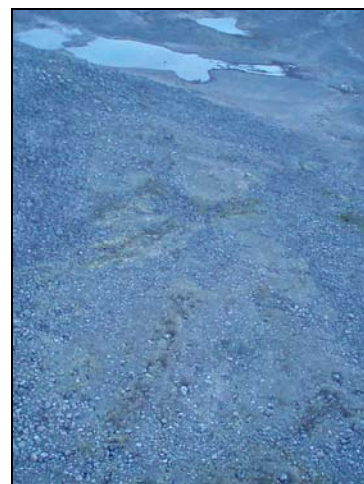
Figure 1: Aerial view of area near crossing R20

Cockburn Lake is several km downstream of the crossing site. There is an unnamed lake ~1 km downstream of the crossing site. All downstream areas are inaccessible.

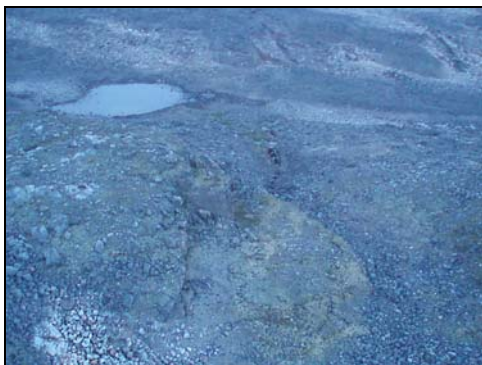
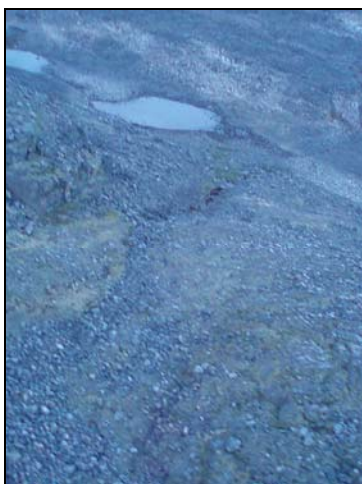
Figure 1: Aerial view of area near crossing R21

Cockburn Lake is several km downstream of the crossing site. There is a small, unnamed river ~50 m downstream of the crossing site. All downstream areas are inaccessible.

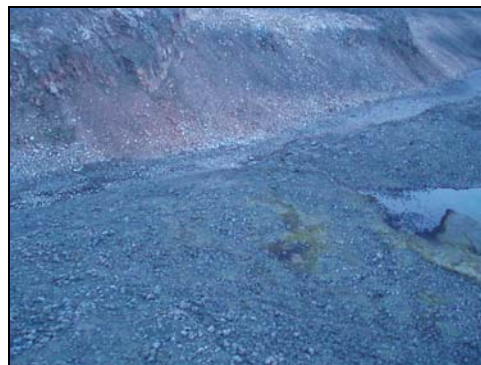
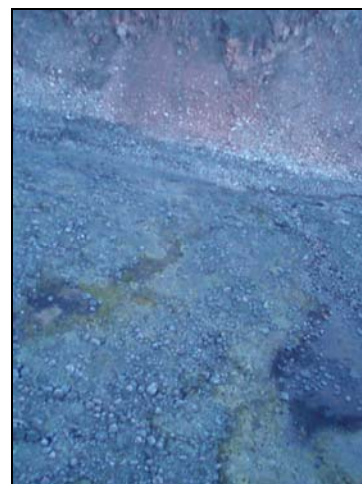
Figure 1: Aerial view of area near crossing R22

Cockburn Lake is several km downstream of the crossing site. There is a small, unnamed river ~50 m downstream of the crossing site. All downstream areas are inaccessible.
