BAFFINLAND IRON MINES CORPORATION

MARY RIVER PROJECT

Access Road Stream Crossing Sites (MAP I)

Rail Alignment Watercourse Crossing Assessment

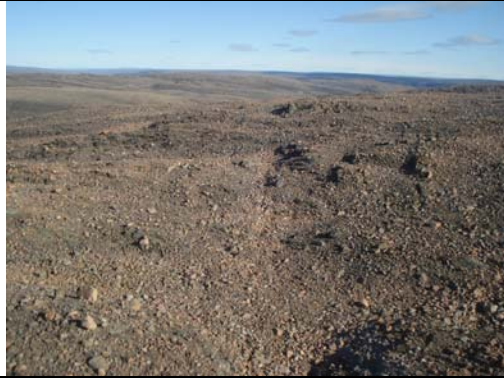
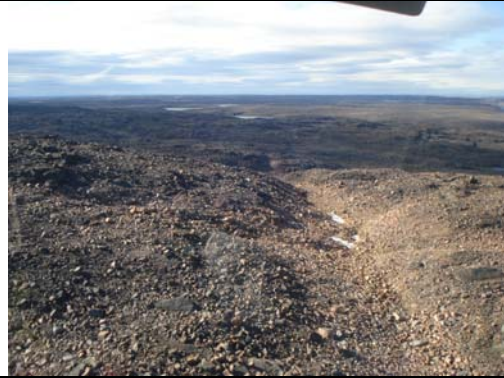
Dry, mountain top drain. No headwaters. Channel not well defined.

Fish Habitat Quality – NO FISH HABITAT

Figure 1. Aerial view looking upstream (A), aerial view looking downstream (B).

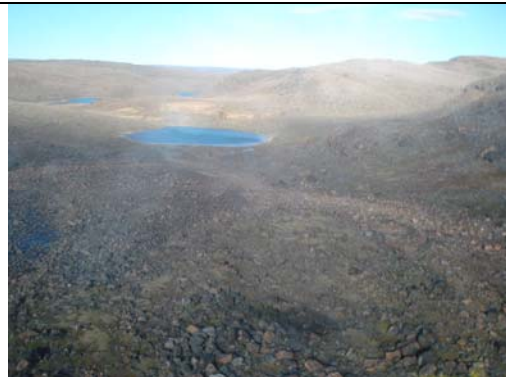
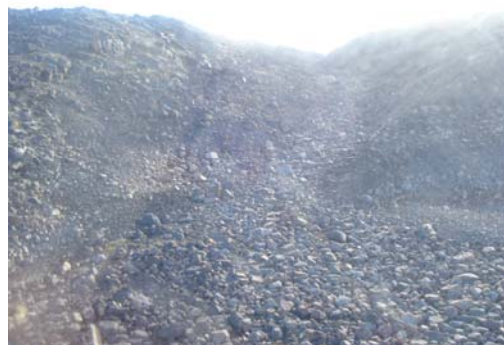
Dry channel. Steep mountain drain which connects to AR-41.

Fish Habitat Quality – NO FISH HABITAT

Figure 1. Aerial view looking downstream (A), aerial view looking upstream (B).

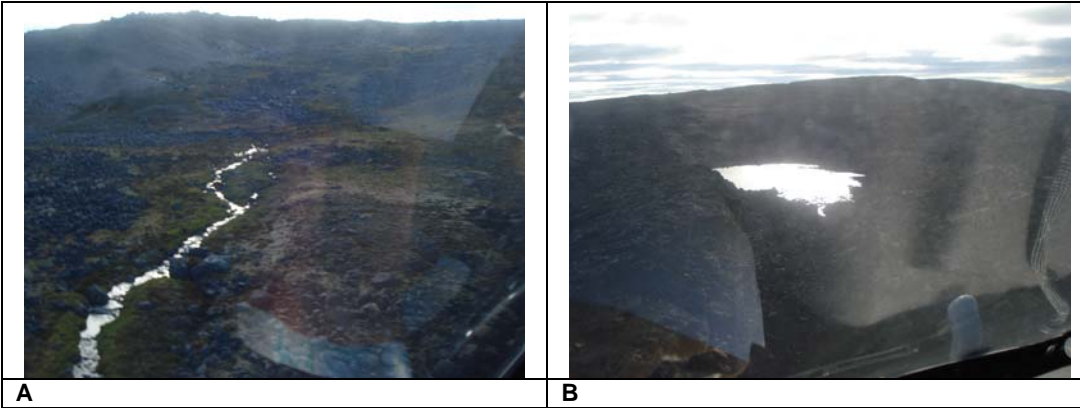
Steep gradient drainage between two shallow ponds (each < 2 m deep). No connection to overwintering habitat.

Fish Habitat Quality – NO FISH HABITAT

Figure 1. View at crossing looking upstream (A), view of headwater pond (B).

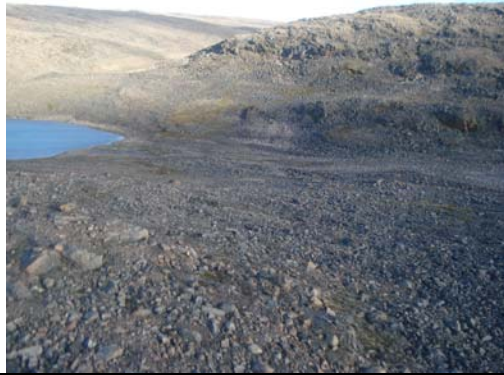
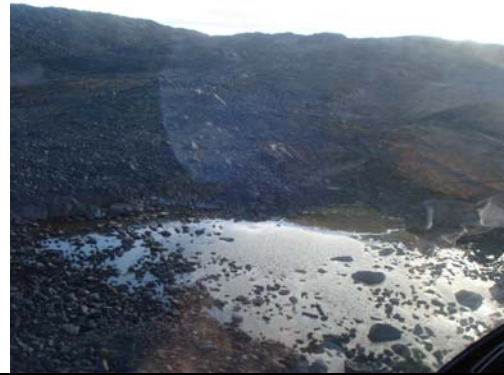
Drainage between two shallow ponds (each < 1 m deep). Poorly defined channel with a ridge between ponds. No connection to overwintering habitat.

Fish Habitat Quality – NO FISH HABITAT

Figure 1. View downstream from crossing (A), view of upstream pond (B).

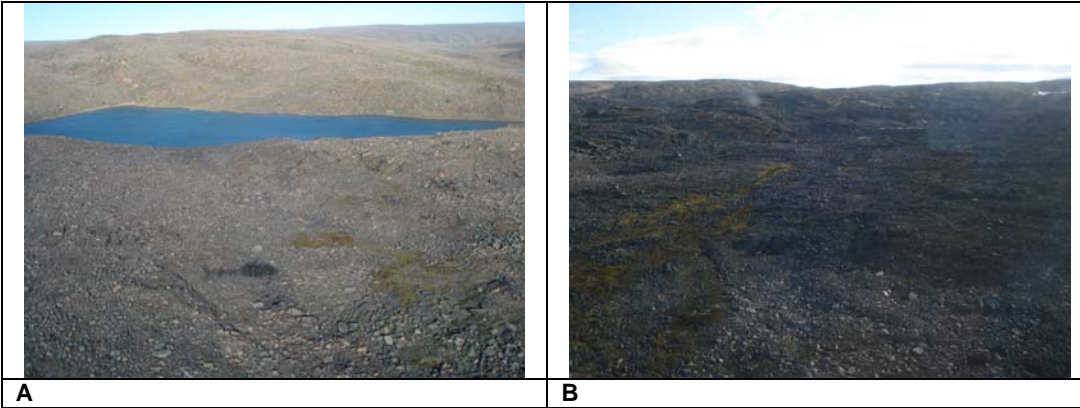
Drainage between a small, shallow (< 1 m deep) pond (upstream of crossing) and the same lake as AR-38 (< 4 m deep) (downstream). Was dry at time of survey.

Fish Habitat Quality – NO FISH HABITAT

Figure 1. View downstream from crossing (A), view upstream from crossing (B).

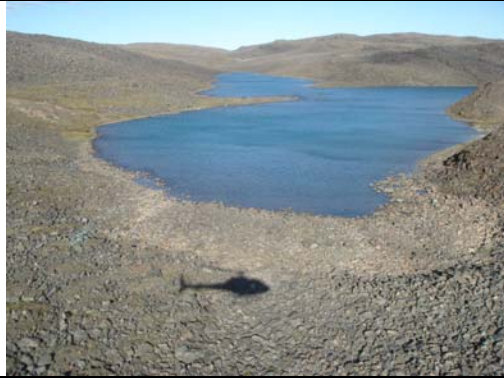
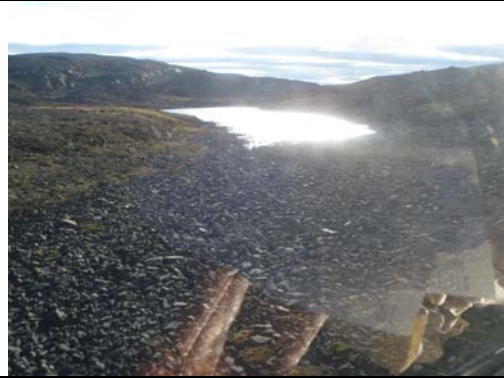
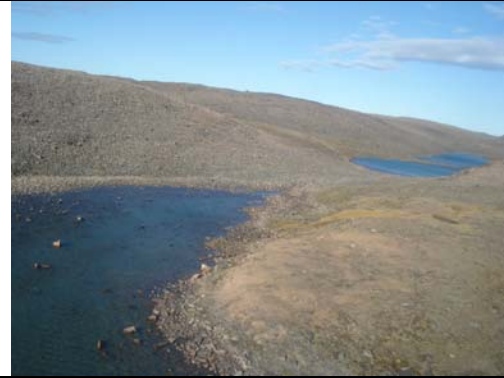
Drainage connects two lakes. No defined channel; water percolating through rock. Water depths of upstream and downstream lakes < 4 m; are unlikely to support fish.

Fish Habitat Quality – NO FISH HABITAT

Figure 1. View downstream of crossing (A), view upstream of crossing (B), view from upstream lake looking downstream (C).

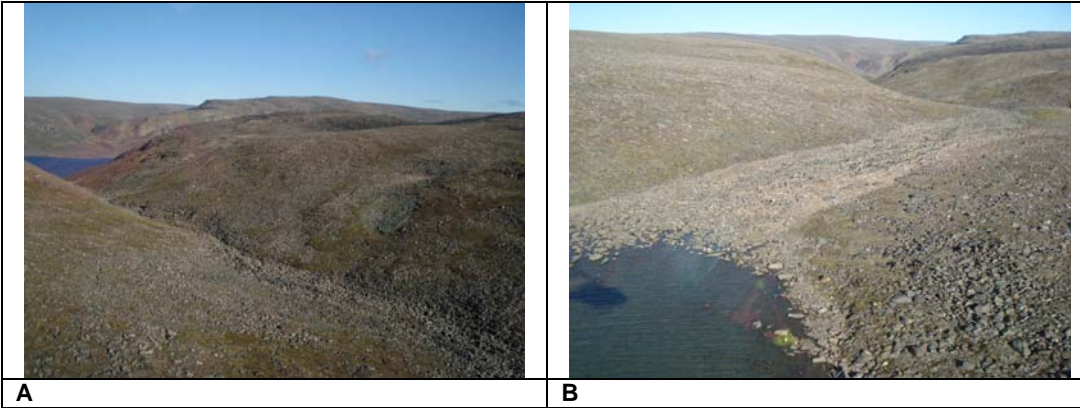
Drainage between Cockburn Lk. (downstream of crossing location) and shallow waterbody (upstream; < 4 m deep) that is unlikely to support fish. Steep gradient between crossing location and Cockburn Lk. would prevent fish from Cockburn Lk. reaching crossing area.

Fish Habitat Quality – NO FISH HABITAT

Figure 1. View of crossing area (A), outlet of upstream waterbody (B).

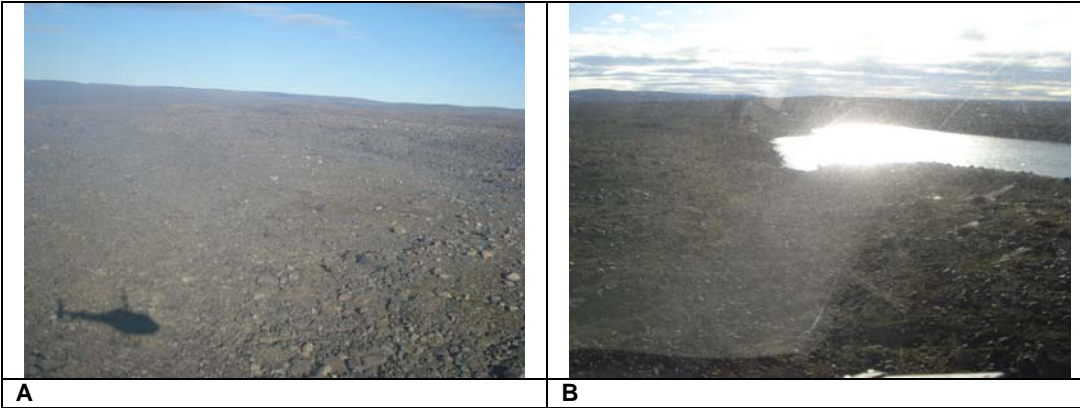
No defined channel. No headwaters. No fish habitat. Land ridge prevents waterbody to the East from entering stream.

Fish Habitat Quality – NO FISH HABITAT

Figure 1. West view of crossing location (A), view of waterbody to the east of crossing (B).

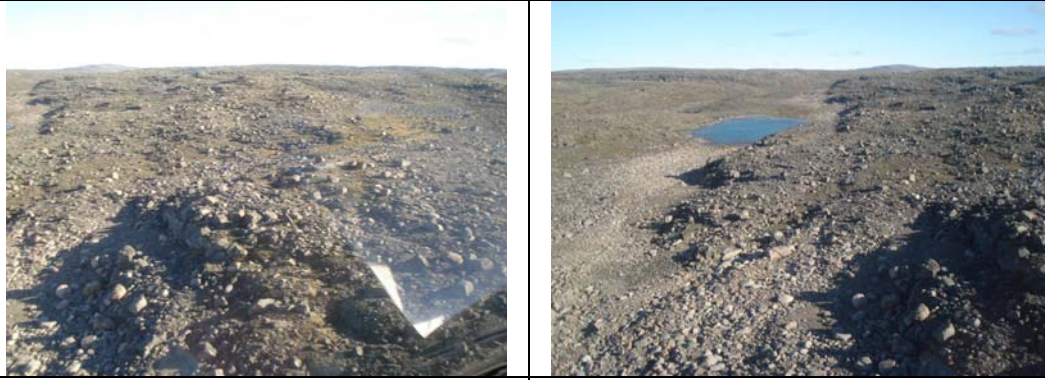
Dry channel at crossing, no defined channel. No headwaters. Tributary to AR-030.

Fish Habitat Quality – NO FISH HABITAT

Figure 1. Aerial view from crossing area looking upstream (A), aerial view of drain's confluence with downstream drain (crossing area is to the right hand side of the photo) (B).

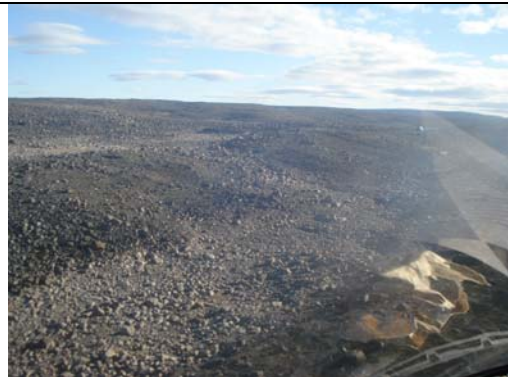
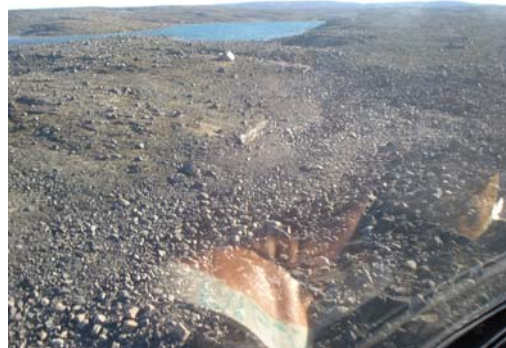
Dry channel at crossing. Large waterbody upstream from crossing (< 4 meters deep). Land ridge between waterbody and stream. Flow of water from waterbody to stream would only occur under conditions of high water.

Fish Habitat Quality – NO FISH HABITAT

Figure 1. View of dry channel at crossing (A), view upstream from crossing (B).

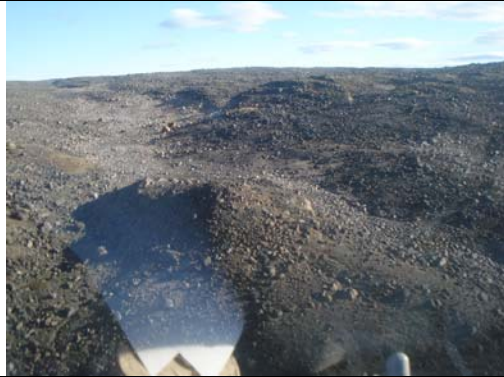
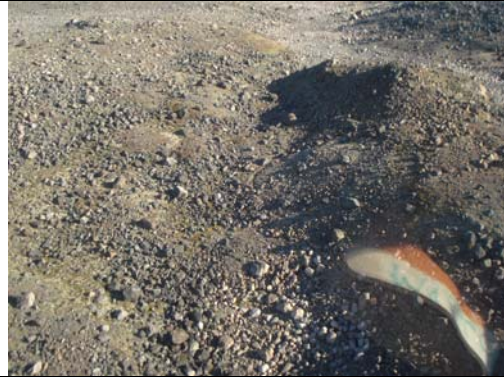
Mountain drain with no headwater lake. Was dry at time of survey. Joins with AR-028.

Fish Habitat Quality – NO FISH HABITAT

Figure 1. Aerial view from crossing area looking downstream towards confluence with AR-028 drain (A), crossing location (B)

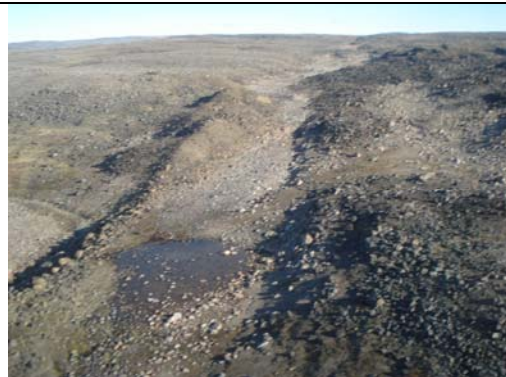
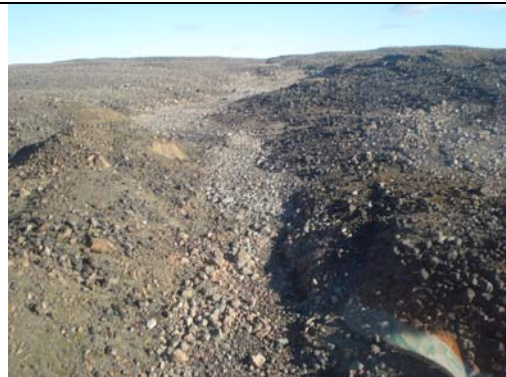
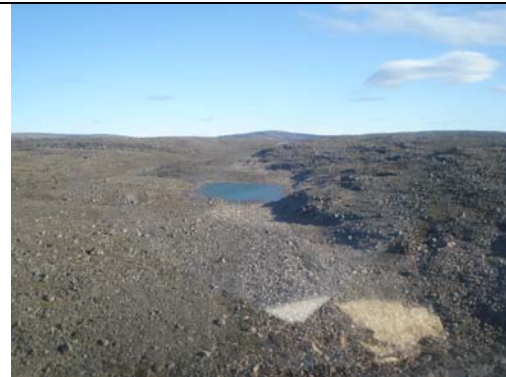
Dry drain flowing to AR-028 from shallow pond. High gradient.

Fish Habitat Quality – NO FISH HABITAT

Figure 1. View of dry drain (A), upstream view of crossing (B), view of upstream pond (C).

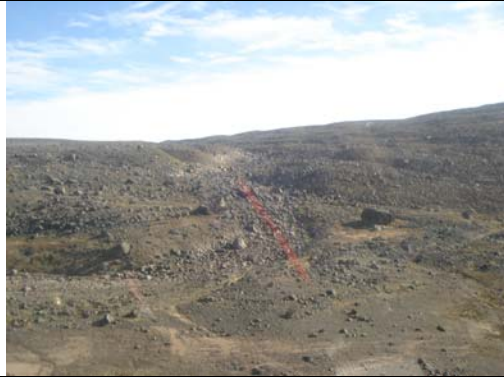
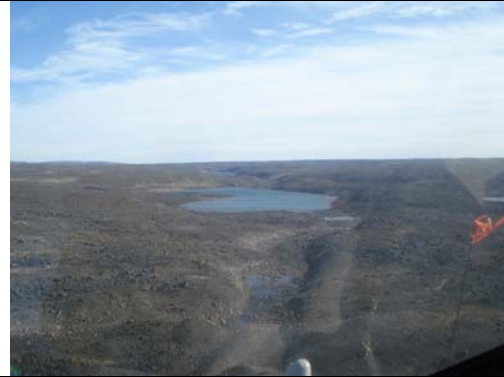
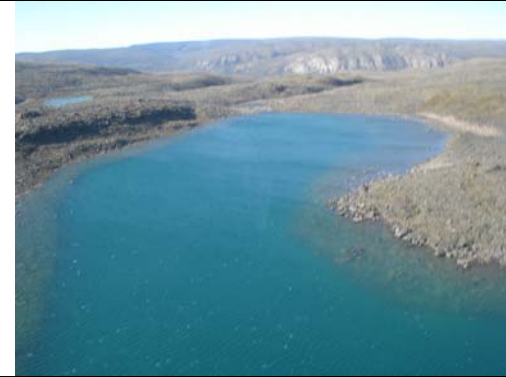
Drains shallow waterbody to Cockburn Lk. Wetted at crossing area, but dry further downstream. The upstream waterbody is < 4 m deep and is unlikely to support fish. A steep gradient between Cockburn Lk. and the crossing location would prevent fish from Cockburn Lk. reaching crossing area.

Fish Habitat Quality – NO FISH HABITAT

Figure 1. Aerial view from Cockburn Lk. looking upstream at drain's steep gradient (A), aerial view from crossing location looking upstream at headwater lake(B), downstream view of headwater lake and outlet (C).

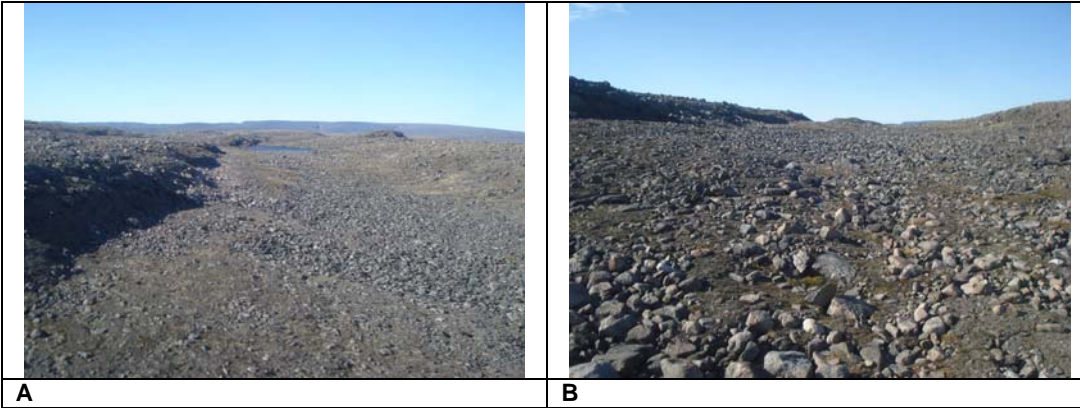
Figure 1. Aerial view from crossing area looking upstream towards smaller waterbody (A), aerial view from larger waterbody looking upstream at steep gradient (B).

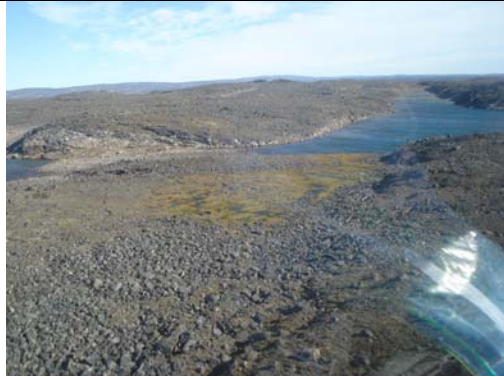
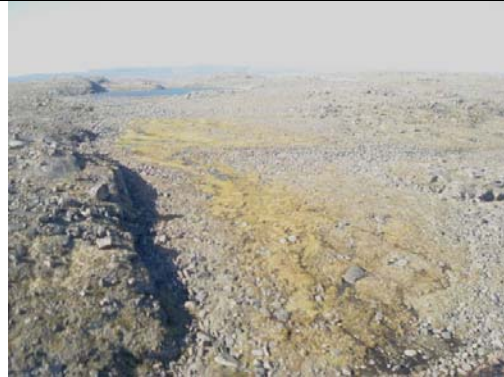
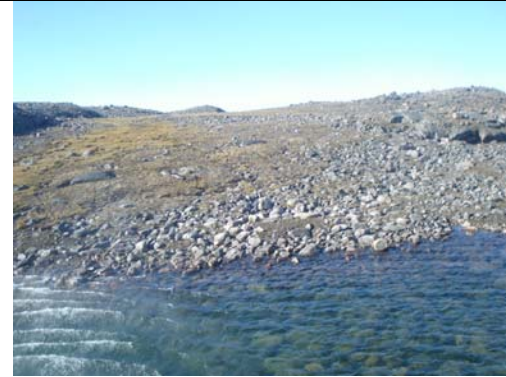
Figure 1. Aerial view from crossing area looking downstream towards larger waterbody (cobble area is the drainage) (A), aerial view from crossing area looking upstream towards smaller waterbody (B), aerial view from larger waterbody looking upstream at steep gradient (C).

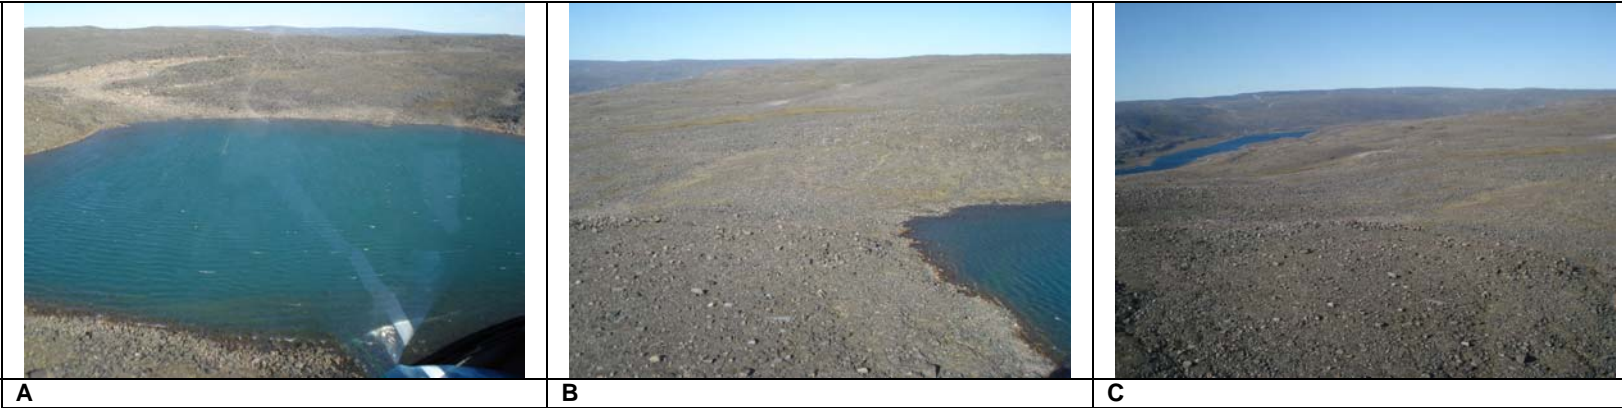
Figure 1. Aerial view upstream of crossing area at headwaters (A), aerial view of crossing area (B), aerial view looking downstream of crossing location (C).

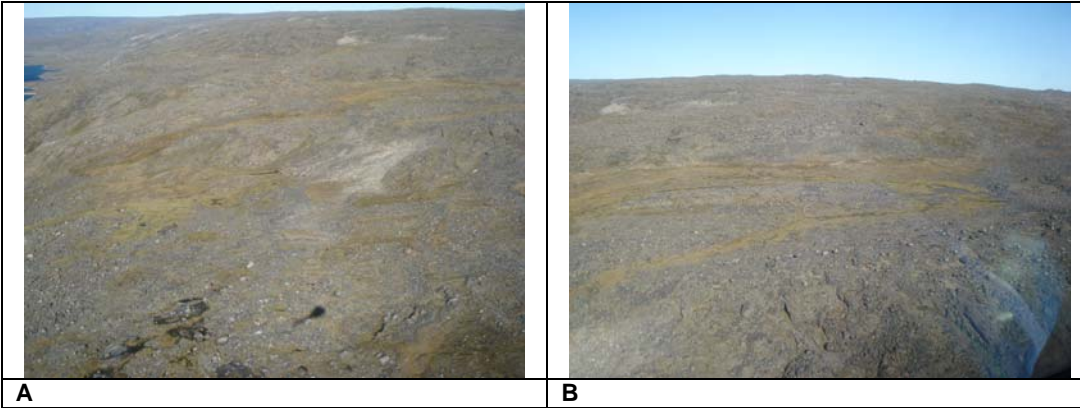
Figure 1. Aerial view of crossing location (A), aerial view upstream of crossing location (B).

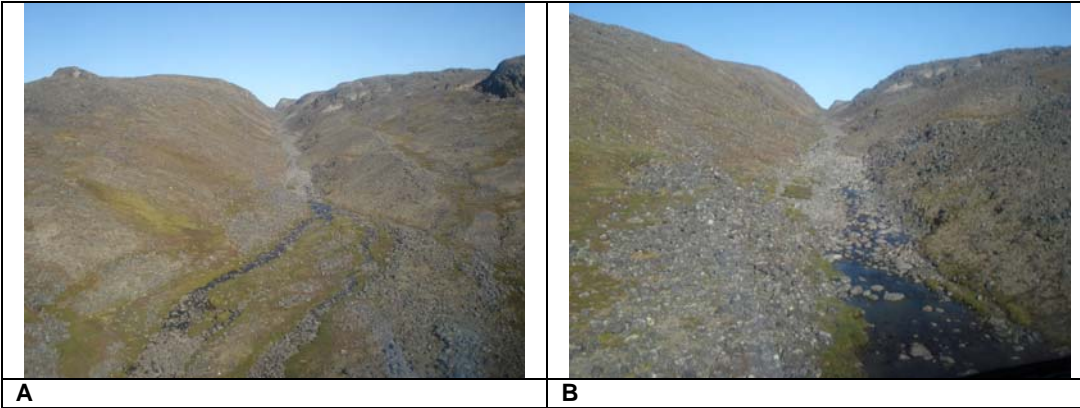
Figure 1. Aerial view from downstream of the crossing location looking upstream (A) and (B).

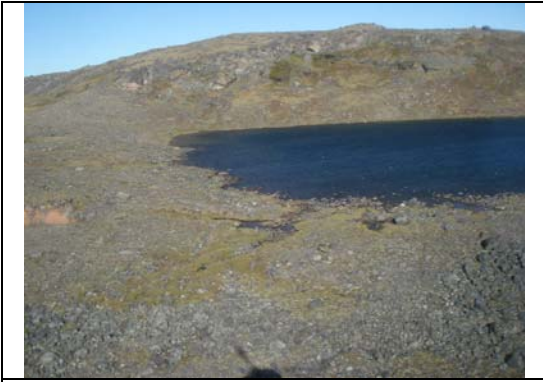
Figure 1. Aerial view of dry drain from small deep lake on top of mountain (A)

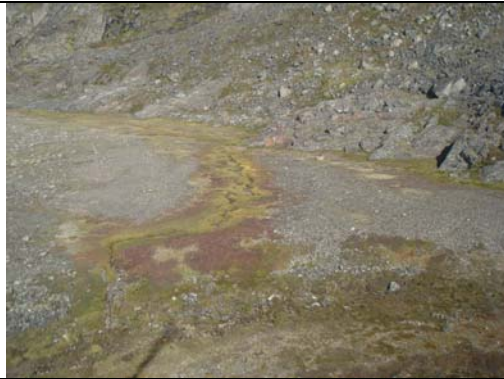
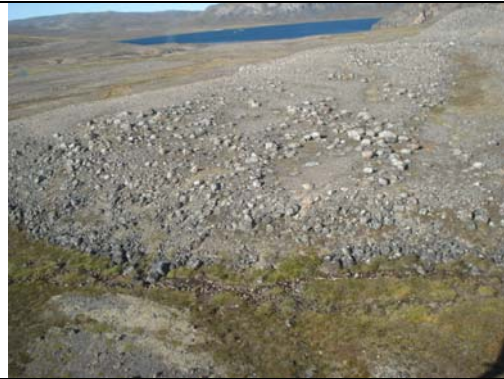
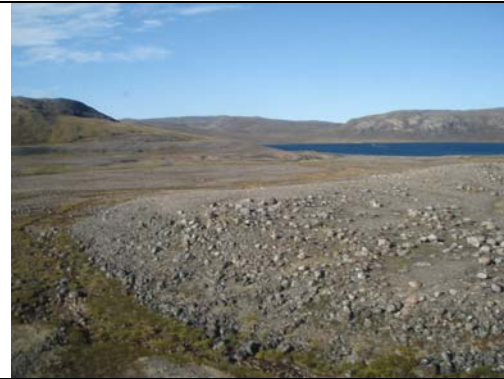
Figure 1. Aerial view looking upstream towards crossing location (A), aerial view at crossing location (B), aerial view looking downstream of crossing (C)

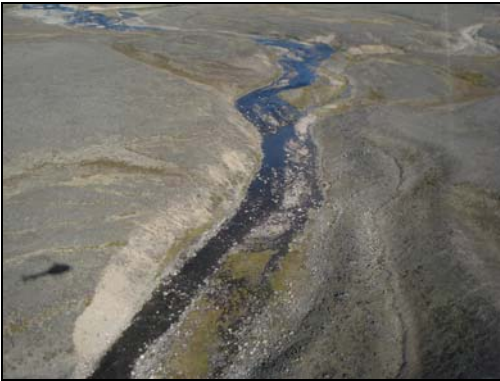
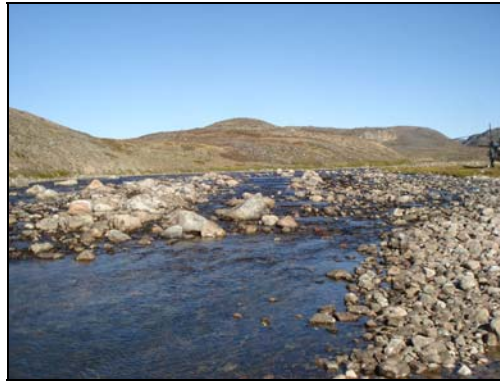
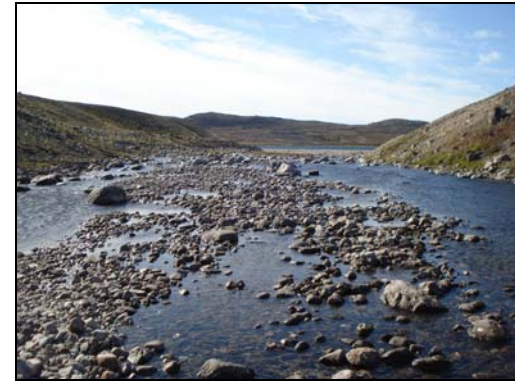
Although electrofishing was not conducted, habitat near the crossing is suitable for rearing of both species. Connected to Cockburn Lake downstream of crossing; no downstream barriers observed.

Figure 1. Aerial view of crossing area (A), view upstream of crossing (B), and downstream of crossing (C).

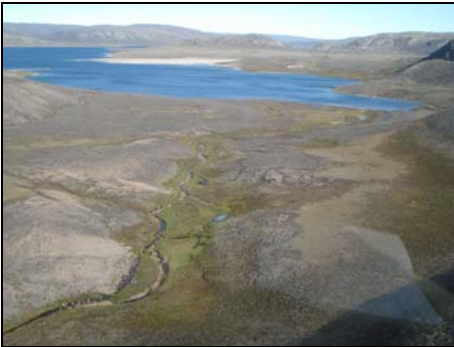
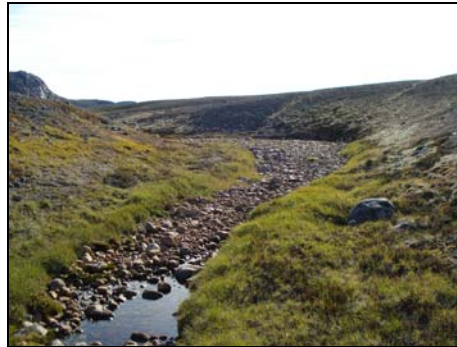
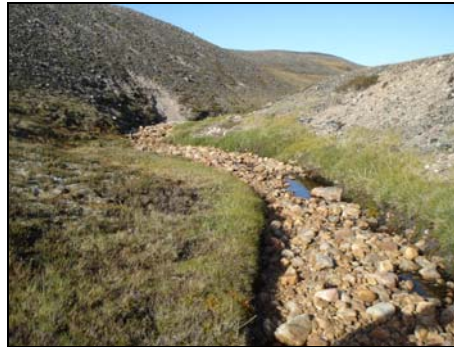
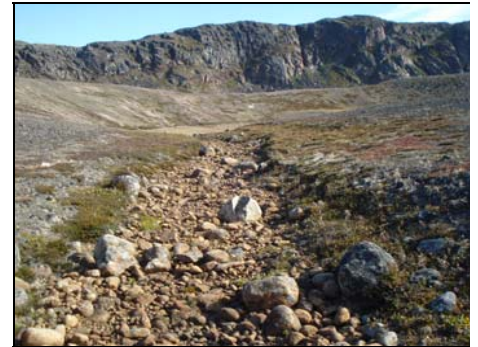
Figure 1. Aerial view of crossing area (A), view upstream of crossing (B), downstream of crossing (C), and view upstream from 60 m upstream of the crossing (D).

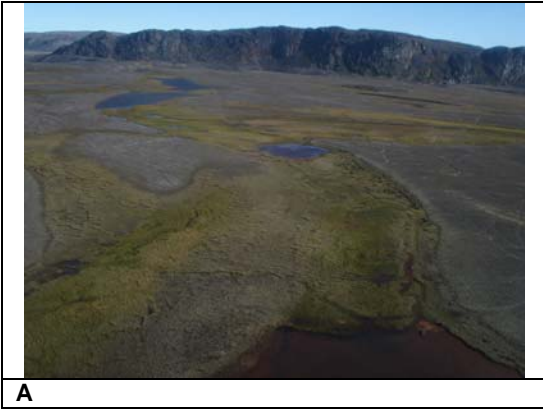
Figure 1. Aerial view of crossing area (A).

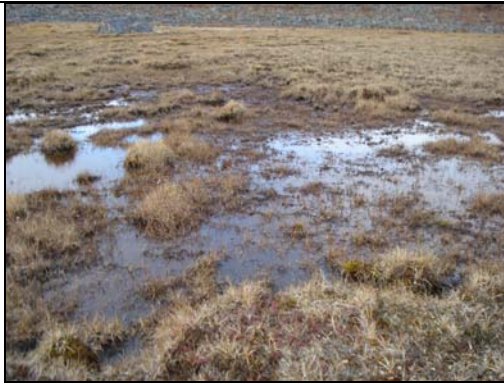
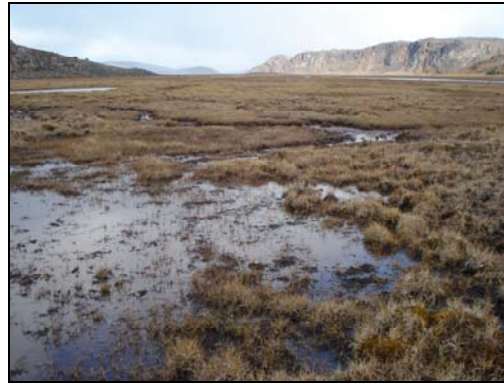
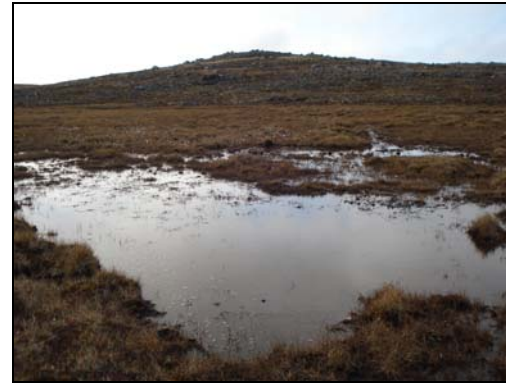
Figure 1. View of habitat at crossing (A), downstream of crossing (B) and upstream of crossing (C).

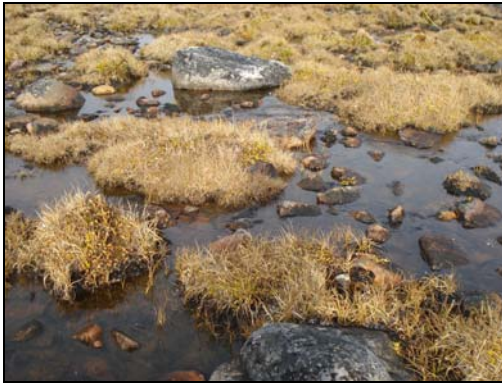
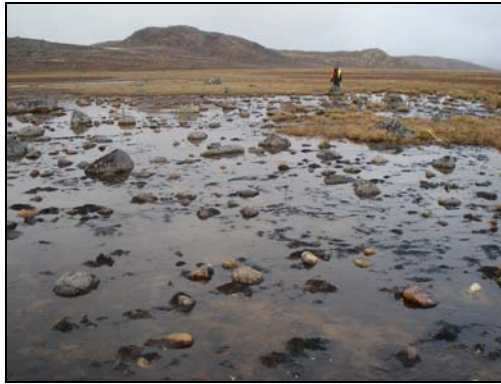
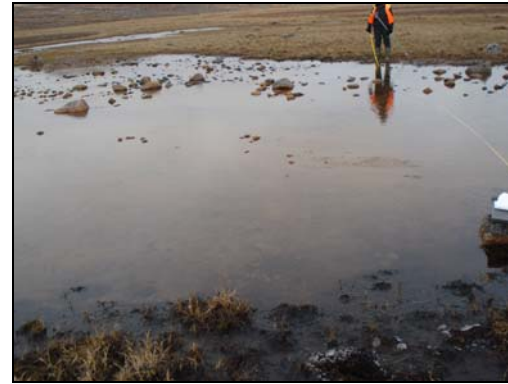
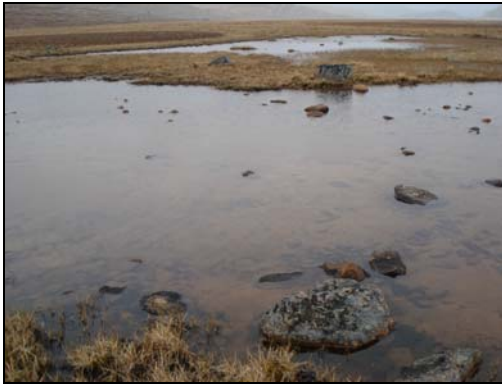
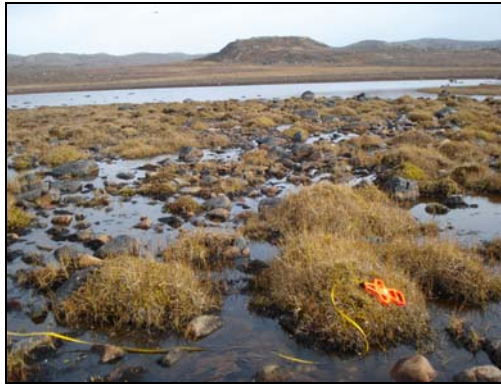
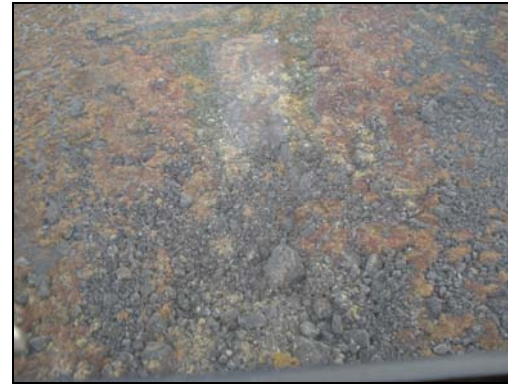
Figure 1. View of habitat, (A) 40m downstream across, (B) 20m downstream, (C) 20m upstream, (D) 40m upstream across, (E) at crossing across, and (F) upstream barrier.

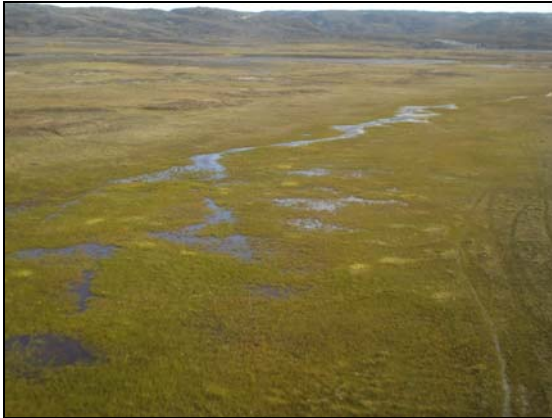
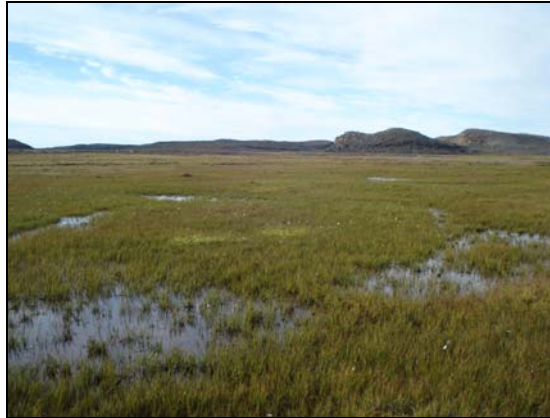
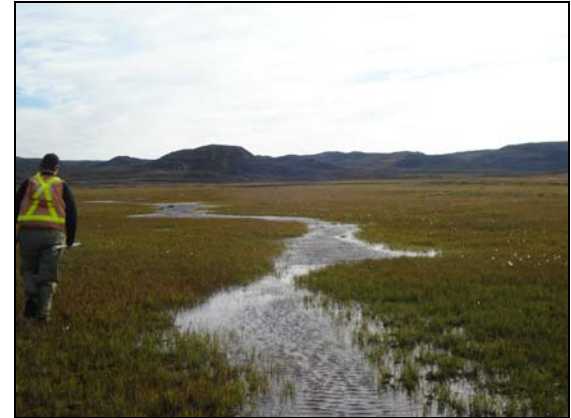
Approximately 20 m upstream of the crossing location, the watercourse channel disappears and the habitat becomes fen-like (i.e., saturated grass). NNST habitat would be rated Marginal in this fen-like habitat as water depth is diminished. Habitat at and downstream of the crossing may be used by NNST for spawning. Further downstream, there is a connection to an overwintering waterbody.

Figure 1. Aerial view of crossing area (A), view upstream of crossing (B), and view downstream of crossing (C).
