MARY RIVER PROJECT

Quarry Sites (MAP B)

# Rail Alignment Watercourse Crossing Assessment

**Crossing ID:** Q64+400  
**UTM Coordinates:** 17 W 600174 7868669

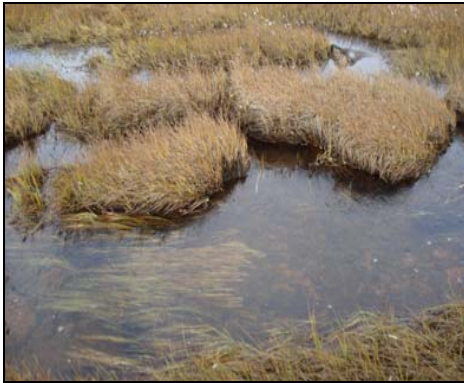
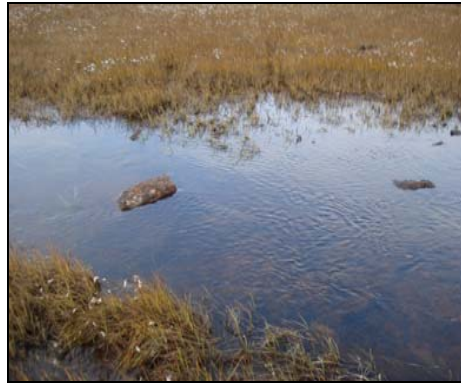
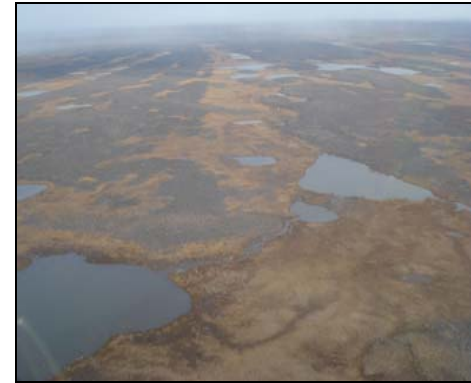
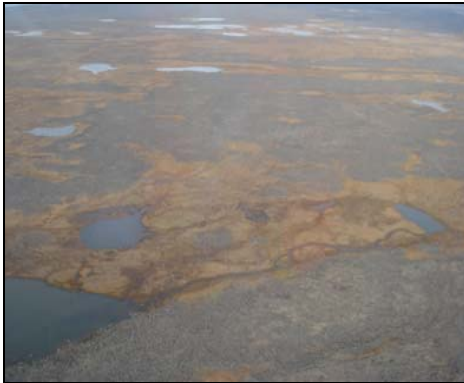
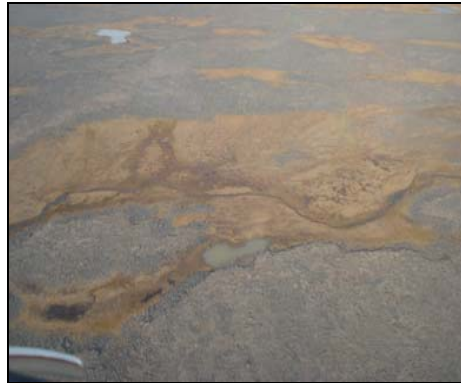
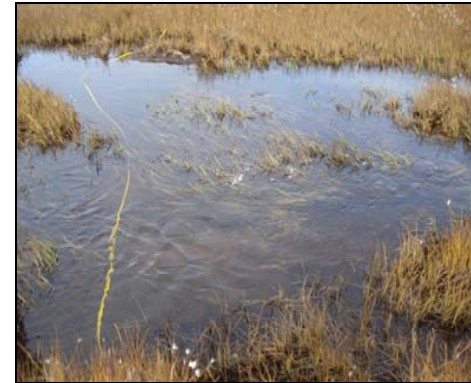
The quarry site itself is dry, but it has a couple of tiny ponds near it. Any water in the area should be considered fish habitat. There is a connection of lakes and pools at UTM 17 W 601289 7868513 with a large downstream pond at UTM 17 W 598750 7869322 that eventually connects at a large downstream river at UTM 17 W 595984 7868932. Fish will be in any waterbody that the road crosses if it leads east from the AR near AR-113. This stream may not actually be crossed at this location but it connects to all of the ponds and streams to the west where the access road will lie. The quarry site is actually 200m away from the assessed water. Waypoint 525 at the 20 U

**Figure 1.** View of habitat at 20M DS across (A), 20m US across (B), aerial view downstream of assessment (C), aerial view of crossing (D-E), and crossing across (F).
