Baffinland Iron Mines Mary River Project
Watercourse Crossing Assessment

Baffinland Iron Mines Mary River Project

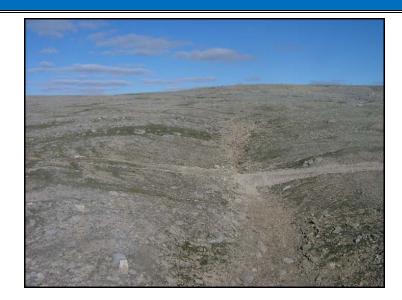
Figure 1: Aerial view of proposed crossing showing a dry cobble/gravel creek bed.

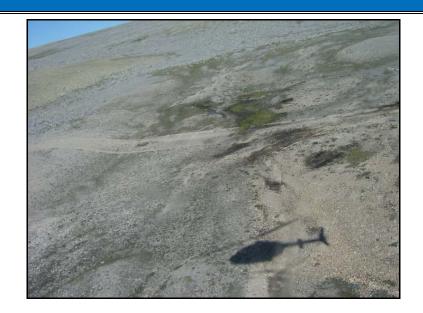
Figure 1: Aerial view of proposed crossing showing an almost completely dry cobble/gravel creek bed.

This waterbody is ephemeral and provides no suitable fish habitat. Even during high water in spring there is not likely any fish use. There is a cliff downstream of the crossing that would represent a significant barrier to fish passage even if water levels were sufficient.

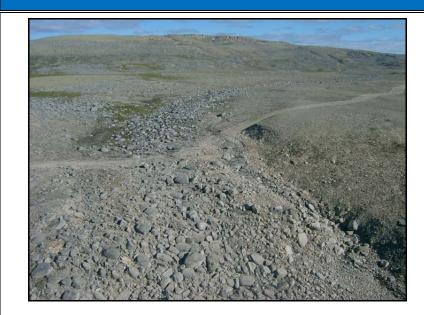
Figure 1: Aerial view of proposed crossing showing a completely dry cobble/gravel creek bed.

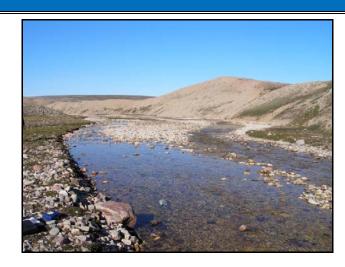
Figure 1: Downstream view from proposed crossing showing riffle habitat with cobble substrate.

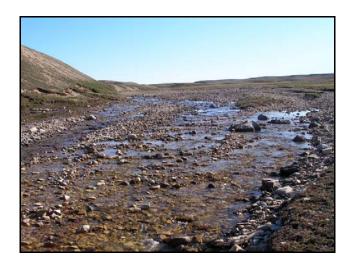
$\textbf{Figure 2:} \ \textbf{Upstream view from proposed crossing showing more riffle habitat}.$
