### **Bulk Sample Road Watercourse Crossing Assessment**

Baffinland Iron Mines Mary River Project Watercourse Crossing Assessment

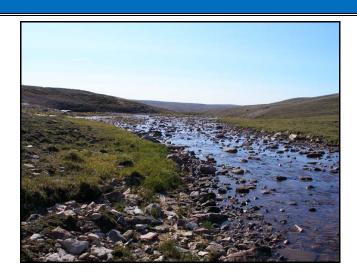
Figure 1: Downstream view from proposed crossing showing riffle habitat with cobble substrate.

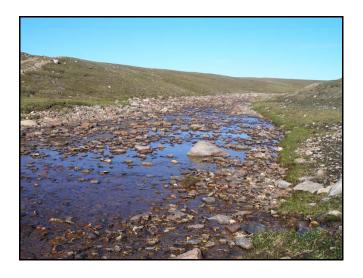
Figure 2: Upstream view from proposed crossing showing more riffle habitat.

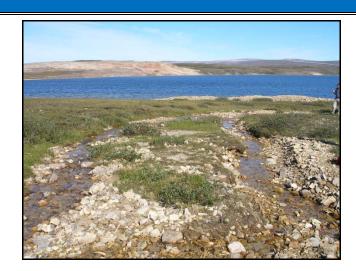
**Figure 1:** Downstream view from proposed crossing showing cascade, cobble habitat and downstream lake.

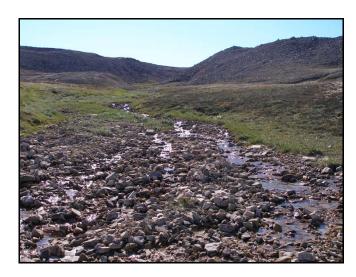
Figure 2: Upstream view from proposed crossing more cascade habitat.

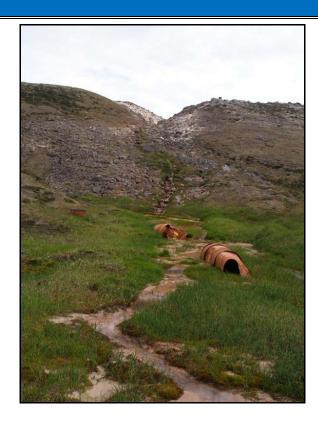
**Figure 1:** Upstream view from proposed crossing showing nearly dry habitat and empty fuel drums.

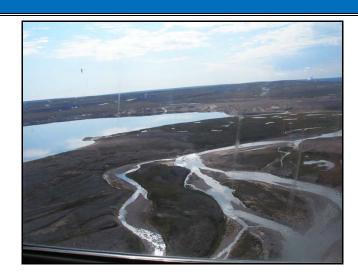
Figure 1: Downstream aerial view from proposed crossing showing riffle-pool habitat and multiple wetted channels.

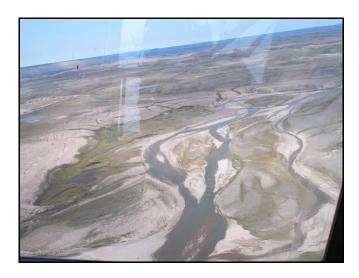
Figure 2: Upstream aerial view from proposed crossing showing the braided channel.
