ROAD CV-0-0A

LOCATION AND CROSSING DESCRIPTION

**BAFFINLAND IRON MINES
MARY RIVER PROJECT**

North/South Consultants Inc.
Aquatic Environment Specialists

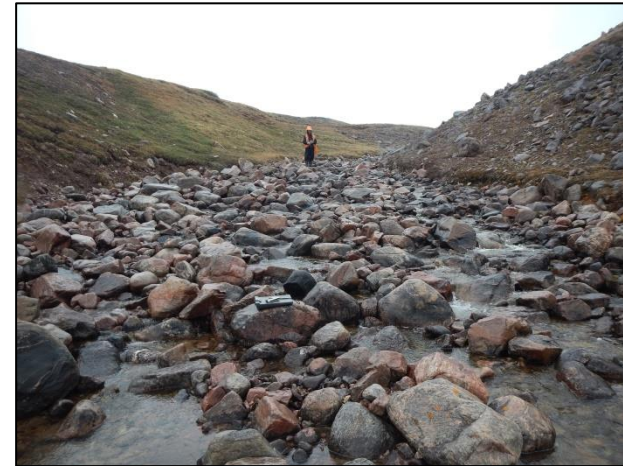
Upstream/ Downstream	UTM		Barrier Type			Height (m)	Gradient (°)	Description	Site Label
	Easting	Northing	1	2	3				
Downstream	504487	7975861	HG				10	Permanent Barrier: gradient increases from 10-20 degrees moving upstream from this location	A
Downstream	504651	7975776	VD	HG		2.0	20	Permanent Barrier: high gradient (dry at time of assessment)	B

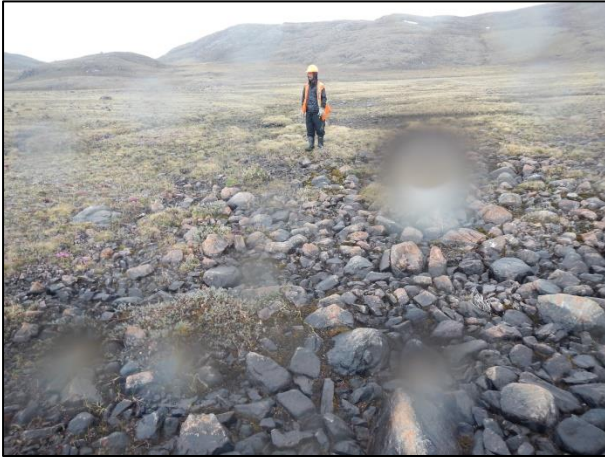
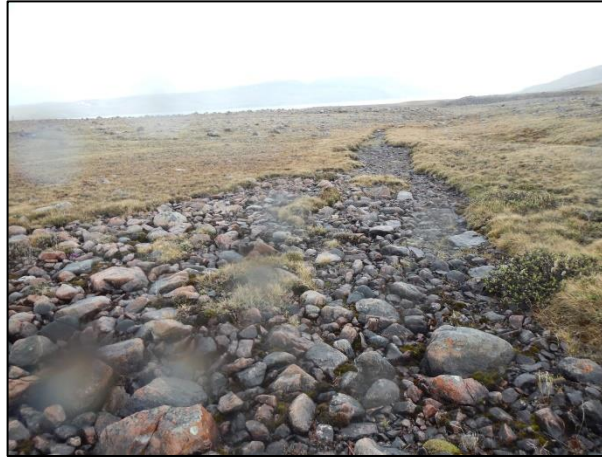
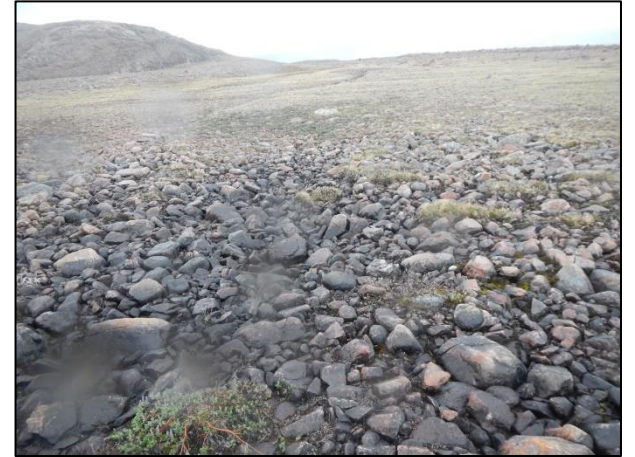
The access road loop at the northern terminus of the North Rail crosses a headwater stream at two locations. The crossing at CV-0-0A is located 60 m upstream of crossing CV-0-0B. This stream flows north into Milne Inlet approximately 1.4 km downstream. At the crossing location, the stream is only a small meltwater channel at the top of a plateau, which was dry at the time of the spring 2019 survey.

Photos 1. Photos taken at the crossing centreline in spring: (A) facing upstream; (B) facing downstream; and (C) across (left bank looking at right bank).
