# PORT SITE P-CULV-5

**BAFFINLAND IRON MINES  
MARY RIVER PROJECT**

**North/South Consultants Inc.**  
Aquatic Environment Specialists

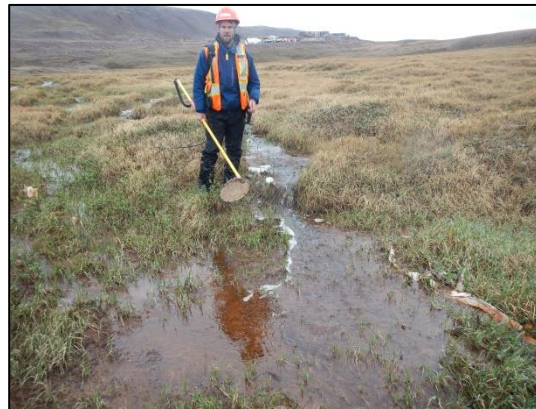
Upstream/ Downstream	UTM		Barrier Type			Height (m)	Gradient (°)	Description	Site Label
	Easting	Northing	1	2	3				
Downstream	503680	7974206	VD	SHALL		0.2		Potential permanent barrier: Small vertical drop with shallow water	A
Downstream	503547	7974255	VD	SHALL		0.2		Potential permanent barrier: Small vertical drop with shallow water	B
Downstream	503475	7974318	VD	SHALL		0.45		Potential permanent barrier: Moderate vertical drop with shallow water	C

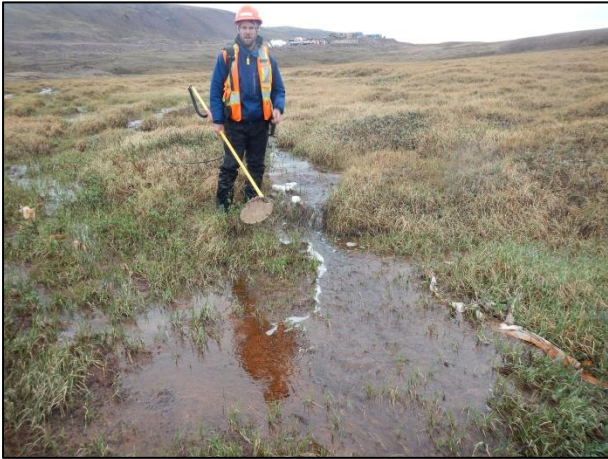
A

**Photos 1.** Photos taken of port site P-Culv-5 site in spring: (A) facing upstream; (B) facing across (from left bank looking towards right bank); and (C) across the pond infill on the north branch.
