LOCATION AND CROSSING DESCRIPTION

Site ID:	CV-0-1	Dates Surveyed:	18-Jun-19	Waterbody Type:	Stream
Project Interaction:	Rail Daylight + Culvert; Receiving Diversion	Centreline UTM Coordinates:	17W 504289 E 7975593 N	Culvert Length (m):	12
Number of Barrels:	1	Culvert Diameter/Span (mm):	900	Slope (%):	1

BAFFINLAND IRON MINES MARY RIVER PROJECT

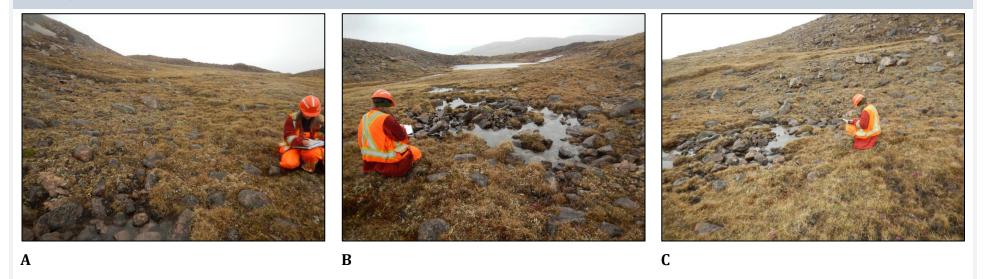
Photos 1. Photos taken at the crossing centreline in spring: (A) facing upstream; (B) facing downstream; and (C) across (right bank looking at left bank).
