RAIL CV-102-2

LOCATION AND CROSSING DESCRIPTION

**BAFFINLAND IRON MINES
MARY RIVER PROJECT**

North/South Consultants Inc.
Aquatic Environment Specialists

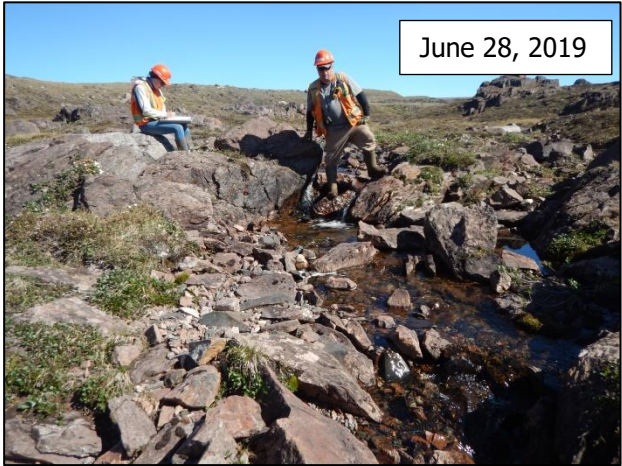
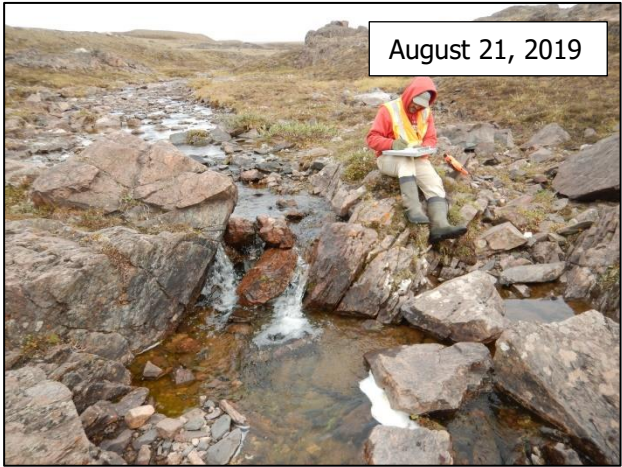
Upstream/ Downstream	UTM		Barrier Type			Height (m)	Gradient (°)	Description	Site Label
	Easting	Northing	1	2	3				
Downstream	NO BARRIERS								
Upstream	556153	7915744	VD			0.6		Permanent Barrier: Hundreds of fish up to base of vertical drop, none observed above	A
