RAIL CV-107-3

LOCATION AND CROSSING DESCRIPTION

BAFFINLAND IRON MINES
MARY RIVER PROJECT

**North/South Consultants Inc.**
Aquatic Environment Specialists

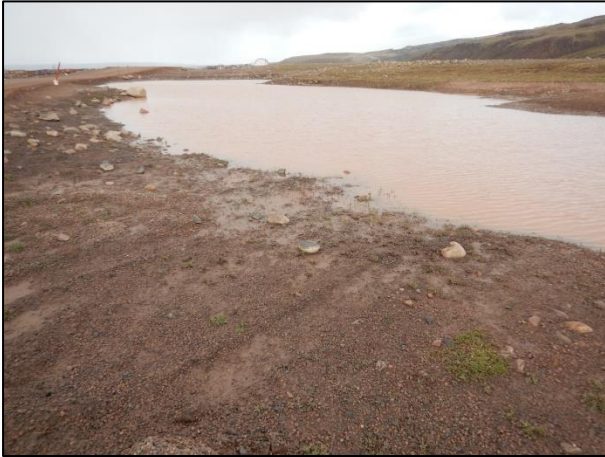
A

Photos 1. Photos of the pond in spring 2019: (A) at the infill site looking northwest; (B) at the infill site looking west; and (C) looking east towards the infill location.
