RAIL CV-108-3

LOCATION AND CROSSING DESCRIPTION

**BAFFINLAND IRON MINES
MARY RIVER PROJECT**

North/South Consultants Inc.
Aquatic Environment Specialists

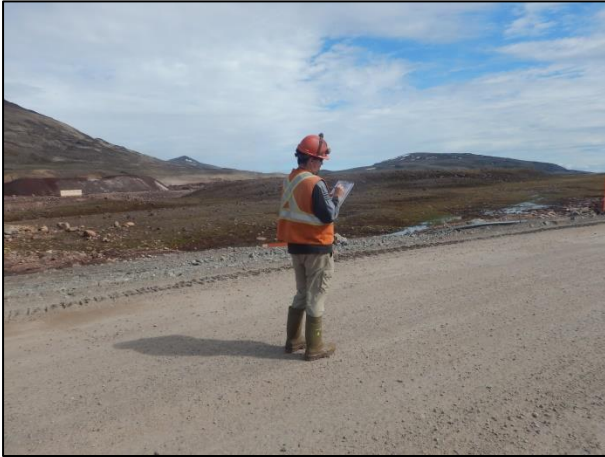
A

Photos 1. Photos taken at the crossing centreline in spring: (A) facing upstream; (B) facing downstream; and (C) across (right bank looking at left bank).
