LOCATION AND CROSSING DESCRIPTION

Site ID: CV-110-3 **Dates Surveyed:** 01-Jul-19 Waterbody Type: Pond **Project Interaction:** Rail Pond Infilling + Culvert **Centreline UTM Coordinates:** 17W 561445 E 7912240 N Culvert Length (m): 30 5 Number of Barrels: Culvert Diameter/Span (mm): 1200 Slope (%):

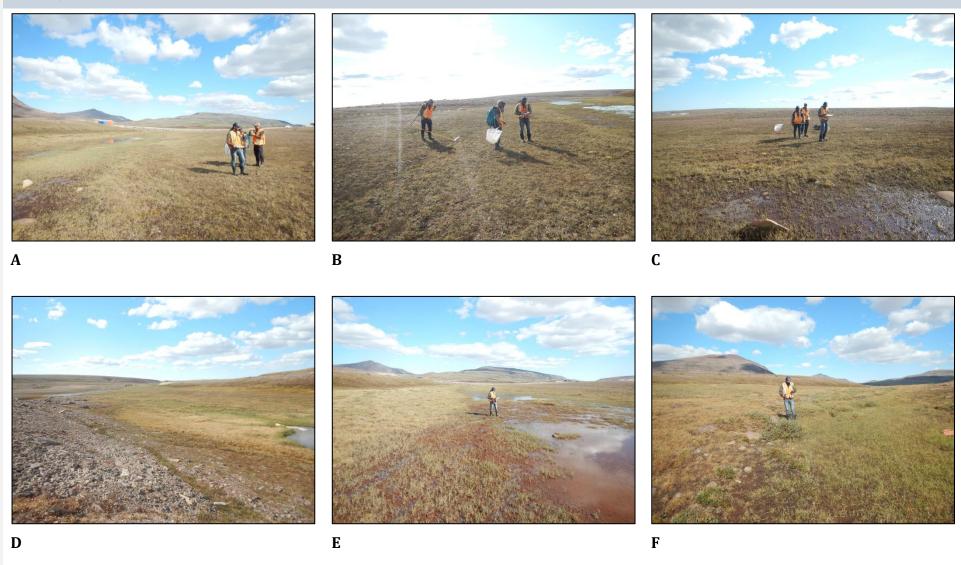
Electrofishing was limited to areas of the pond near site CV-110-3 that were sufficiently deep enough for electrofisher use. There was no clear outflow or connectivity to the west towards an adjacent pond. The area between the ponds was a series of isolated shallow pools among vegetation with no clear passage or flow in spring 2019. There was some connectivity to adjacent pools at the time of the survey.

Photos 1. Photos of the pond infilled at CV-110-3: (A) at the infill site looking east; (B) at the infill site looking west; (C) at the infill site looking north across the pond; (D) looking west towards distant unconnected ponds; (E) eastern end of CV-110-2/110-3 marshy pond complex; and (F) terrain west of CV-110-2/110-3.
