LOCATION AND CROSSING DESCRIPTION

Site ID: CV-110-4 **Dates Surveyed:** 29-Jun-19 Waterbody Type: Pond Rail Pond Infilling + Culvert **Centreline UTM Coordinates:** 17W 561546 E 7912425 N **Project Interaction:** Culvert Length (m): 30 Number of Barrels: Culvert Diameter/Span (mm): 1200 Slope (%): 5

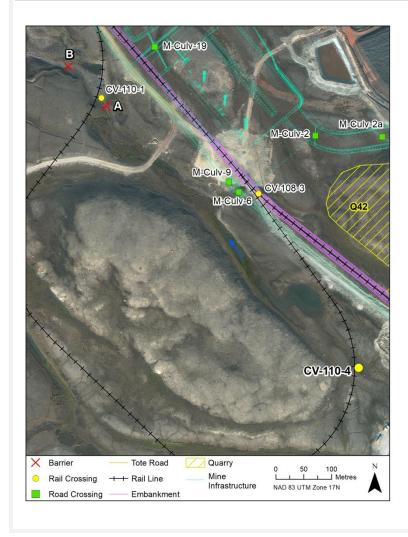
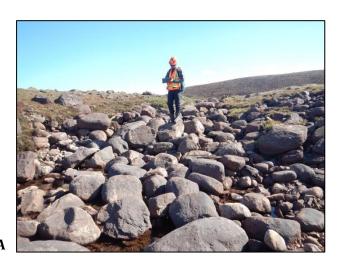
Upstream/	UTM		Barrier Type		Height	Gradient	Description	Site	
Downstream	Easting	Northing	1	2	3	(m)	(°)	Description	
Downstream	561093	7912895	VD	HG	В	0.55	15	Permanent Barrier: Upper end of long barrier	Α
Downstream	561025	7912966	В					Permanent Barrier: Lower end of long barrier	В

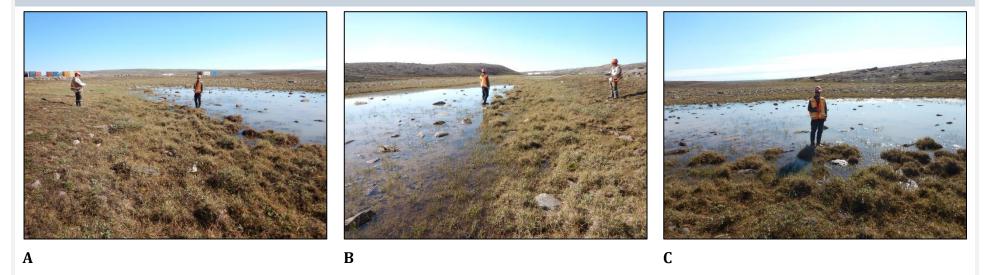
Photos 1. Photos of the pond at CV-110-4: (A) at the infill site looking southeast; (B) at the infill site looking northwest; and (C) at the infill site looking north across the pond.
