ROAD M-CULV-6

LOCATION AND CROSSING DESCRIPTION

**BAFFINLAND IRON MINES
MARY RIVER PROJECT**

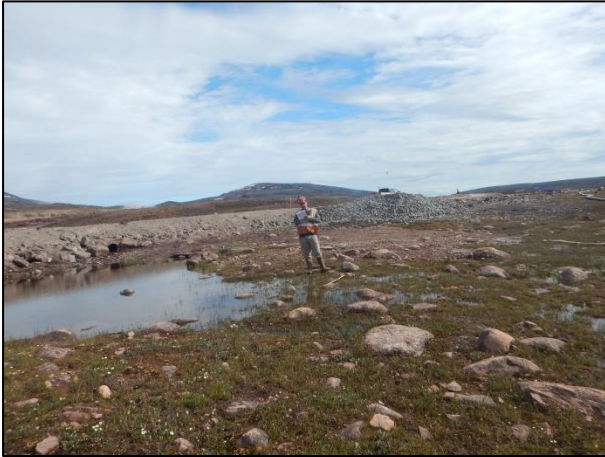
A

Photos 1. Photos taken at the crossing centreline in spring: (A) facing upstream; (B) facing downstream; and (C) across (right bank looking at left bank). The existing access road is also visible in the photographs.
