LOCATION AND CROSSING DESCRIPTION

27-Jun-19 Site ID: M-Culv-13 **Dates Surveyed:** Waterbody Type: Stream **Project Interaction:** Road Culvert **Centreline UTM Coordinates:** 17W 562044 E 7912124 N Culvert Length (m): 13.7 Number of Barrels: Culvert Diameter/Span (mm): 600 Slope (%): 6.3

BAFFINLAND IRON MINES MARY RIVER PROJECT

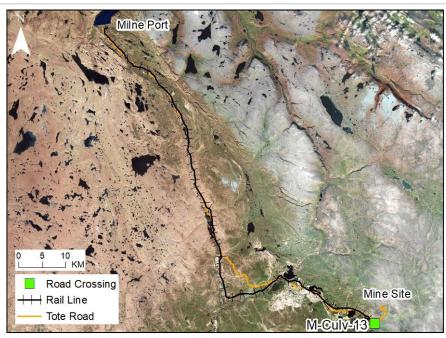
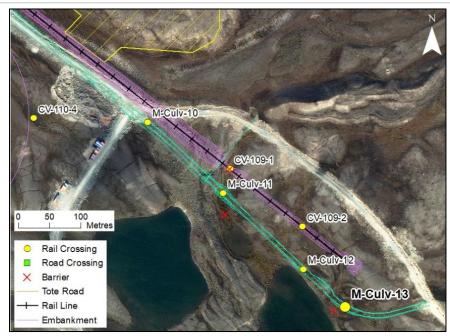
An access road will cross an unnamed intermittent stream at M-Culv-13 that drains southwest to a small lake 30 m downstream. The stream collects local snowmelt from a steep hill during freshet and was dry in spring 2019. There is a permanent subsurface flow barrier where the hill gradient becomes greatest (20 m downstream from the centreline).

There is no fish habitat in this stream.

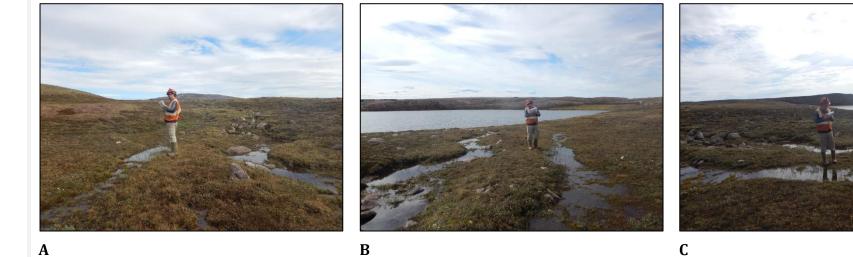
The downstream lake may have sufficient depths to support overwintering, but a downstream subsurface flow barrier prevents fish access to the M-Culv-13 site.

Photos 1. Photos of M-Culv-13 at the crossing centreline from spring 2019; (A) facing upstream; (B) facing downstream; and (C) facing across (from the left bank looking towards the right bank).
