LOCATION AND CROSSING DESCRIPTION

Site ID: CV-102-7a **Dates Surveyed:** 20-Jun-19 Waterbody Type: Pond **Centreline UTM Coordinates:** Rail Pond Infilling 17W 557379 E 7915248 N Culvert Length (m): **Project Interaction:** N/A Number of Barrels: N/A Culvert Diameter/Span (mm): Slope (%): N/A

BAFFINLAND IRON MINES MARY RIVER PROJECT

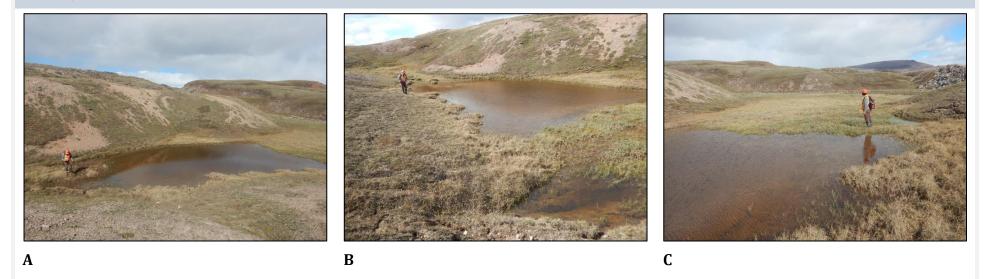
No fish were observed in the entire pond in spring 2019 (visibility extended to the bottom of the pond). The pond is likely frequently isolated and there is a permanent downstream vertical barrier to upstream fish passage. Due to the barrier, this pond does not provide fish habitat.

Photos 1. Photos of the pond in spring: (A) looking northeast; (B) looking north; and (C) looking southeast.
