RAIL CV-4-5

**BAFFINLAND IRON MINES
MARY RIVER PROJECT**

North/South Consultants Inc.
Aquatic Environment Specialists

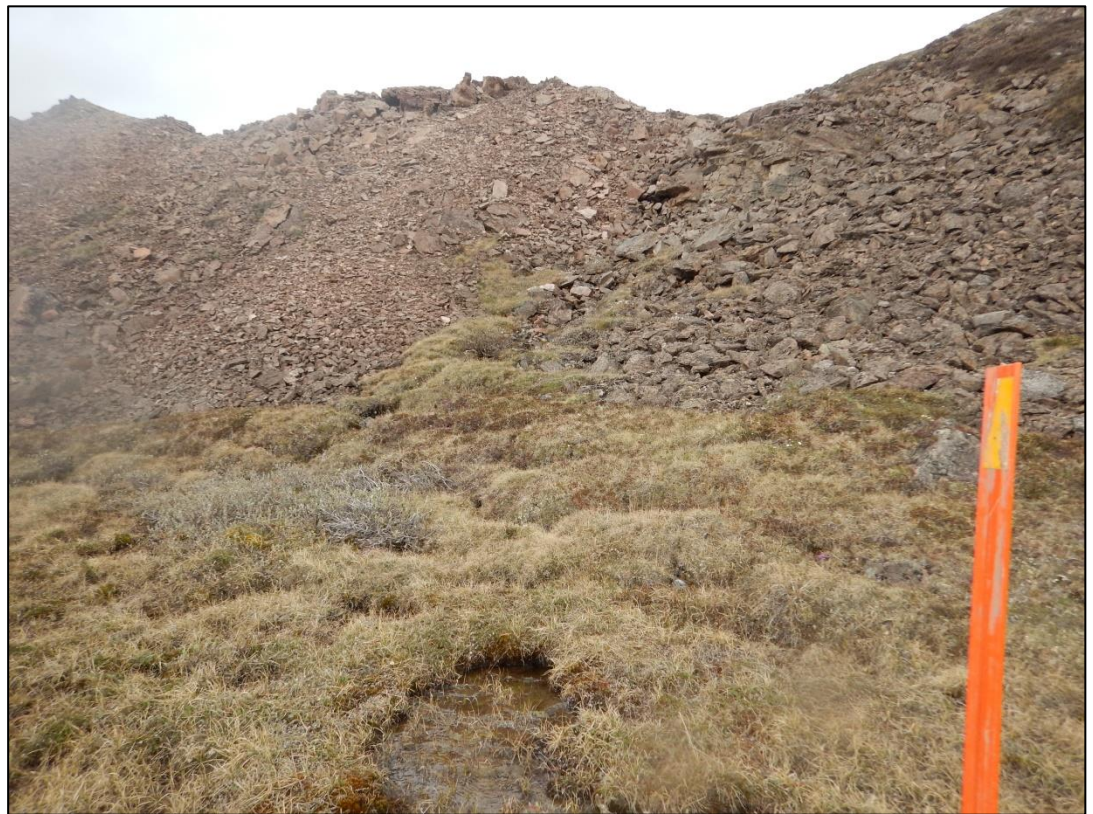
Upstream/ Downstream	UTM		Barrier Type			Height (m)	Gradient (°)	Description	Site Label
	Easting	Northing	1	2	3				
Upstream, at, and downstream	506066	7972198	SSF	HG			>10	Permanent Barrier: Subsurface flow from upstream to downstream of the crossing, leaving only a small wetted area.	A

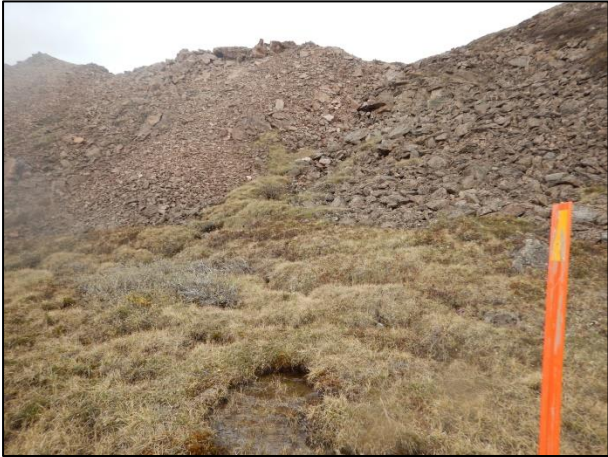
A

Mostly dry, undefined channel upstream and downstream of the crossing with a small wetted area. No surface water connectivity to upstream or downstream waterbodies. There is no fish habitat at this crossing.

Photos 1. Photos taken at the crossing centreline in spring (A) facing upstream; (B) facing downstream; and (C) across (left bank looking at right bank).
