#### LOCATION AND CROSSING DESCRIPTION

Site ID: CV-5-3 **Dates Surveyed:** 15-Jun-19 Waterbody Type: Stream Rail Daylight + Culvert **Centreline UTM Coordinates:** 17W 506308 E 7971808 N **Project Interaction:** Culvert Length (m): 12 Number of Barrels: Culvert Diameter/Span (mm): 1500 **Slope (%):**

BAFFINLAND IRON MINES MARY RIVER PROJECT

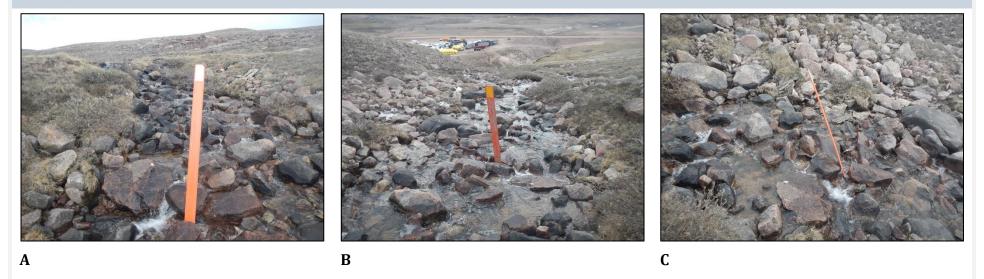
The stream near the crossing is steep with occasional vertical drops, preventing all fish access. There is no fish habitat at the crossing.

**Photos 1.** Photos taken at the crossing centreline in spring (A) facing upstream; (B) facing downstream; and (C) across (left bank looking at right bank).
