LOCATION AND CROSSING DESCRIPTION

Site ID: CV-8-0 **Dates Surveyed:** 16-Jun-19 Waterbody Type: Stream **Centreline UTM Coordinates: Project Interaction:** Rail Culvert 17W 508289 E 7969746 N Culvert Length (m): 24 Number of Barrels: Culvert Diameter/Span (mm): 900 **Slope (%):** 5

BAFFINLAND IRON MINES MARY RIVER PROJECT

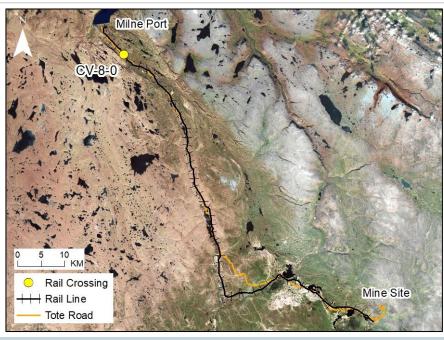
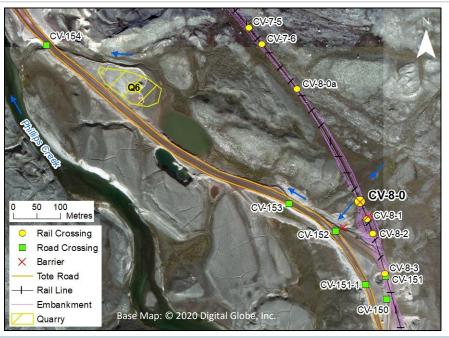
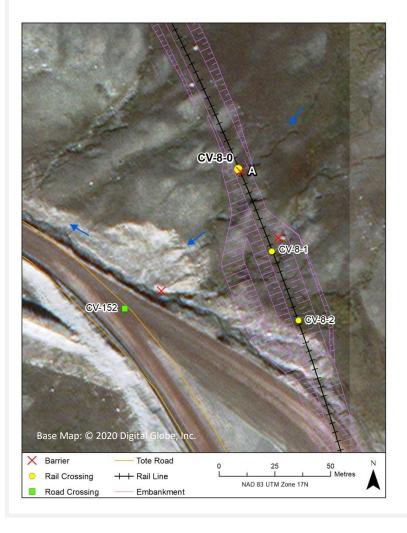
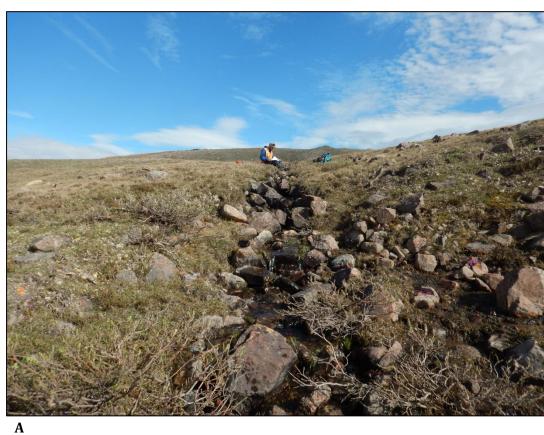
The drainage ditch is steep with some patches of subsurface flow under cobble, but the stream is also located on a hill with a high gradient that acts as a natural permanent barrier to upstream fish passage. The site is not connected to upstream overwintering habitat.

Upstream/ Downstream	UTM		Barrier Type			Height	Gradient	Description	
	Easting	Northing	1	2	3	(m)	(°)	Description	
At crossing and downstream	508290	7969745	HG				13	Permanent Barrier: High gradient stream from crossing to roadside ditch	Α

Photos 1. Photos taken at the crossing centreline in spring (A) facing upstream; (B) facing downstream; (C) across (right bank looking at left bank); and (D) where the stream flows into the roadside ditch.
