RAIL CV-8-2

LOCATION AND CROSSING DESCRIPTION

BAFFINLAND IRON MINES
MARY RIVER PROJECT

**North/South Consultants Inc.**
Aquatic Environment Specialists

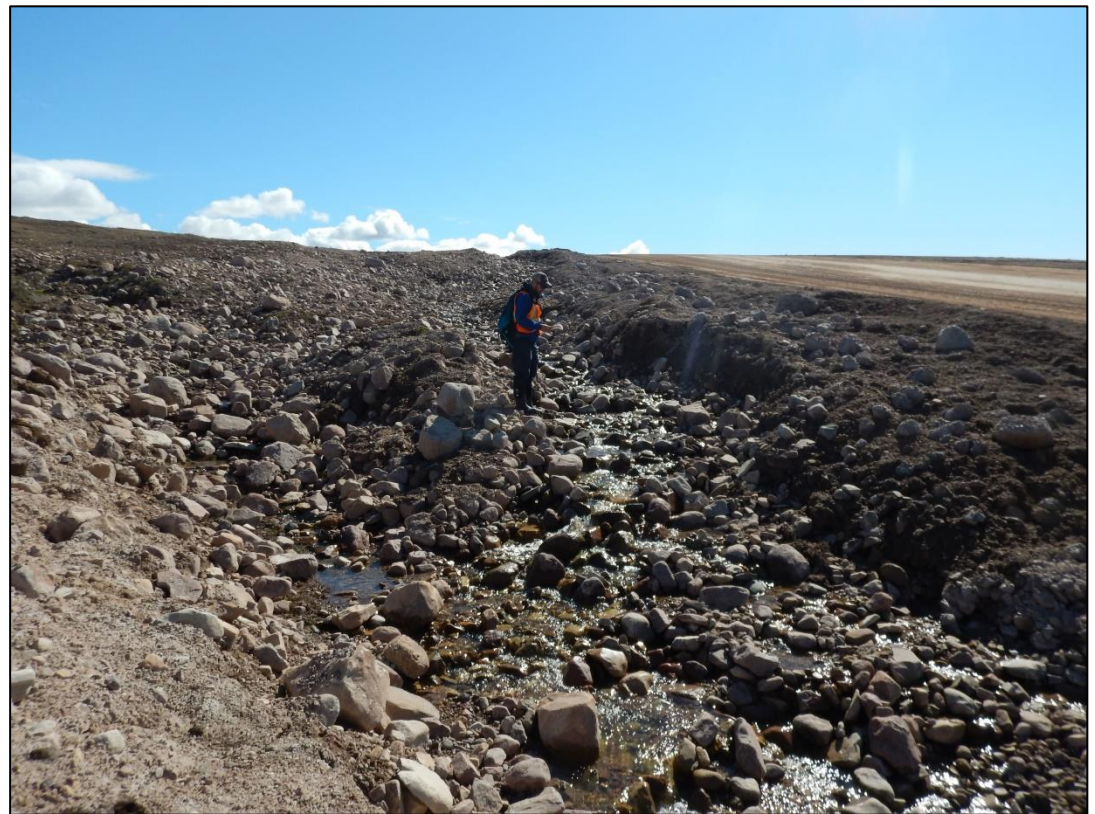
Upstream/ Downstream	UTM		Barrier Type			Height (m)	Gradient (°)	Description	Site Label
	Easting	Northing	1	2	3				
At crossing and downstream	508255	7969691	HG	SSF			>10	Permanent Barrier: High gradient and subsurface flow where drainage meets roadside diversion ditch	A

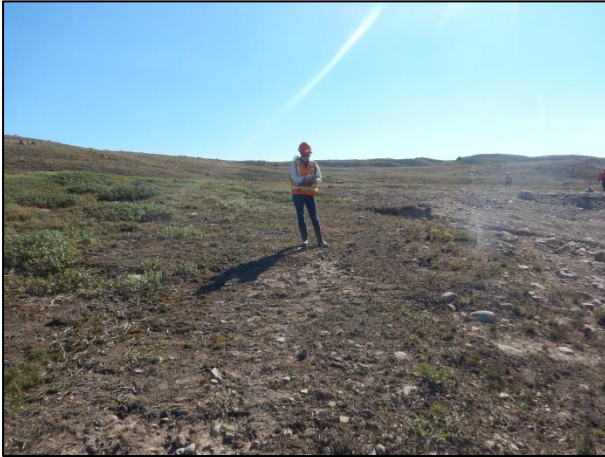
A

Photos 1. Photos taken in spring 2019: (A) at the crossing centreline 16 June facing east; (B) at the nearby channel facing downstream on 16 June; and (C) at the nearby channel facing upstream on 2 July 2019
