RAIL CV-8-3

LOCATION AND CROSSING DESCRIPTION

BAFFINLAND IRON MINES
MARY RIVER PROJECT

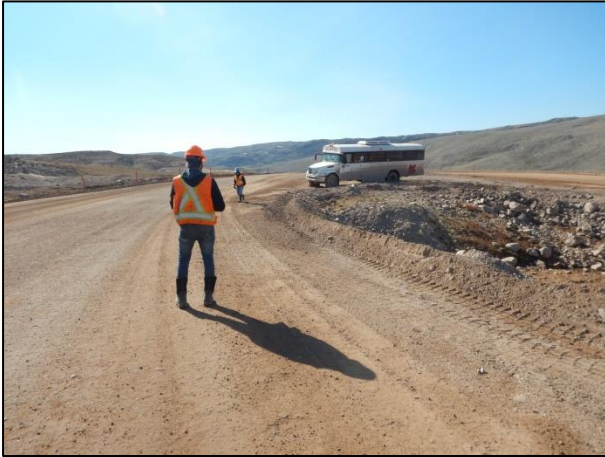
A

Photos 1. Photos taken in spring 2019 of: (A) the rail centreline facing south; (B) the roadside ditch pond facing east on 16 June; and (C) the roadside ditch pond facing east on 2 July.

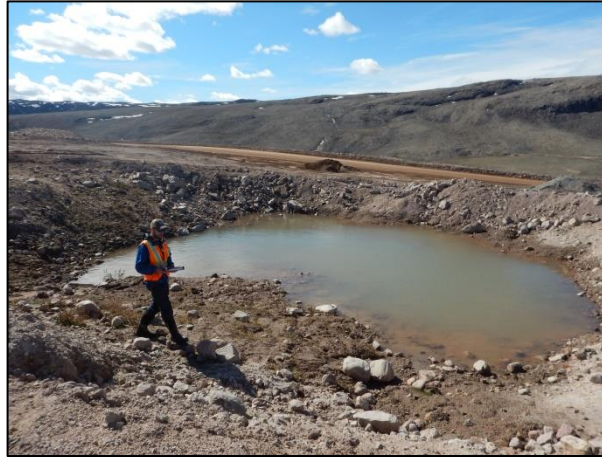
B

The rail overlaps with the existing Tote Road and a roadside ditch pond at CV-8-3. The pond is located between the northbound and southbound lanes of the Tote Road. The pond is a small depression in road aggregate that collects water during snow melt and precipitation. This pond had nearly dried up between 16 June and 2 July 2019. The pond is fully isolated, as there are no culverts on either section of the road.
