RAIL CV-10-5

LOCATION AND CROSSING DESCRIPTION

Site ID:	CV-10-5	Dates Surveyed:	16-Jun-19 and 2-Jul-19	Waterbody Type:	Stream
Project Interaction:	Rail Culvert	Centreline UTM Coordinates:	17W 509853 E 7967818 N	Culvert Length (m):	30
Number of Barrels:	1	Culvert Diameter/Span (mm):	900	Slope (%):	5

**BAFFINLAND IRON MINES
MARY RIVER PROJECT**

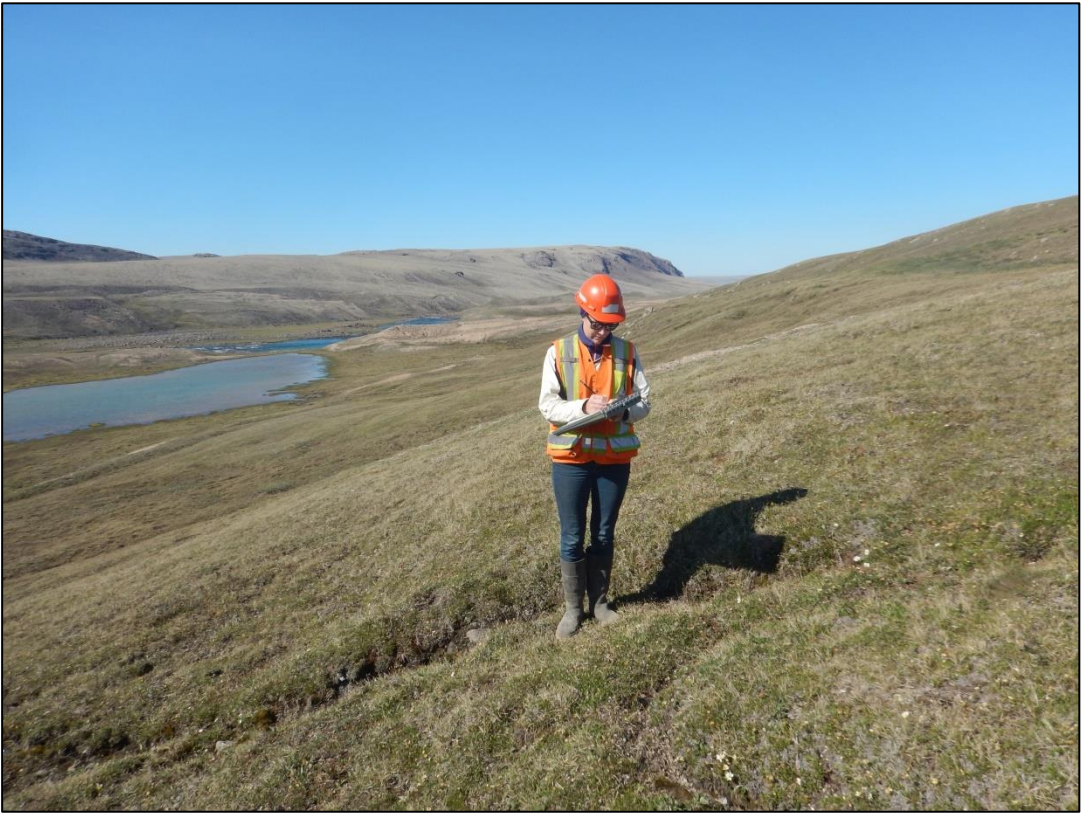
Upstream/ Downstream	UTM		Barrier Type			Height (m)	Gradient (°)	Description	Site Label
	Easting	Northing	1	2	3				
At crossing	509852	7967817	HG				13	Permanent Barrier: High gradient at and downstream of the crossing centreline extending for at least 50 m	A

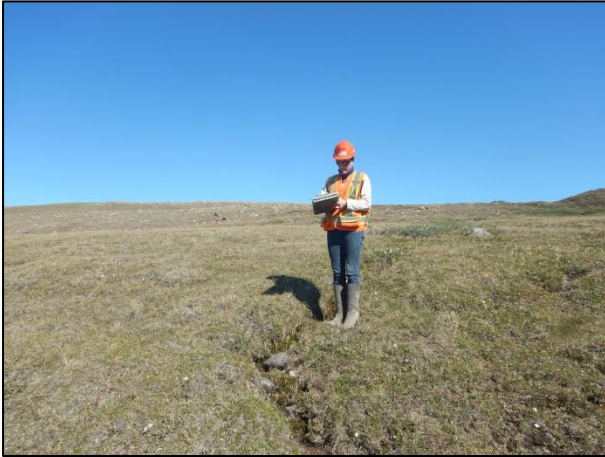
A

Photos 1. Ground photos taken at the crossing centreline in spring 2019: (A) facing upstream; (B) facing downstream; and (C) across (left bank looking at right bank). Aerial photo of crossing area (D) and downstream pond (E).
