RAIL CV-15-2

LOCATION AND CROSSING DESCRIPTION

BAFFINLAND IRON MINES
MARY RIVER PROJECT

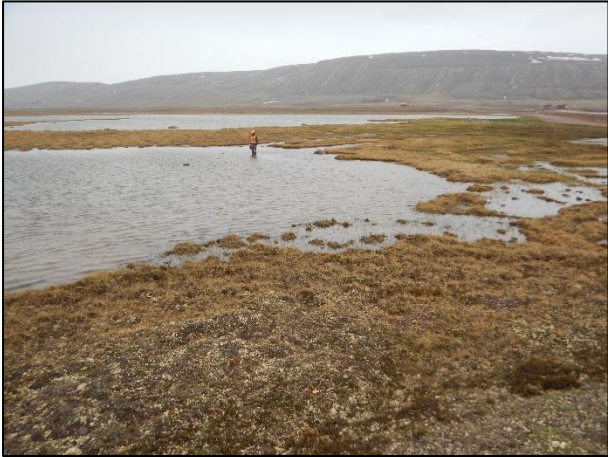
A

Photos 1. Photos of the pond CV-15-2: (A) across the infill location looking southeast; (B) at the pond outflow looking upstream towards the pond; (C) at the pond outflow site looking downstream towards the Tote Road; (D) habitat in the outflow stream; and (E and F) upstream and downstream ends of the Tote Road culvert.

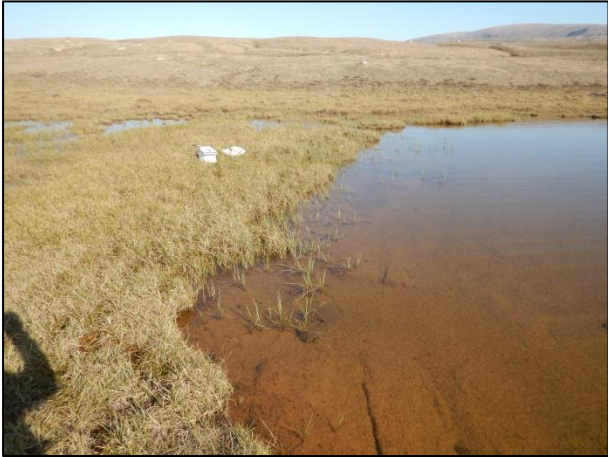
A

Photos 2. Photos of the pond CV-15-3: (A) at the encroachment location looking north; (B) at the encroachment site looking south; (C) at the encroachment site looking east; and (D) at the encroachment site looking west.
