RAIL CV-15-3

LOCATION AND CROSSING DESCRIPTION

**BAFFINLAND IRON MINES
MARY RIVER PROJECT**

North/South Consultants Inc.
Aquatic Environment Specialists

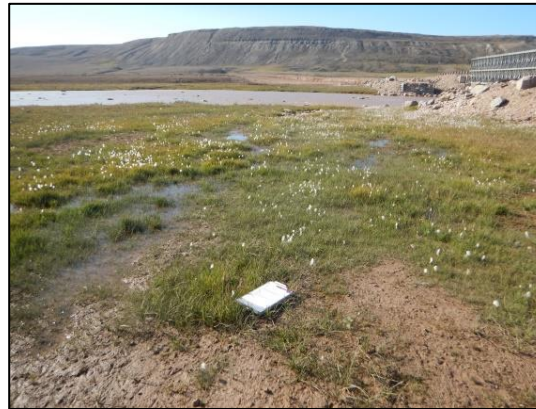
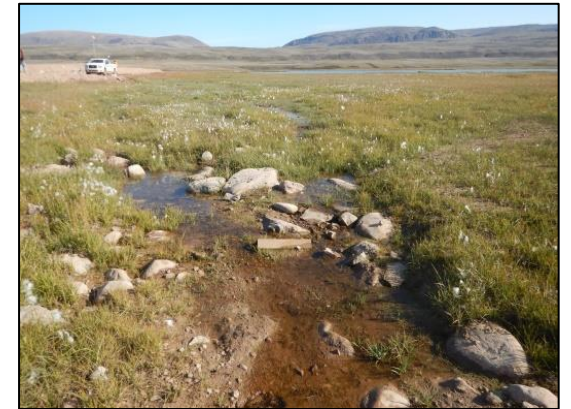
Upstream/ Downstream	UTM		Barrier Type			Height (m)	Gradient (°)	Description	Site Label
	Easting	Northing	1	2	3				
Inflowing Stream	All inflows appear to be diffuse over terrestrial habitat and not fish-bearing								
Outflowing Stream	513610	7965928	Other					Intermittent Barrier: Summer only – disconnected pools	A
Outflowing Stream	513603	7965911	B	SHALL				Intermittent Barrier: Summer only - Boulder garden and shallow depths at mouth	B

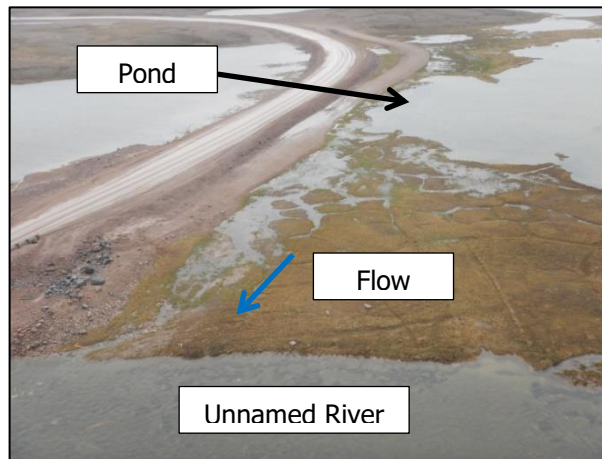
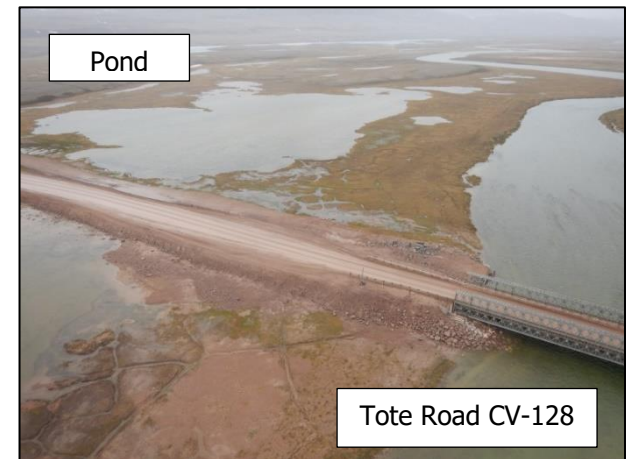
Photos 1. Photos of the pond CV-15-3: (A) at the encroachment location looking east; (B) at the encroachment site looking offshore to the southeast; (C) at the encroachment site looking south; (D) at the encroachment site looking southwest; and (E and F) pond showing connection to Unnamed downstream river at the Tote Road bridge CV-128 in spring.

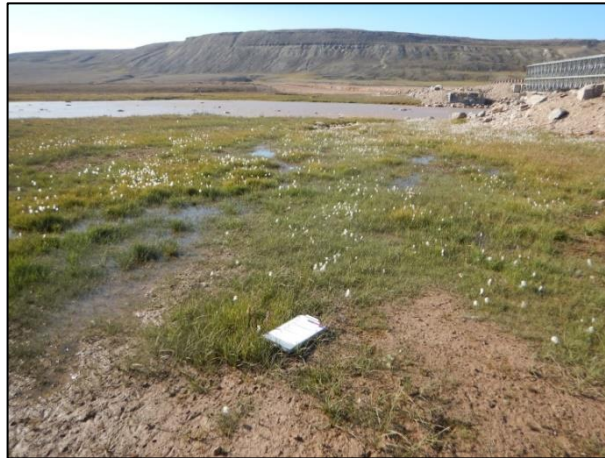
E

Photos 2. Photos of the pond CV-15-3: (A) at the encroachment location looking north; (B) at the encroachment site looking southeast; (C) at the encroachment site looking east; (D) at the encroachment site looking west; (E) pond outflow looking towards the unnamed river; and (F) pond outflow at the confluence with the unnamed river showing boulder garden.
