LOCATION AND CROSSING DESCRIPTION

Site ID: CV-15-4 **Dates Surveyed:** 18-Jun-19 Waterbody Type: Pond Rail Pond Infilling **Centreline UTM Coordinates:** 17W 514123 E 7965711 N **Project Interaction:** Culvert Length (m): N/A Number of Barrels: N/A Culvert Diameter/Span (mm): N/A Slope (%): N/A

BAFFINLAND IRON MINES MARY RIVER PROJECT

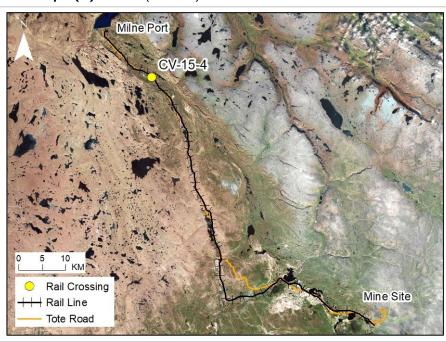
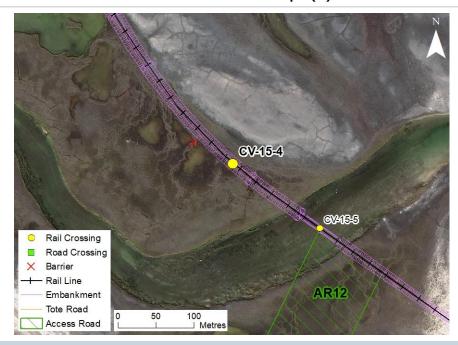
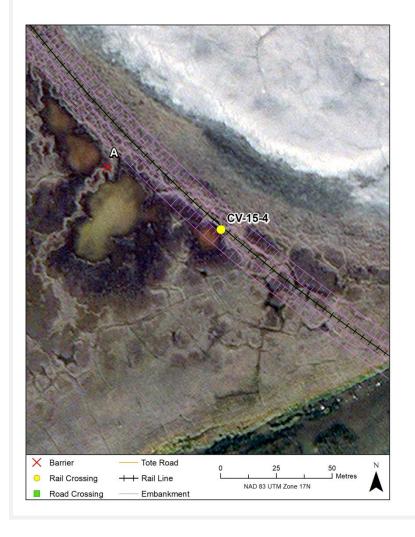
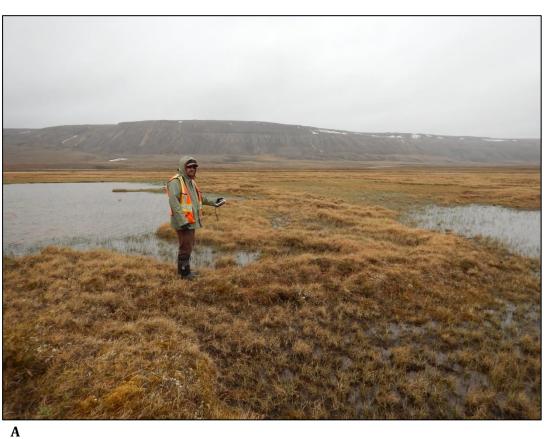
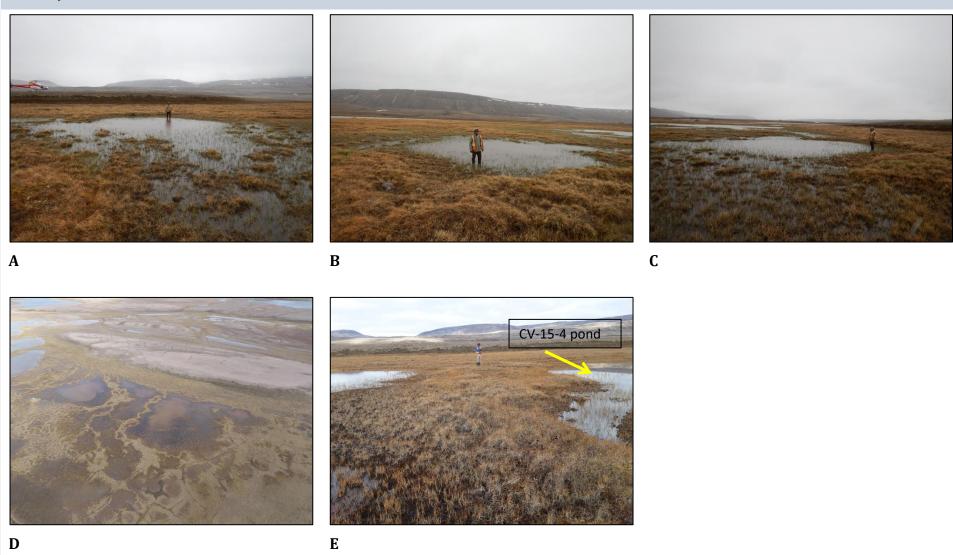
Shallow pond (maximum depth approximately 0.2 m) northeast of the existing Tote Road that will be infilled by the rail at CV-15-4. The pond consists of a series of weakly interconnected pools through shallow (<0.02 m) water. The pool was isolated in spring 2019 and would not be connected to nearby fish habitat at CV-15-2, CV-15-3, or CV-15-5 under any flows. No fish were observed in 2018 or 2019. The pond is of insufficient depth to support overwintering. There is no fish habitat at CV-15-4. A lack of connectivity and fish habitat in this pond were confirmed during a summer/fall visit in 2020.

Upstream/	UTM		Barrier Type		Height Gradient	Description			
Downstream	Easting	Northing	1	2	3	(m)	(°)	Description	
Inflowing Stream	All inflows appear to be diffuse over terrestrial habitat and not fish-bearing								
Outflowing Stream	514072	7965739	other			0.35		Permanent Barrier: Berm of vegetation blocking any outflow

Photos 1. Photos of the pond at CV-15-4 in spring 2018, spring 2019, and summer/fall 2020: (A) looking northeast in 2019 (B) looking southwest in 2019; and (C) looking northwest in 2019; (D) aerial photo of pond taken in fall 2018; and (E) vegetation berm barrier between CV-15-4 and ponds to the west in 2020.
