Re: Baffinland Iron Mines Corporation (Baffinland) - Submission of 2014 Annual Geotechnical Inspection, Water Licence Type 'A' No. 2AM-MRY1325

ANNUAL GEOTECHNICAL INVESTIGATION

MARY RIVER PROJECT

2014 INSPECTIONS

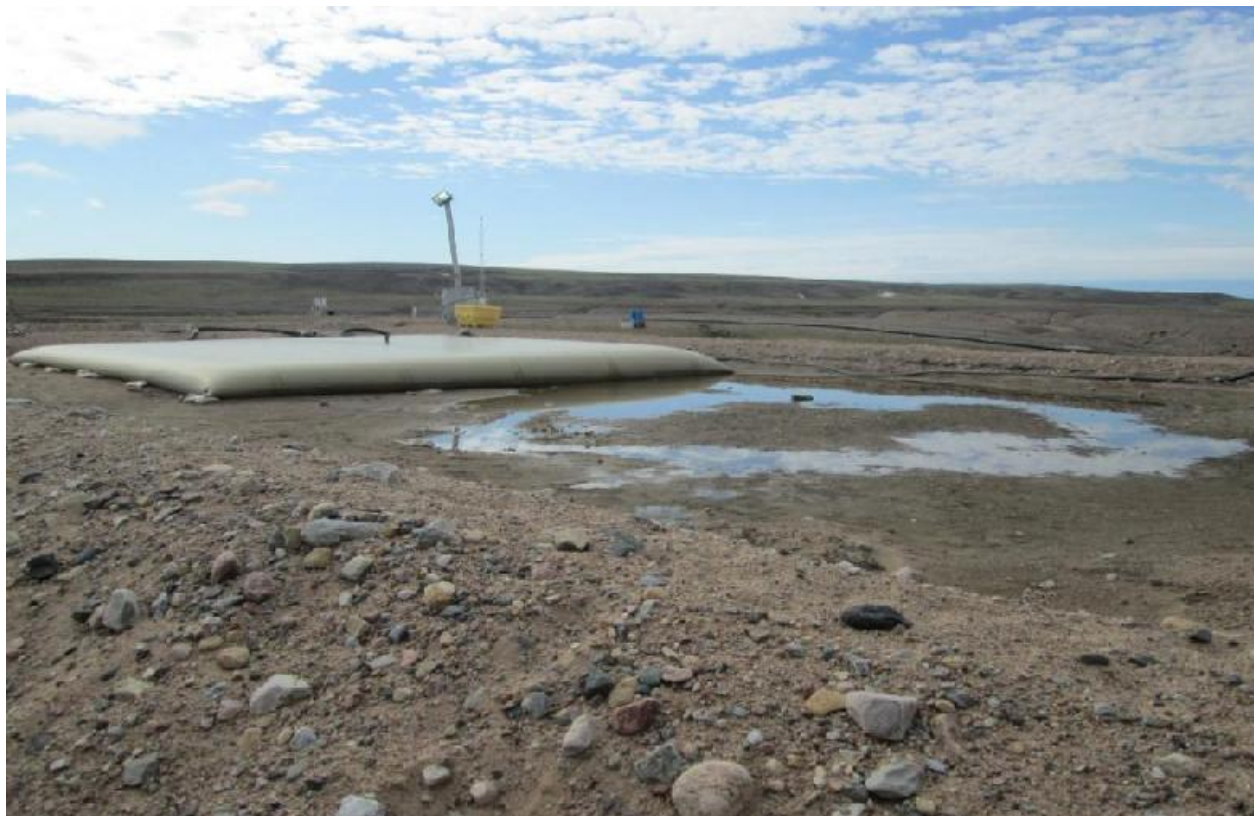
Generator Fuel Storage Facility Containment

The structure was visually inspected for any signs of subsidence or cracking and no such indications were noted. There was no sign of seepage at the base of the structure noted. The soil structure is considered to be stable in its present condition and is in conformance with our design principles.

We recommended that the water ponding above the bottom of the containment gravel cover be removed regularly by creating a sump in the gravel and pumping out the water to below the gravel surface.

We recommend that Baffinland Iron Mines continue to control the fuel in the bladder at a height of 30".

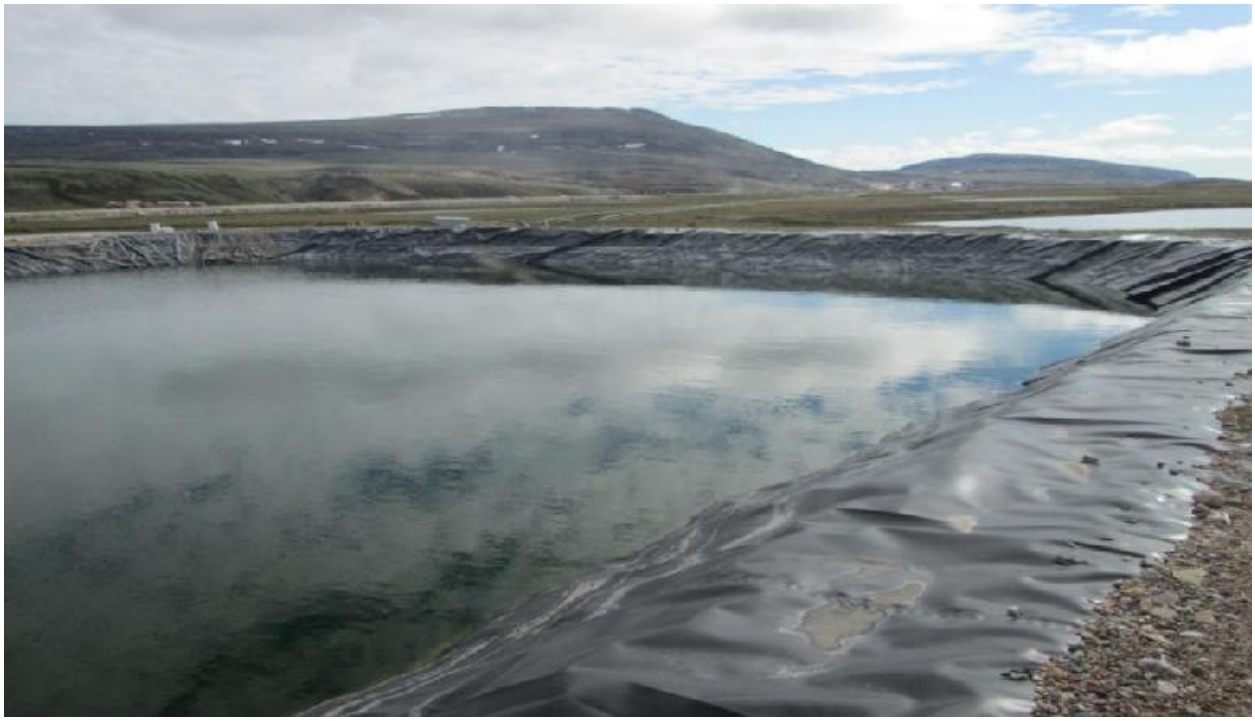
Polishing/Waste Stabilization Pond #1.

Our review of the area around the pond at the base of the slopes showed no sign of seepage and hence we conclude that the liner has been effective in containing sewage and there are no tears or ruptures in the membrane, excepting some minor tears from past activity at the top of the dyke well above the allowable effluent level in the structure in the horizontal portion of the membrane.

Many of the tears that had occurred in the liner on the top of the dyke have been patched during the period between reviews in 2008 and 2009 and are holding well. As well, there are no signs of weather related deterioration of the liner where it is exposed.

Monitoring points have been set up on the top of the dyke and have been monitored since 2009. Settlements have occurred since that time. These settlements have not led to any stress cracks in the structure. These settlements are an indication of consolidation in the berm structure and the active layer beneath the dyke and are not considered to be of any concern.

We see no reason to continue the monitoring of the top of the berm on an annual basis. With the excellent condition of the dyke construction, we see no reason to continue this function.

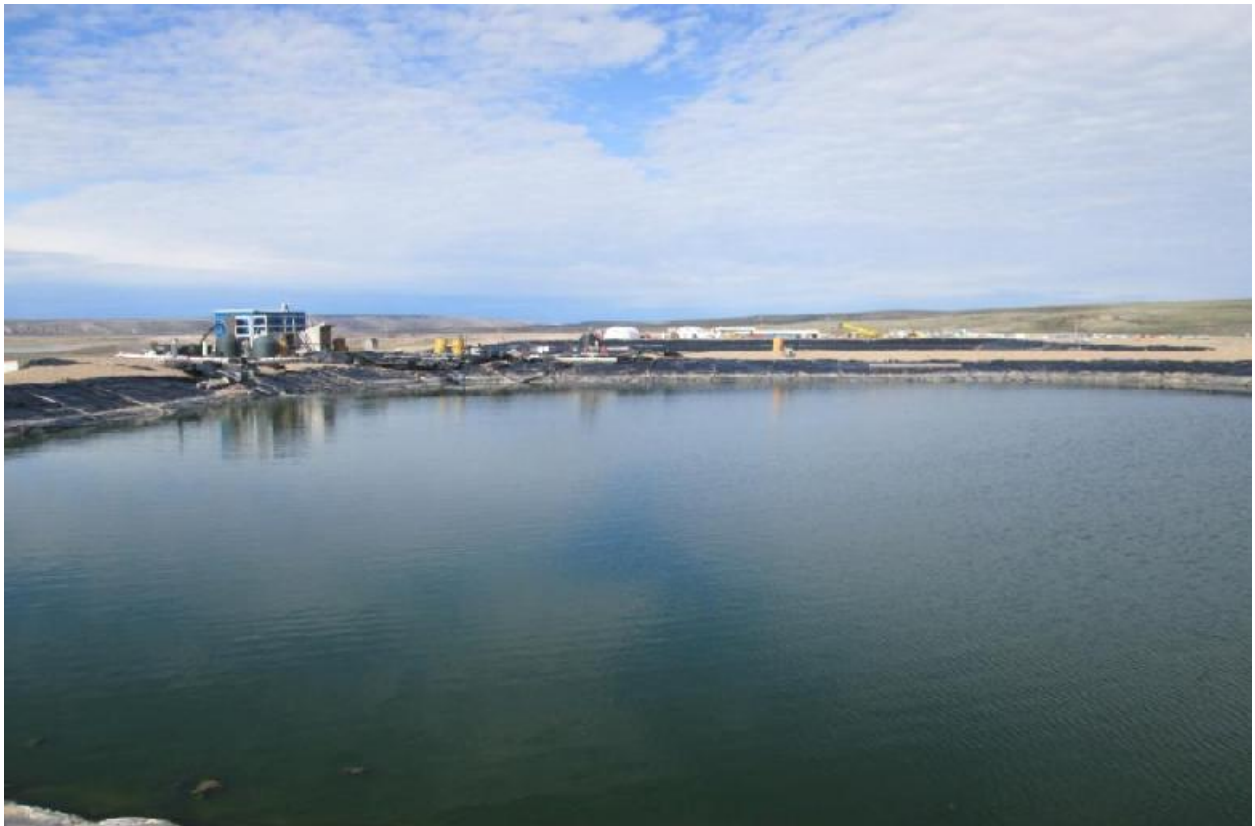
Polishing/Waste Stabilization Ponds #2 and #3.

Our review of the area around the pond at the base of the slopes showed no sign of seepage and hence we conclude that the liner has been effective in containing the sewage and there are no tears or ruptures in the membrane.

Longitudinal cracking which appeared in the dykes of PWSP#3 due to the melt of permafrost wedges in 2009 has not reoccurred and we consider this structure to be stable in its present condition.

Monitoring points have been set upon the top of the dyke and have been monitored since 2009. Settlements have occurred since that time. These settlements have not led to any stress cracks in the structure.

We see no reason to continue the monitoring of the top of the berm on an annual basis. With the excellent condition of the dyke construction, we see no reason to continue this function.

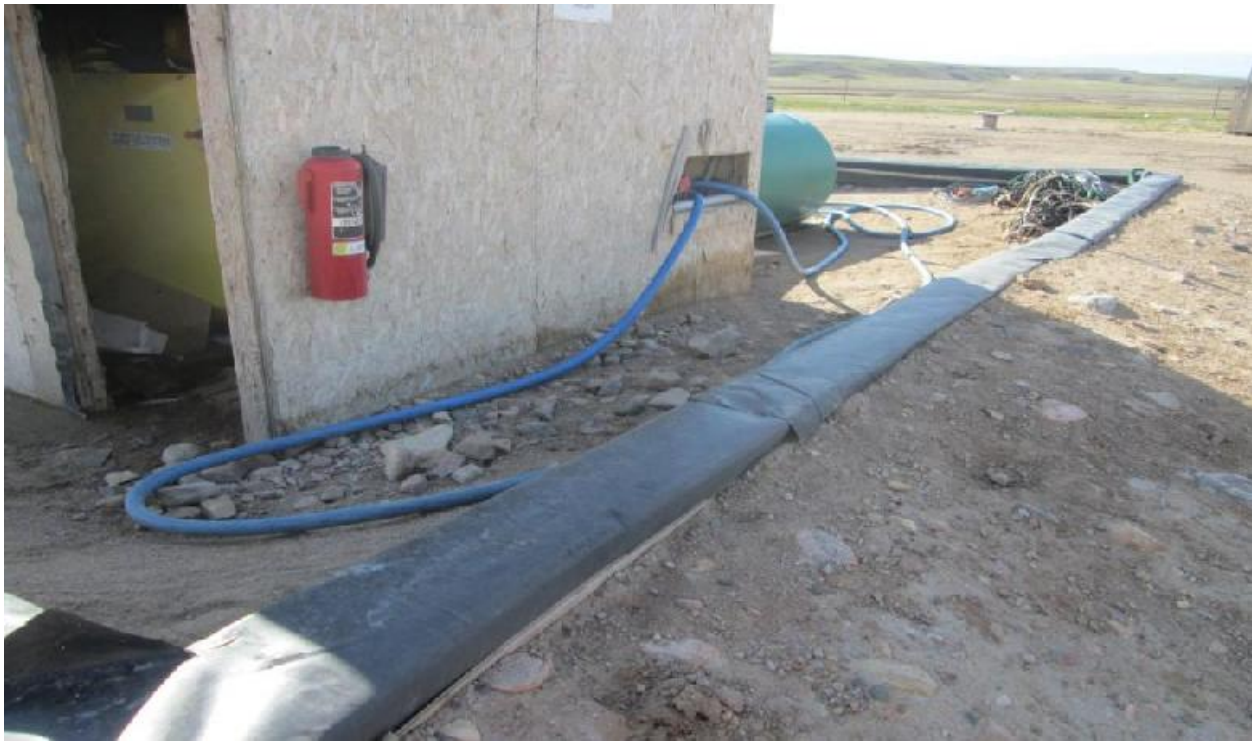
Helicopter Fuel Tank Containment.

In the past, a liner clad wood curb had been added to the top of the berm to prevent the erosion of gravel off the berm, caused by pulling the fuel hose from within the dyke out to the helicopters to provide them with fuel.

A review of the exterior and the top of the berms showed no sign of cracking or settlement which would indicate stress within the structure.

The structure is considered to be stable in its present condition.

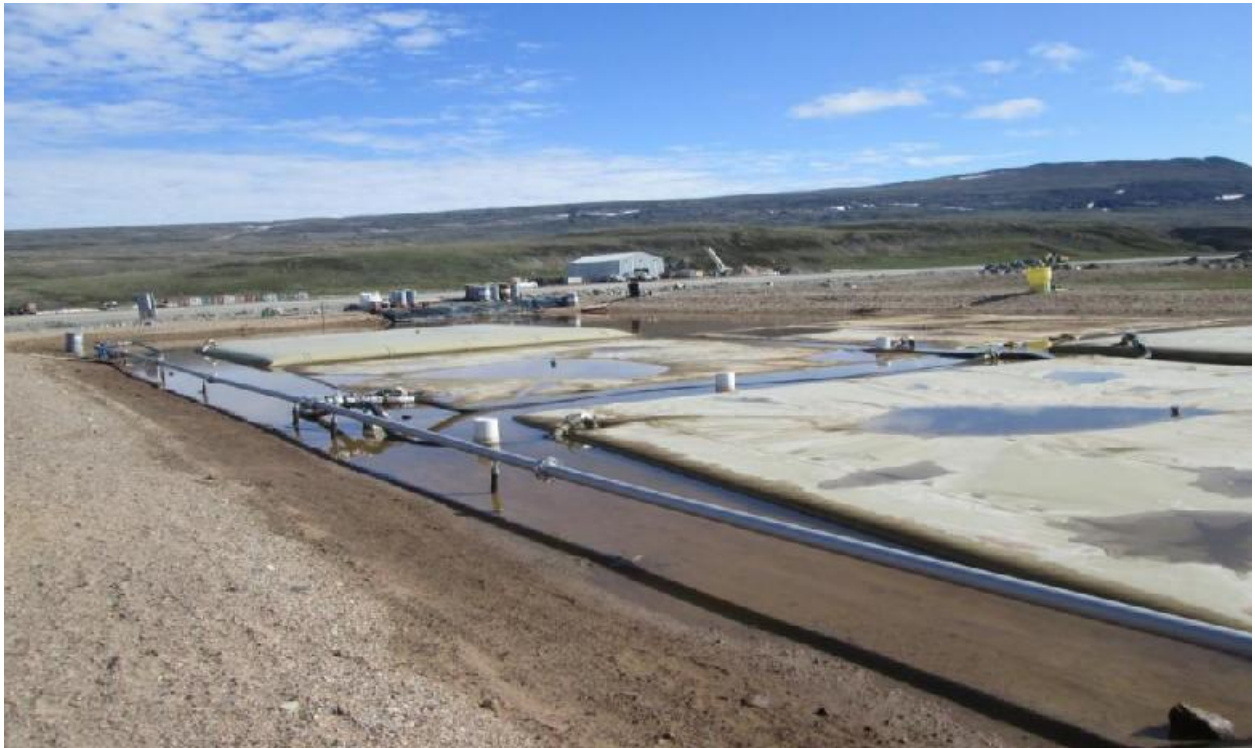
Bulk Fuel Storage Containment.

At the time of our first review, water had not been removed for a period from within the containment and water was ponding above the level of the gravel within the bottom of the containment. There was still considerable factor of safety against failure of oil holding bladders within the dykes with the water level as it exists. Such was the case during the second inspection, but the water had frozen.

We have one recommendation. There is limited storage for spills at the load out end of the facility. Water currently ponds above the gravel in this area confirming the integrity of the liner but minimizing the capacity of the structure for spill containment.

We recommend that this water be removed on a regular basis. If the water proves to be oil impacted, it may be pumped to within the storage containment for treatment at a future date.

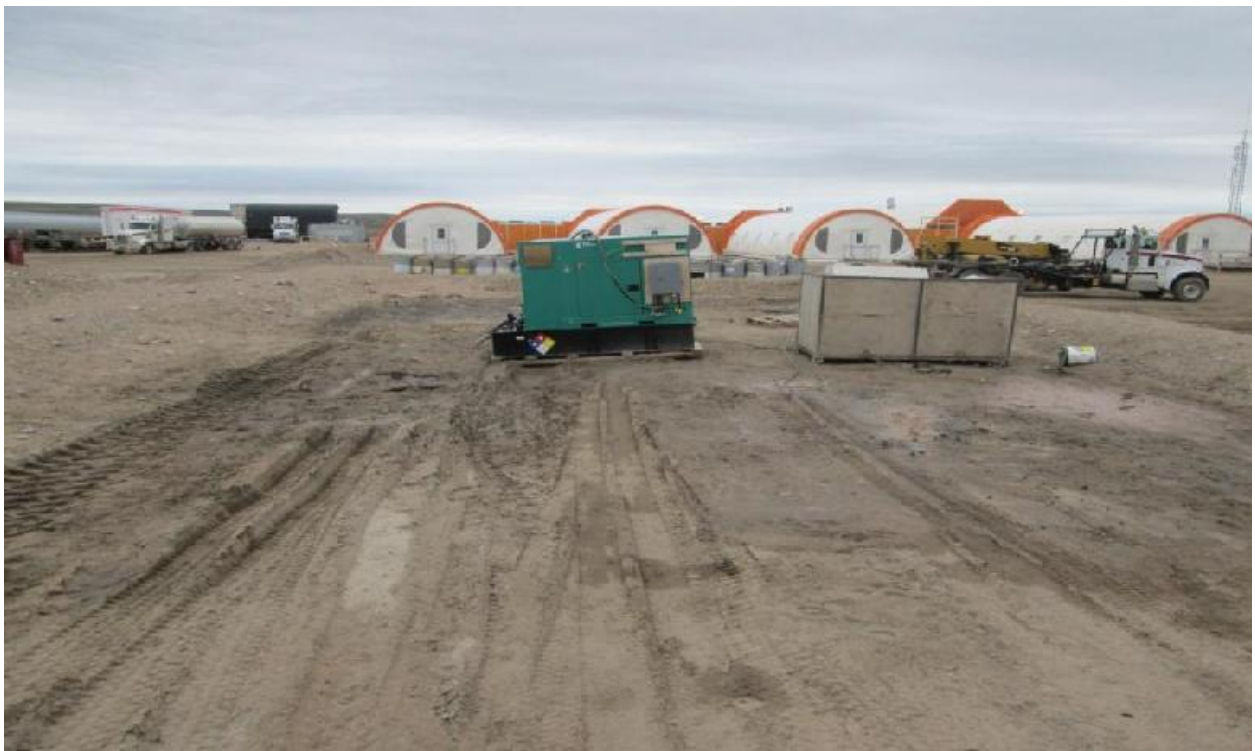
Enviro Tank Storage

This particular structure is constructed contiguous with the Hazardous Waste Storage constructed in 2010 and the Stove Oil Storage cell. It is now utilized as a wash down cell.

We recommend that the geotextile over the liner and the granular cover be made good prior to continuing use of this cell as a wash down cell.
