Re: Ice Bearing Capacity Recommendations
Mary River Ice Airstrip
Mary River Project Site

**Mary River Project
Nolinor Aviation**

REPORT OF AN INSPECTOR OF MINES

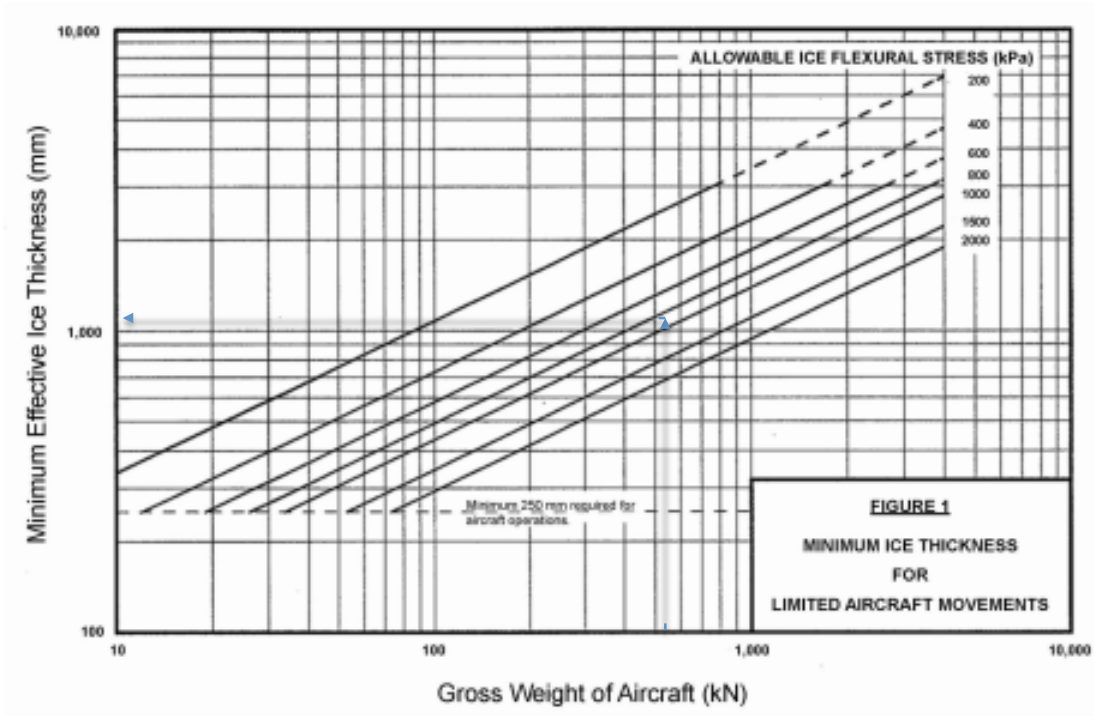
Figure 2 Ice Thickness Chart from Transport Canada Guide

Transport Canada's Advisory Circular 301-001 on ice aerodromes (Civil Aviation, 2011) is the primary reference document for the design and operations of ice aerodromes (airstrips) in Canada. Figure 2 reproduces the Appendix A – Minimum ice thickness for limited aircraft movements from this documents. We used this Figure to estimate the ice thickness for the flexural strength noted in Section 2.1

Based on the Transport Canada method for an allowable ice flexural stress of 800 kPa, the recommended thickness of good quality ice is 120 cm for a maximum aircraft weight of 58,300 kg.

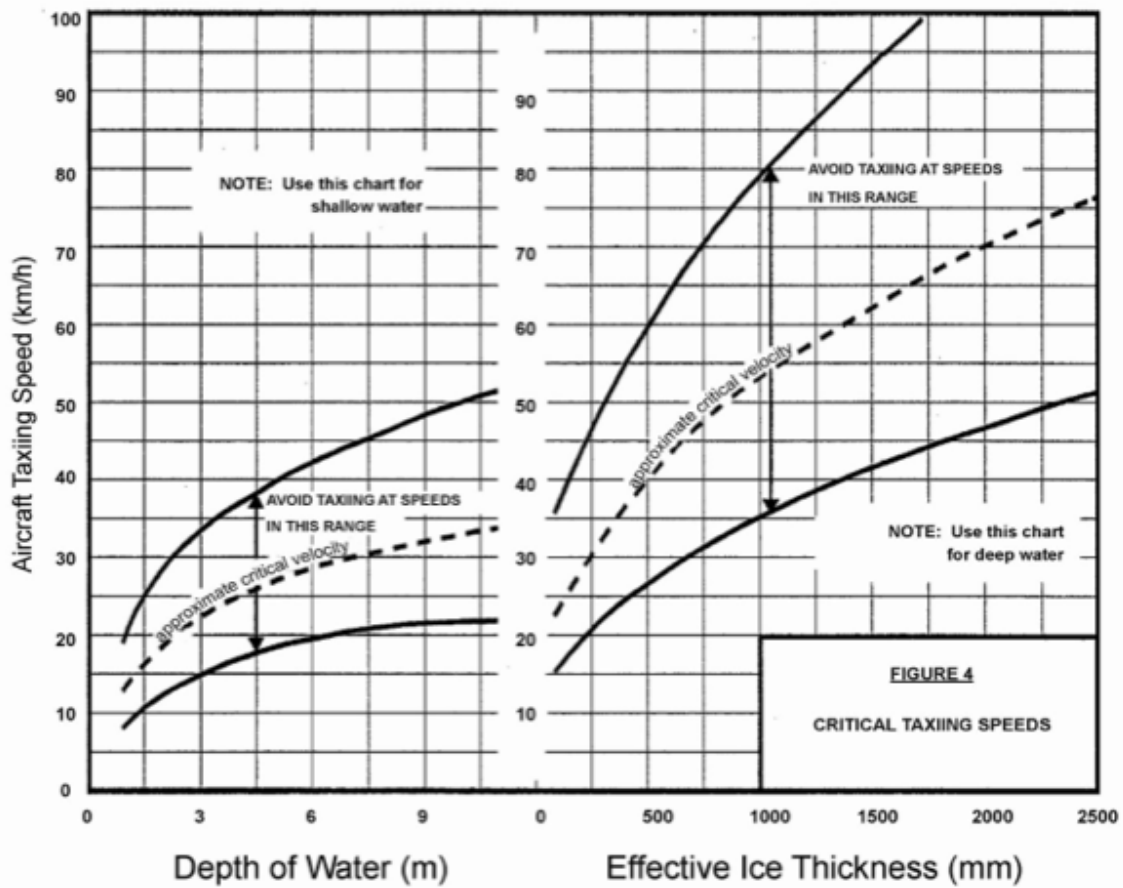
Figure 1 Critical Taxiing Speed (AC 301-003)

Under certain conditions of water depth and ice thickness, a taxiing aircraft will cause hydrodynamic waves under the ice cover that can overstress the ice cover. This overstressing can be critical when the aircraft is operating on ice that meets the minimum ice thickness requirement. Normally limiting the taxiing speeds below the critical speed for the water depth and ice thickness mitigates these stresses.
