APPENDIX E.14

Response to Outstanding 2018 Annual Report Comments

Table E.14 - Baffinland Response to Outstanding Comments on the 2018 QIA & NWB Annual Report for Operations - March 31, 2020

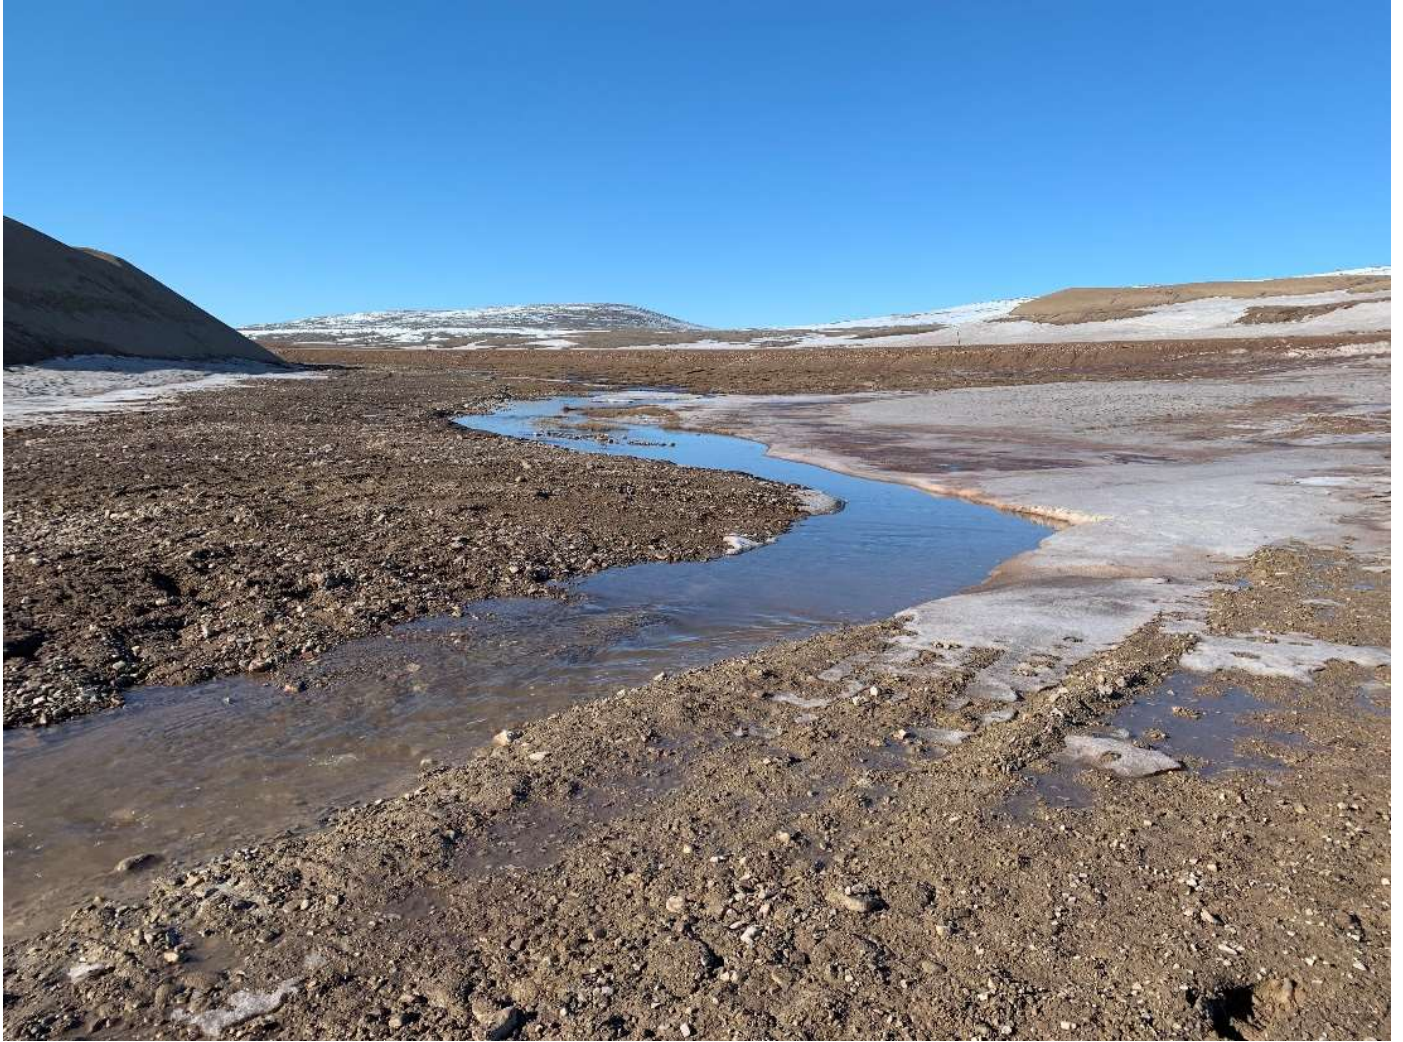
Figure E.14.2: Stream Crossing with Culvert Removed, Historic Roadway Regraded to Restore Natural Drainage, May 2019

2	Going forward, Baffinland include work plan items and modification requests, which were not completed in Table 2.0.	Baffinland has included in Table 2.0 items that were not completed in the given year.	The NWB recognizes the issue as subject to the agreement between the Licensee and the QIA only.
3-1	Baffinland provide supporting documentation to substantiate the reclamation of KM 57.	Baffinland visited the site with QIA representatives in May 2019 during an inspection of the Site, to demonstrate the results of reclamation efforts that were employed. The culvert was removed from the stream crossing and the area re-graded to promote natural drainage. The surface has been scarified to promote natural revegetation. Photographs from this site visit, as well as satellite imagery depicting the extent of works completed to reclaim the historic section of roadway and culvert are appended to this response.	As per Licence Schedule B, Item f(i).
