# CV-216 By-Pass Culvert Crossing Design Brief

Final Report

**Baffinland Iron Mines**

**Nunami Stantec Limited**

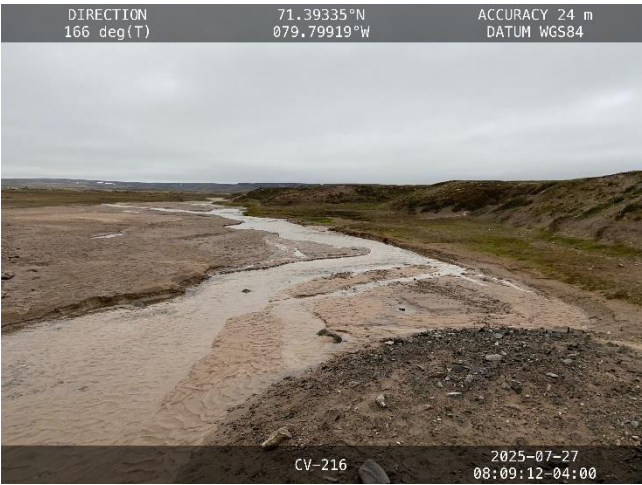
On the upstream side of the culvert crossing, the culverts were crushed or had subsided into the channel bed with flows potentially going through the collapsed culverts or within the pore space of the roadbed aggregate. The surrounding banks and bed consisted of loose sand, which was observed to crumble under minimal finger pressure. During the August site visit, fish were observed upstream of the culvert crossing within pools adjacent to the roadbed.

Photo 1: Culvert Crossing CV216 – Upstream side looking upstream

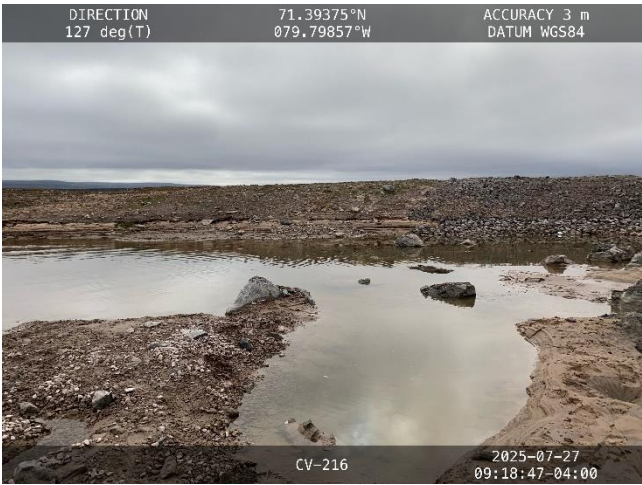
Downstream site conditions observed a potential backwater effect from Muriel Lake. Fish were observed swimming in pools. The banks and bed were composed of medium-fine sand with silt, and algae growth is present both on the sand and at the watercourse mouth near Muriel Lake.

Photo 2: Culvert Crossing CV216 – Downstream side looking downstream

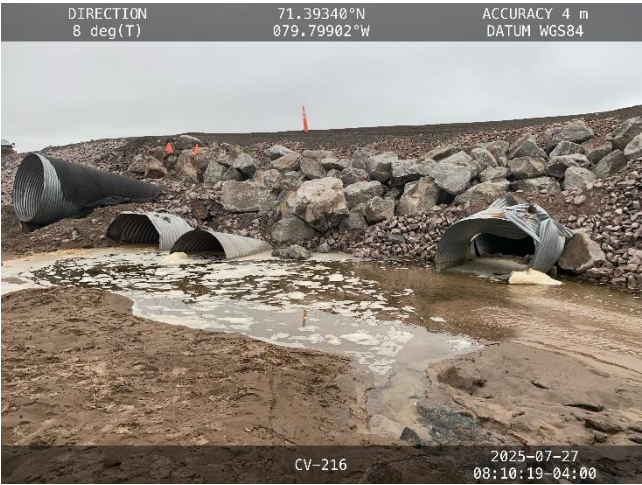
Photo 3: Culvert Crossing CV216 – Inlet

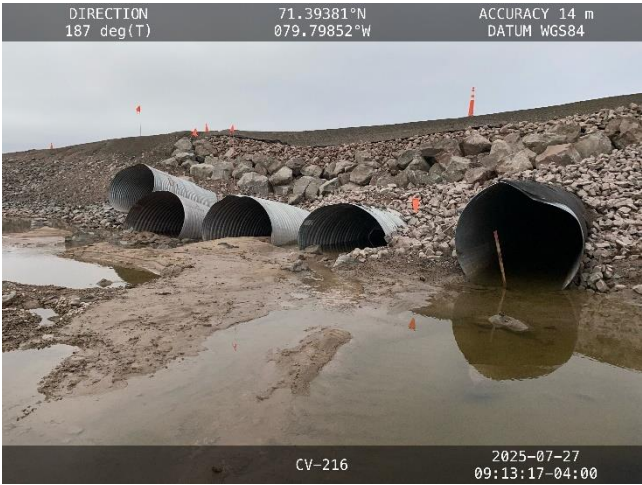
Photo 4: Culvert Crossing CV216 – Outlet

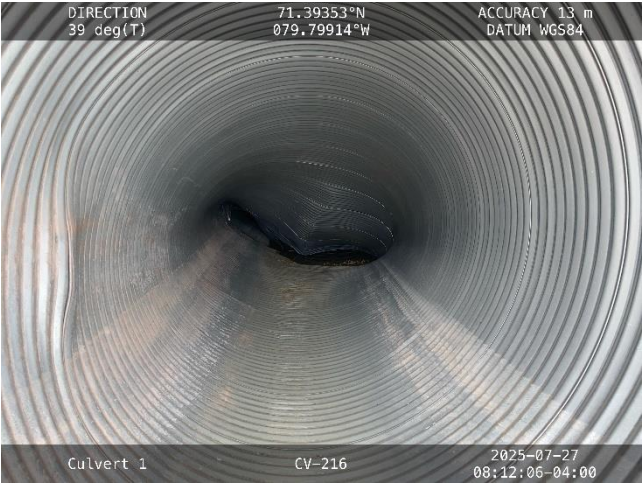
Photo 5: Culvert Crossing CV216 – Culvert 1 upstream

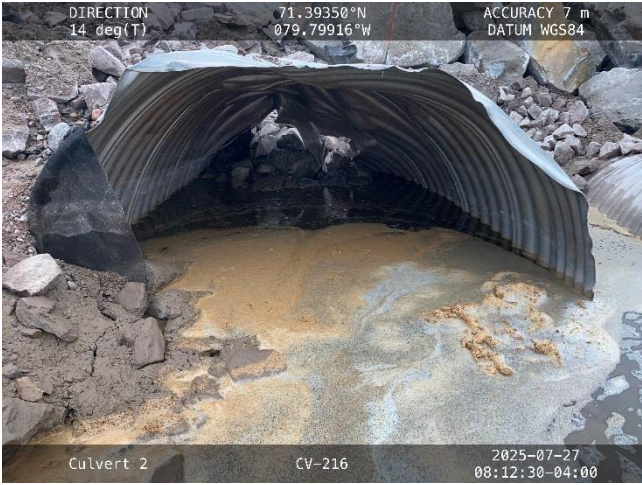
Photo 6: Culvert Crossing CV216 – Culvert 2 upstream

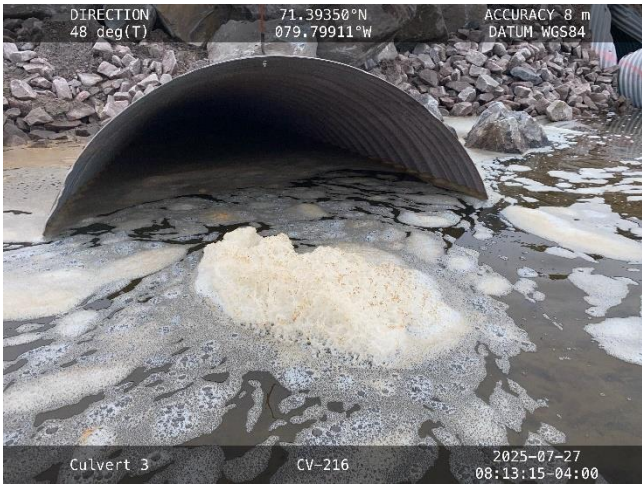
Photo 7: Culvert Crossing CV216 – Culvert 3 upstream

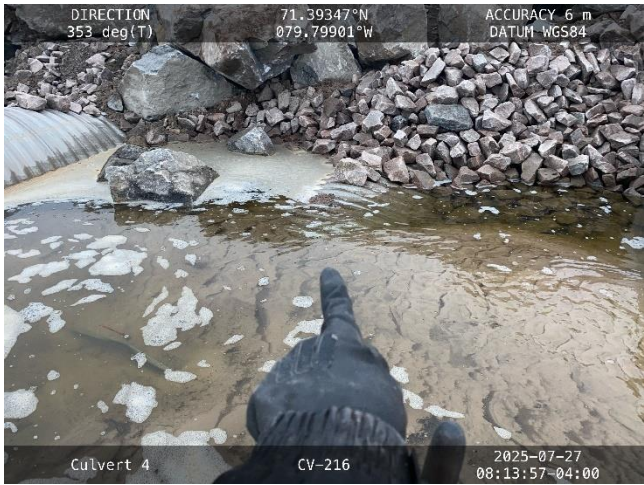
Photo 8: Culvert Crossing CV216 – Culvert 4 upstream

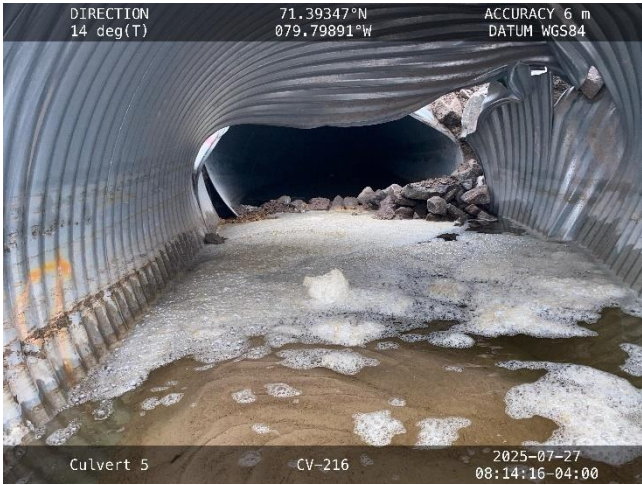
Photo 9: Culvert Crossing CV216 – Culvert 5 upstream

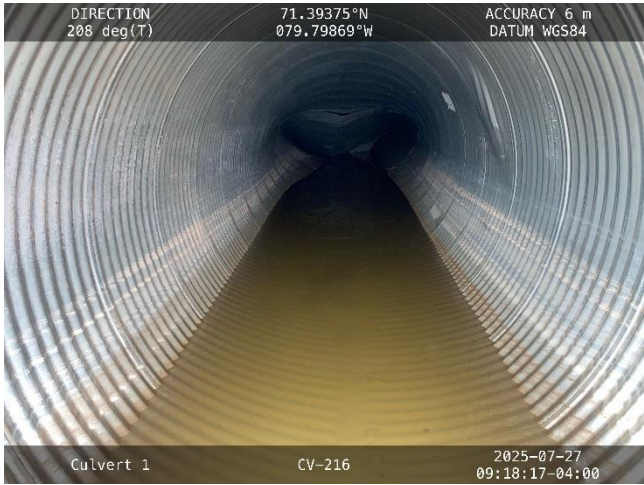
Photo 10: Culvert Crossing CV216 – Culvert 1 downstream

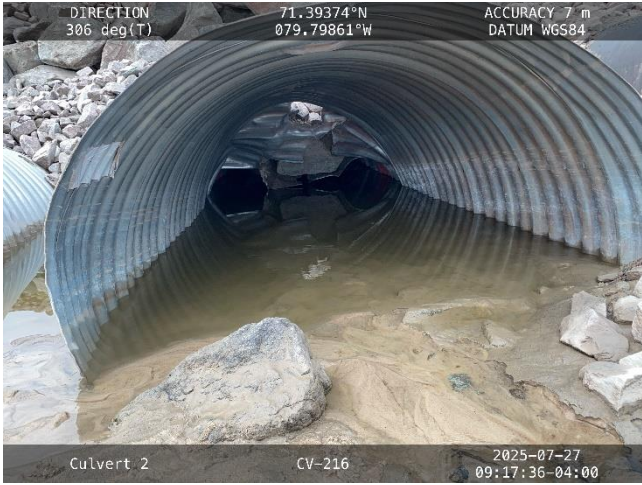
Photo 11: Culvert Crossing CV216 – Culvert 2 downstream

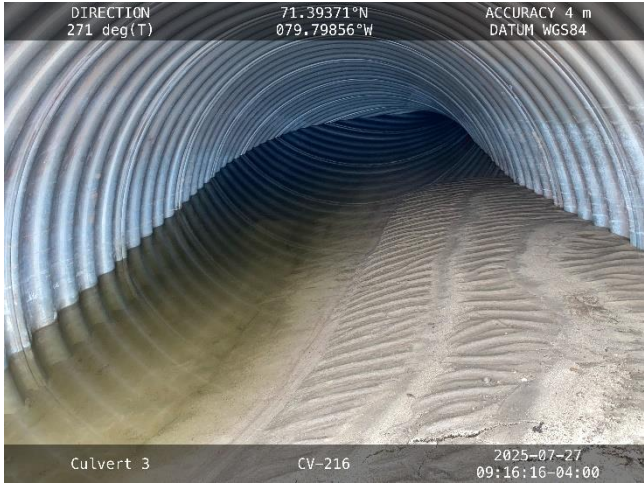
Photo 12: Culvert Crossing CV216 – Culvert 3 downstream

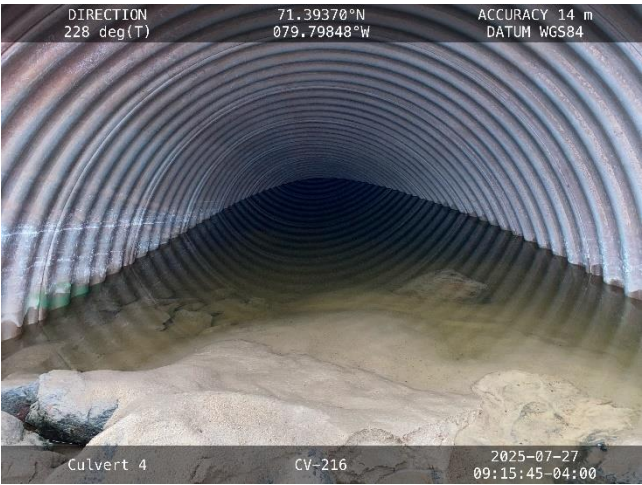
Photo 13: Culvert Crossing CV216 – Culvert 4 downstream

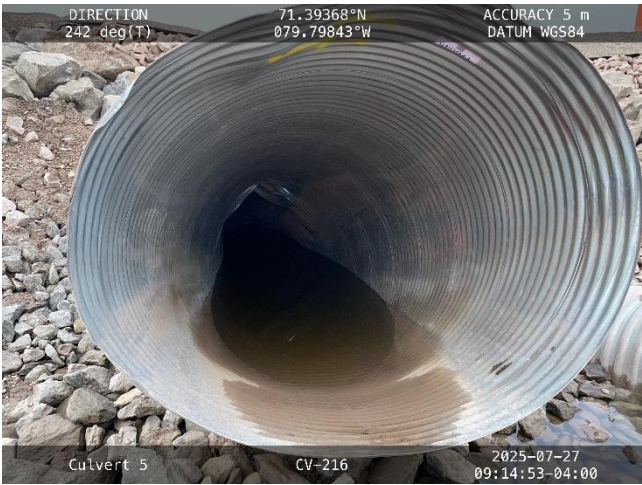
Photo 14: Culvert Crossing CV216 – Culvert 5 downstream
