MARY RIVER PROJECT

4.0 MILNE INLET

MILNE INLET PHOTOS

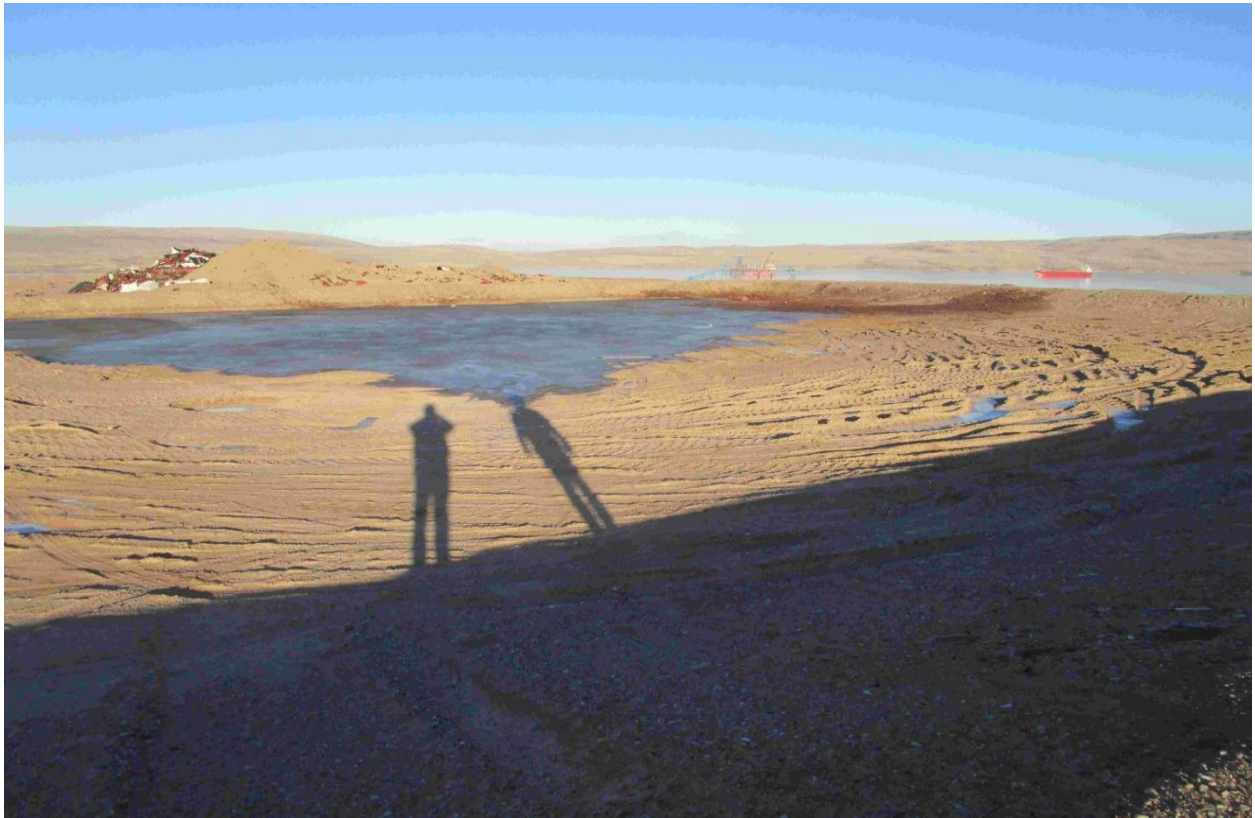
Contaminated Snow Containment

The construction of the contaminated snow containment structure is contiguous with the east end of the landfarm.

The snow containment facility has a containment volume of 929 m³ based on estimates of volume provided by the owner and only a small percentage of the capacity is utilized. Hydrocarbon contaminated water was treated and discharged to the environment in the late summer by means of a portable oily water treatment plant.

The structure appears stable as constructed.

We have no recommendations with respect to this construction at this time.

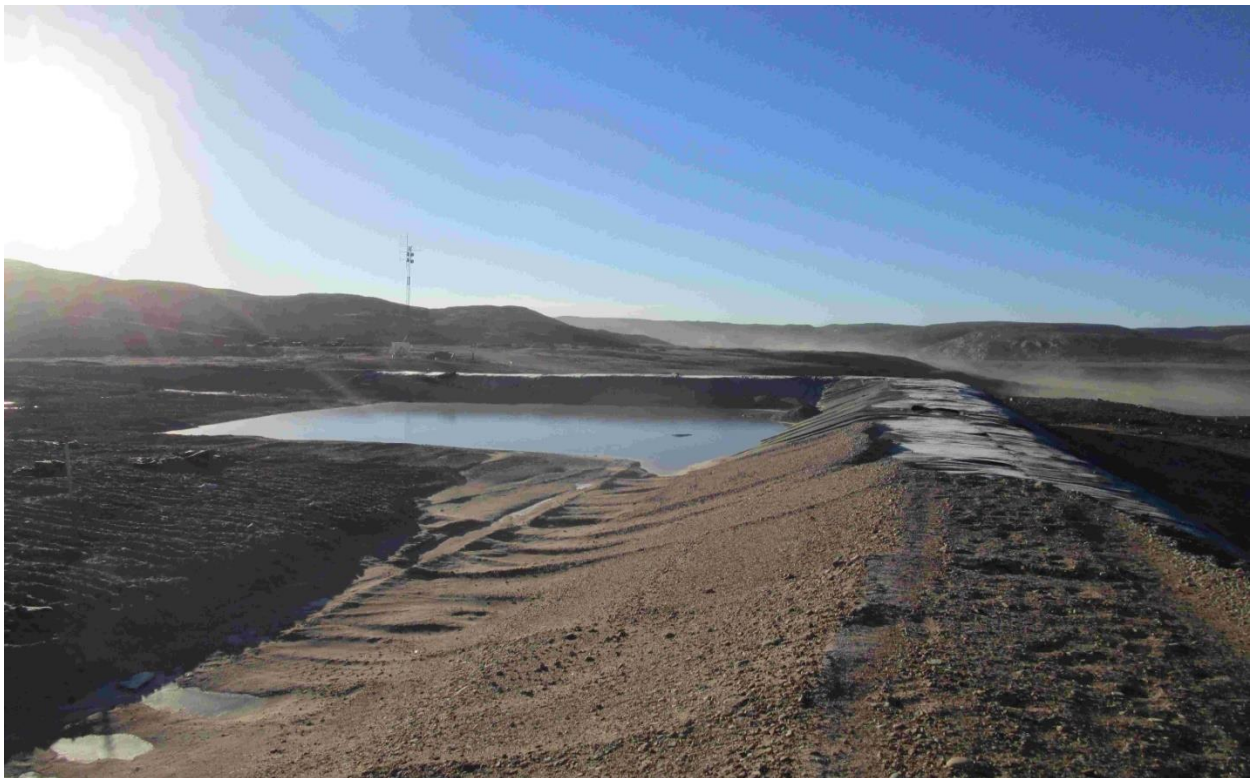
Land farm Containment

The landfarm containment is complete except for soil cover in the area of the sump.

The structure appears stable as constructed.

We recommend that the remaining dyke structure, without protective cover over it, be covered as per the design drawings. This however, is not an absolute requirement..

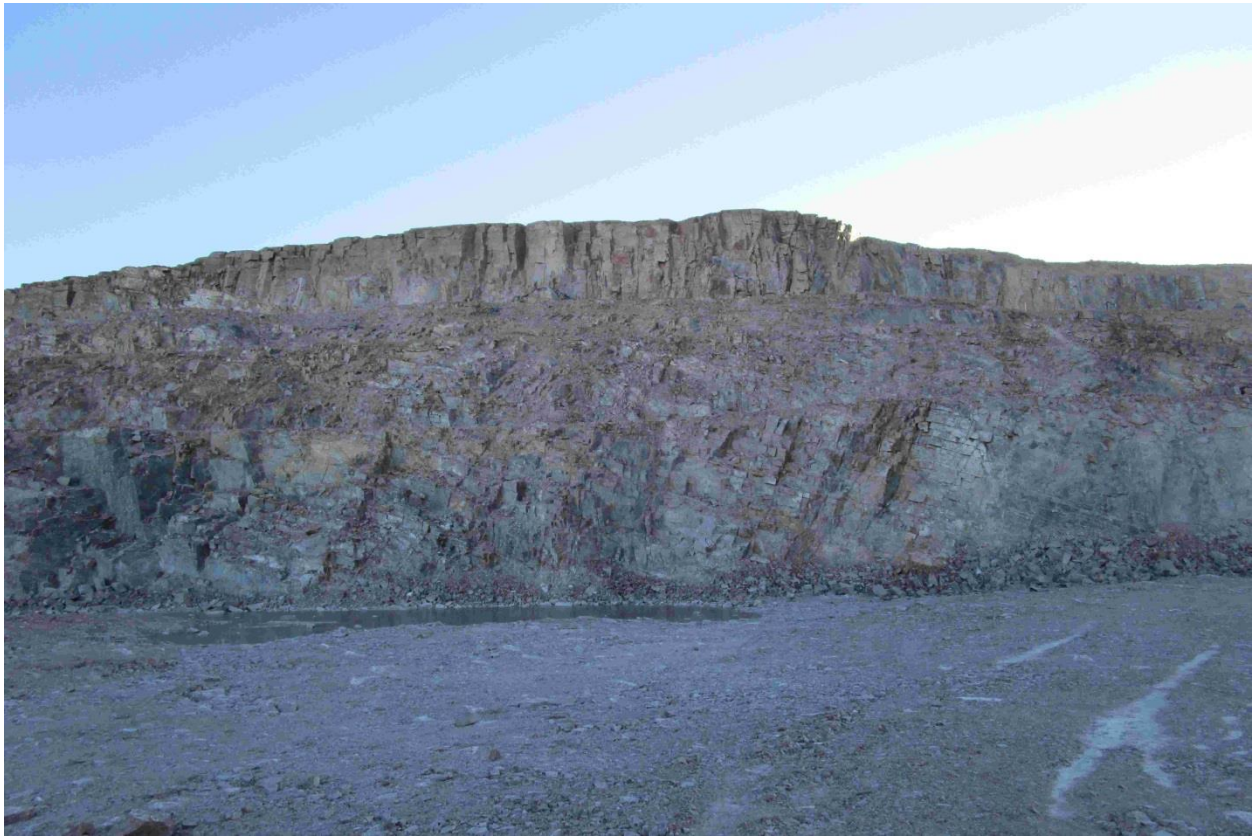
Milne Inlet Quarry

The quarry was inactive at the time of our review and all blasted rock had been removed from the quarry site.

Rock faces appear stable.

We have no recommendations to be made with respect to the quarry.

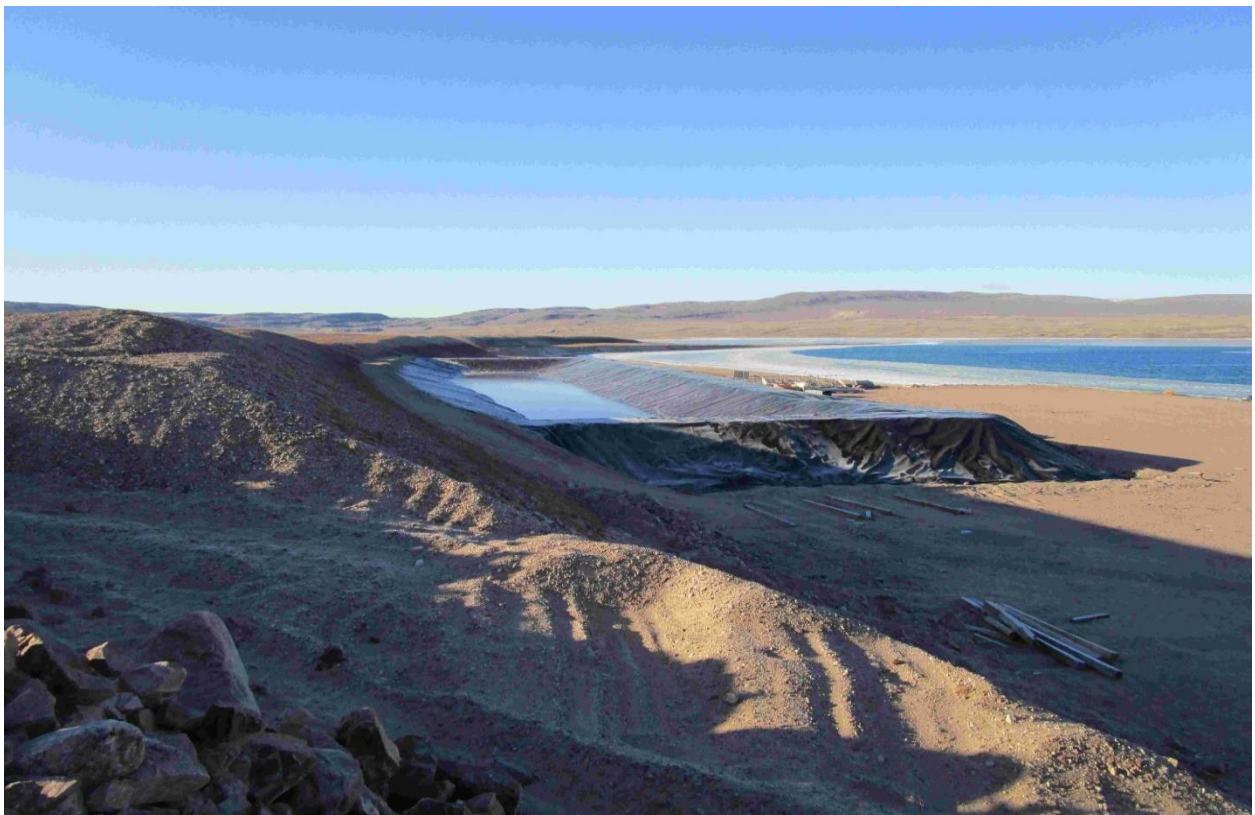
Sediment Pond West

The construction of this sedimentation pond for drainage from the west side of the site is nearing completion except for the west end on the south side where the liner must still be “tucked” in as set out in our July/August report.

We have some concern over the stability of the liner on this pond as we have with the east pond and further recommend that used tire ballast be considered.

Complete construction at the south side, west end, by “tucking” the edge of the liner under the soil.

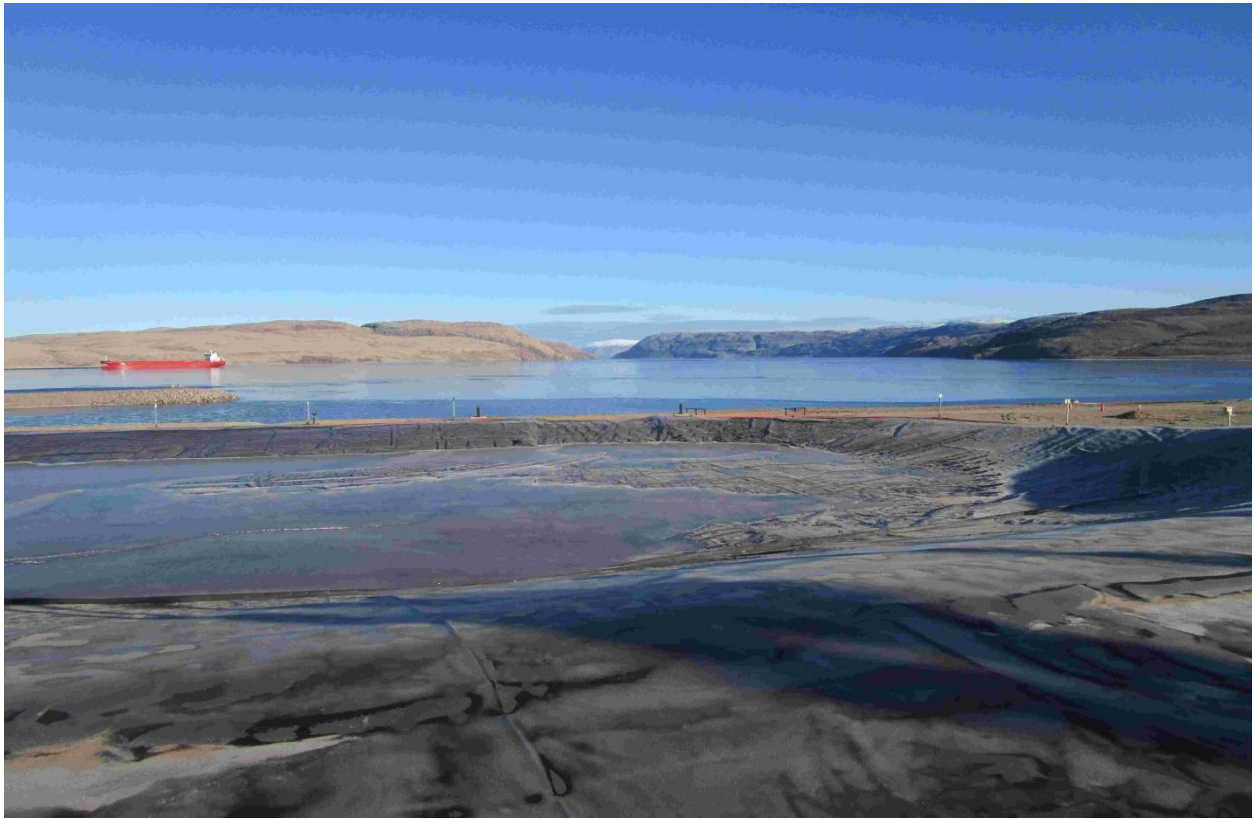
Sediment Pond East

There has been no cover placed over the liner to this point and rip rap has not yet been placed in the outlet weir.

We have concerns over the stability of the liner and recommend more soil ballast on the south edge and possibly tire ballast over the liner which appears subject to wind damage. This shall provide a function for used tires.

We recommend review of the use of a ballast (possibly tires) on the exposed liner at the dyke to prevent wind uplift.

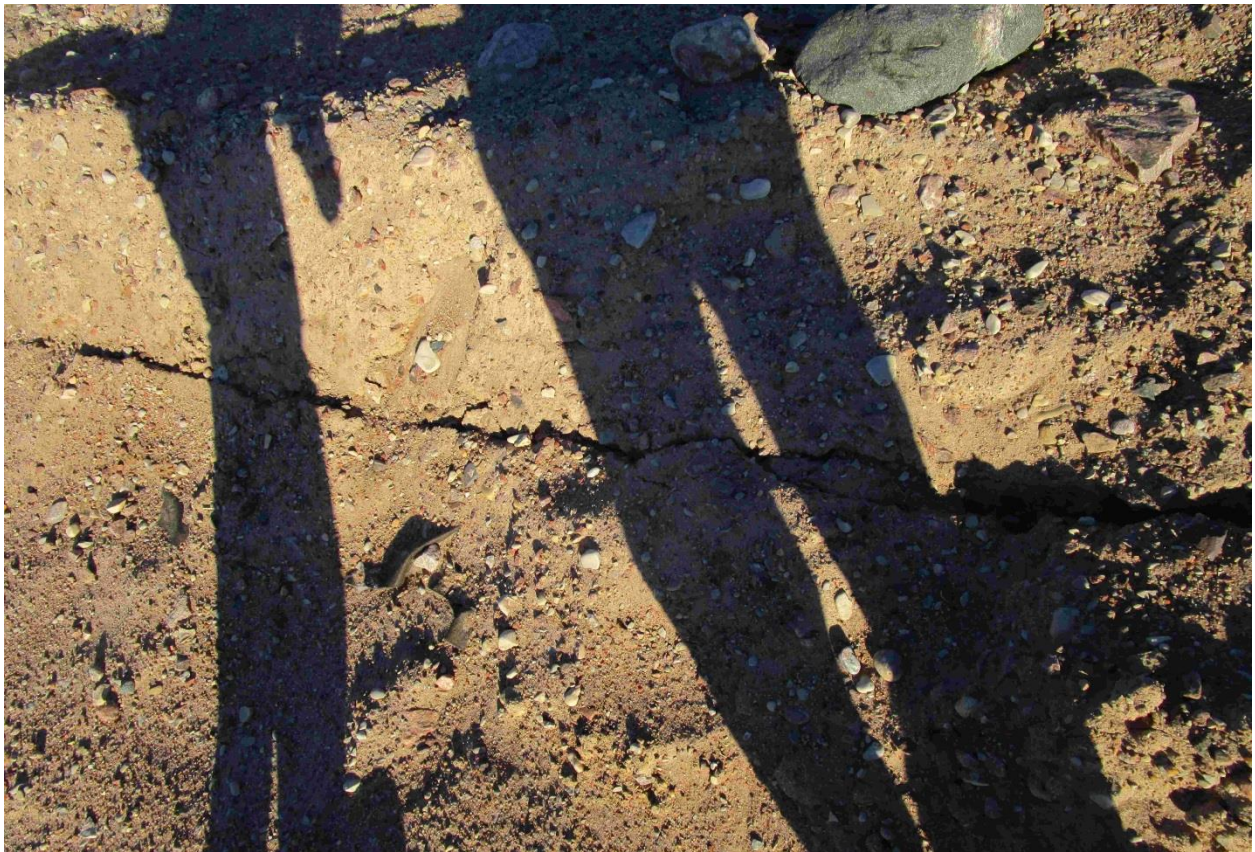
A review of the south edge of the liner shows very minor movement in the liner at the south edge probably due to wind uplift of the liner. This was forecast in our July/August report.

Indicates Movement in Anchorage at Sediment Pond East

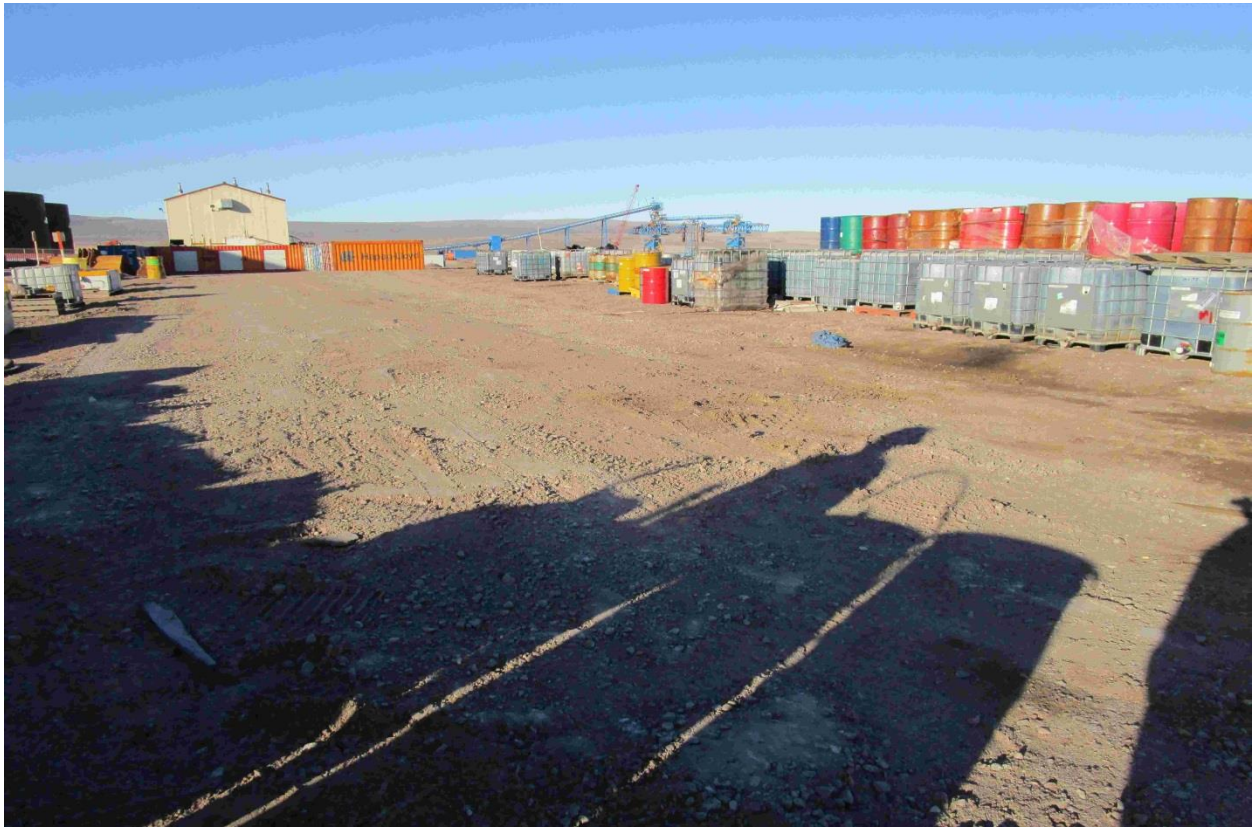
Loading Area Containment Storage MP-HWB-1

This area has been constructed near the loading dock to facilitate assembly of hazardous materials for shipment out. It appears that all material from the temporary hazardous storage containment have now been assembled here.

The travel over the berm that had taken place over the north berm has been dealt with since our last review in July/August and this is not expected to be a future problem.

Construction appears stable.

We have no recommendations with respect to this structure.

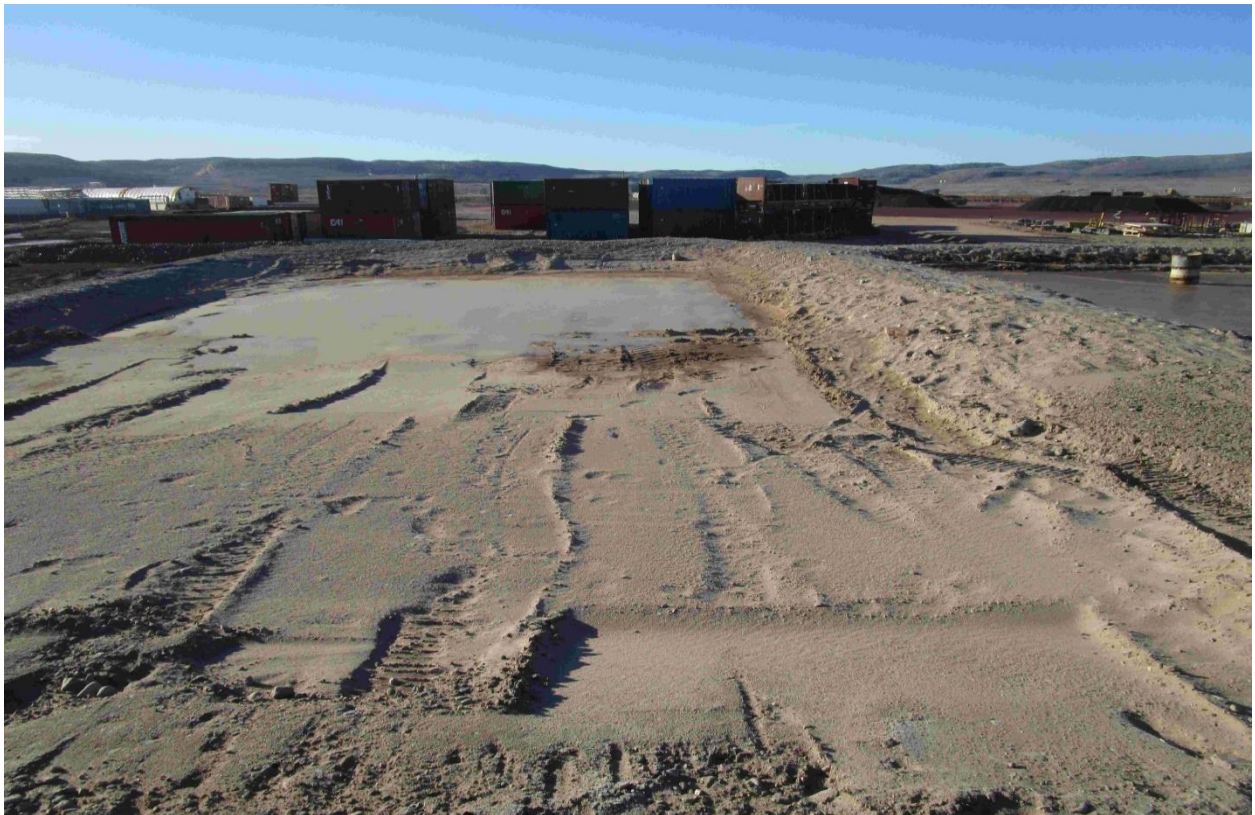
Hazardous Waste Containment MP-HWB-4

There is water ponding in both cells of the original structure confirming the integrity of the liner at this time.

Our review of the area around the dykes, at the base of the slopes, showed no sign of seepage. The structure is considered stable.

We have no recommendations with respect to the use of these two cells at this time.

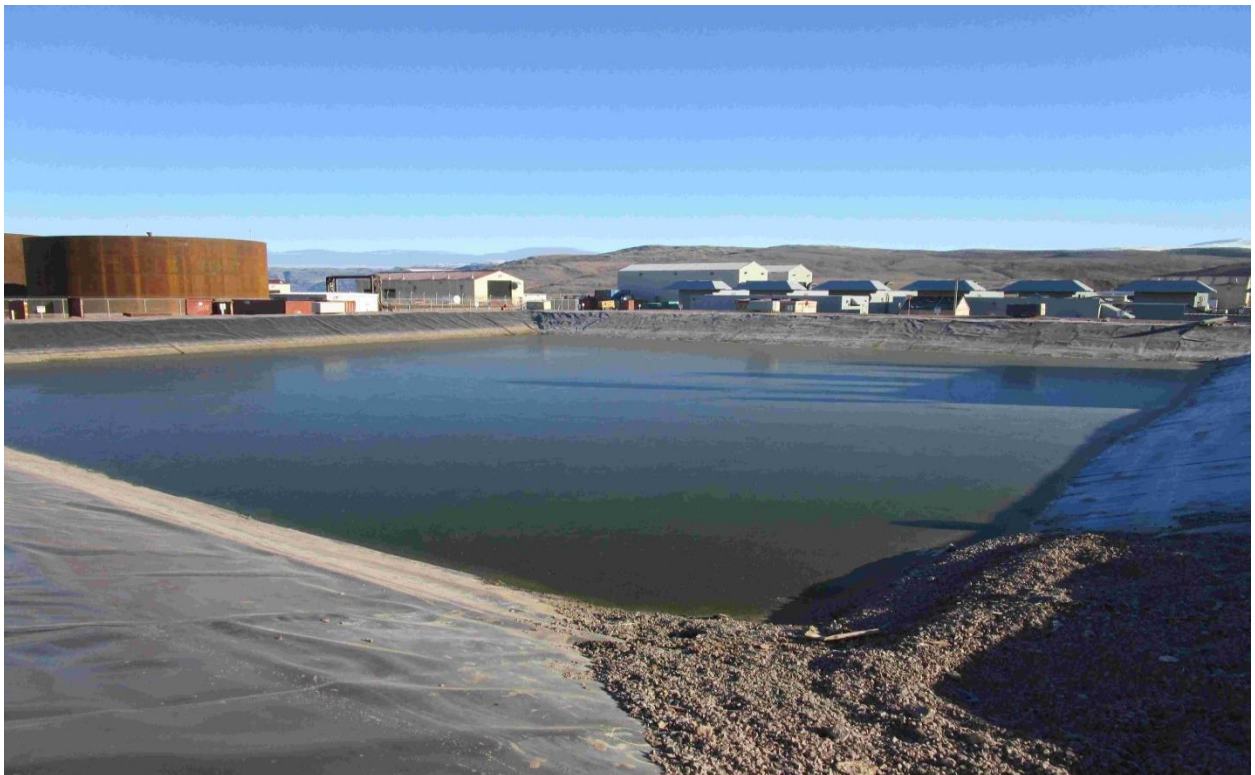
Polishing Waste Stabilization Pond

The containment pond was operating at approximately thirty percent of capacity at the time of our inspection.

We noted no sign of weakness in any of the construction.

We have no recommendations with respect to the use of this structure having no negative comments on the construction of this structure.

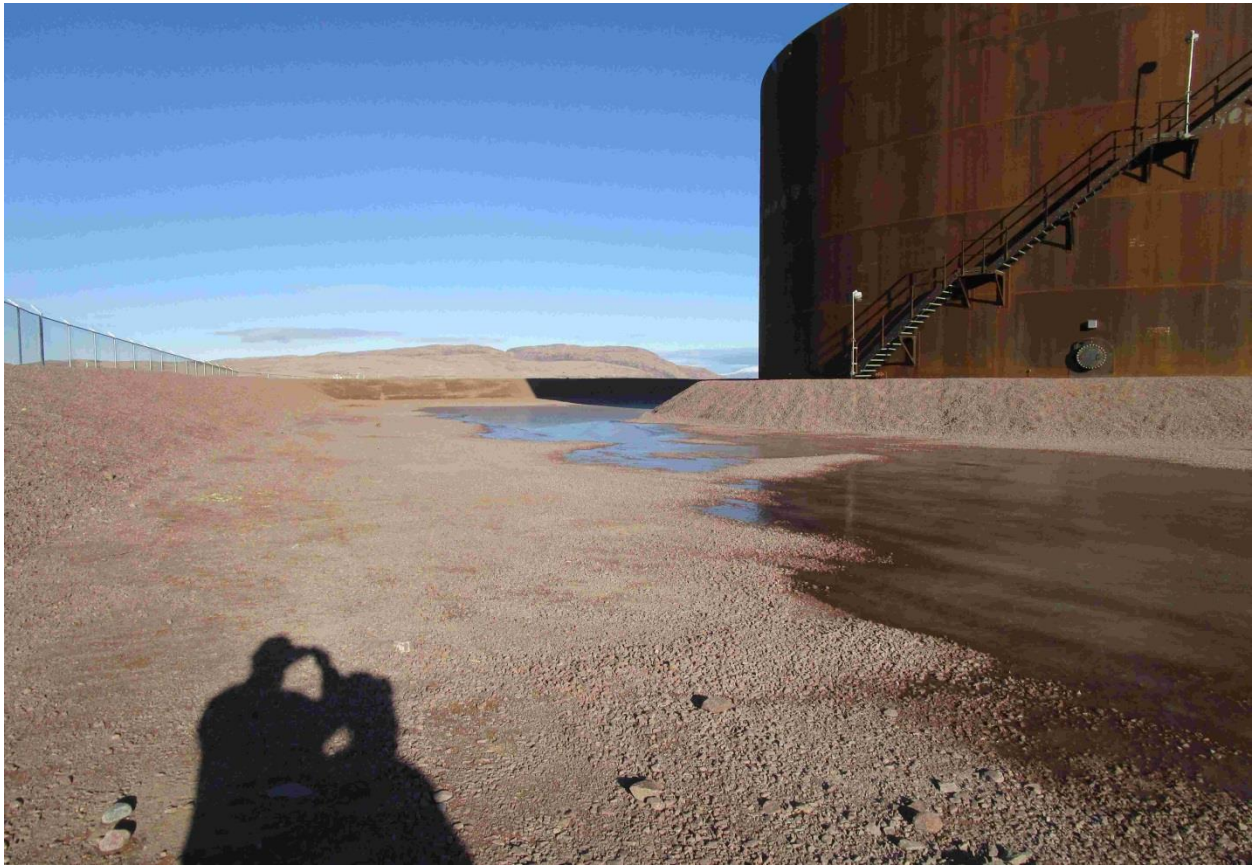
Steel Fuel Tank Containment

We note that the sump placed in the containment is located at the high end of the containment. There is water ponding in the low end of the containment. Water has been pumped from the low end of the containment since our review in July/August and there is considerably less water in the containment

We have minor water ponding at the low end of the containment confirming the integrity of the liner.

We recommend that a sump be considered at the low point at the north end of the containment, to better facilitate the removal of water to minimize the treatment of water should a minor spill occur within the containment.

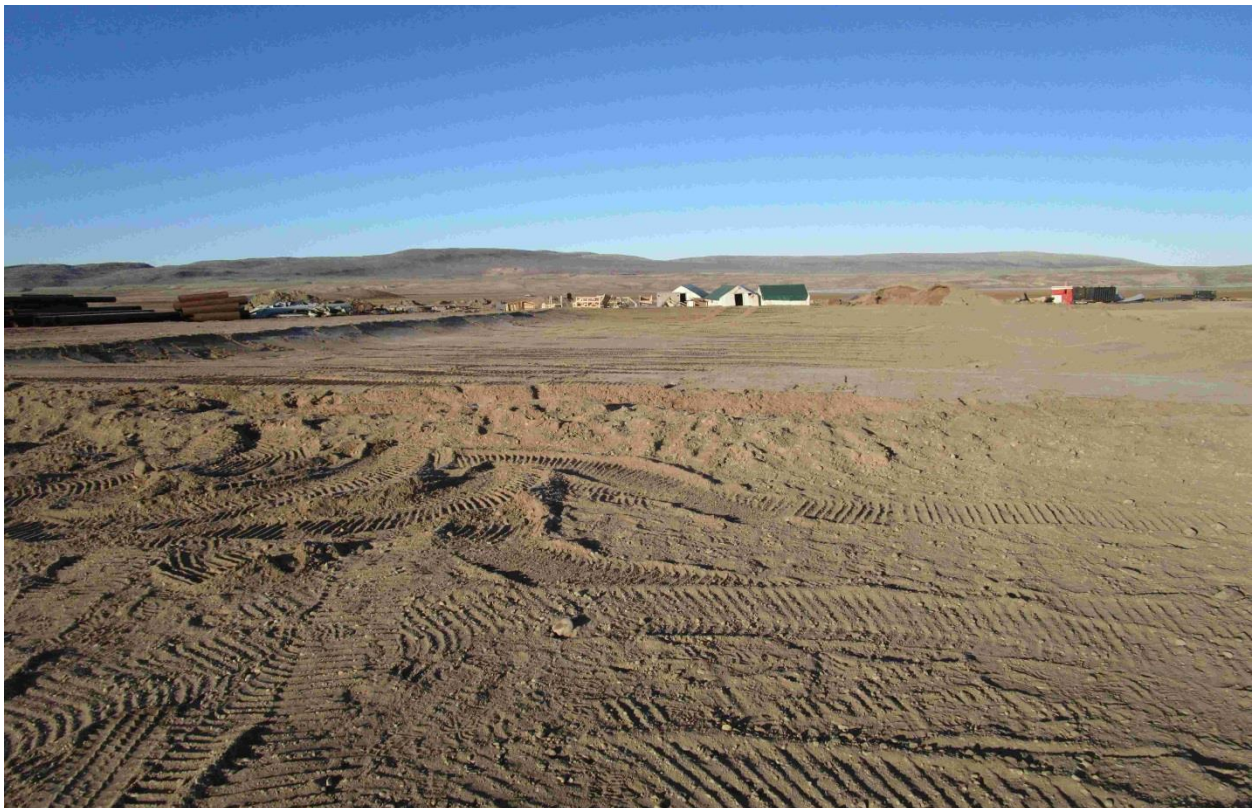
New fuel Dispensing Containment

A new fueling facility for the fueling of B trains is under construction utilizing design drawings prepared by our office.

All work is proceeding well and work conforms to the design drawing which is included in this report.

The liner utilized in the construction is a one piece liner, which minimizes the possibility of failure.
