July 5, 2022

Mr. Allan Knowlton  
Senior Project Manager  
Baffinland Iron Mines Corporation  
#300-2275 Upper Middle Road East  
Oakville, Ontario  
Canada, L6H 0C3

## **RE: Camp Lake Area Water Management Design Brief and Issued for Construction Drawings**

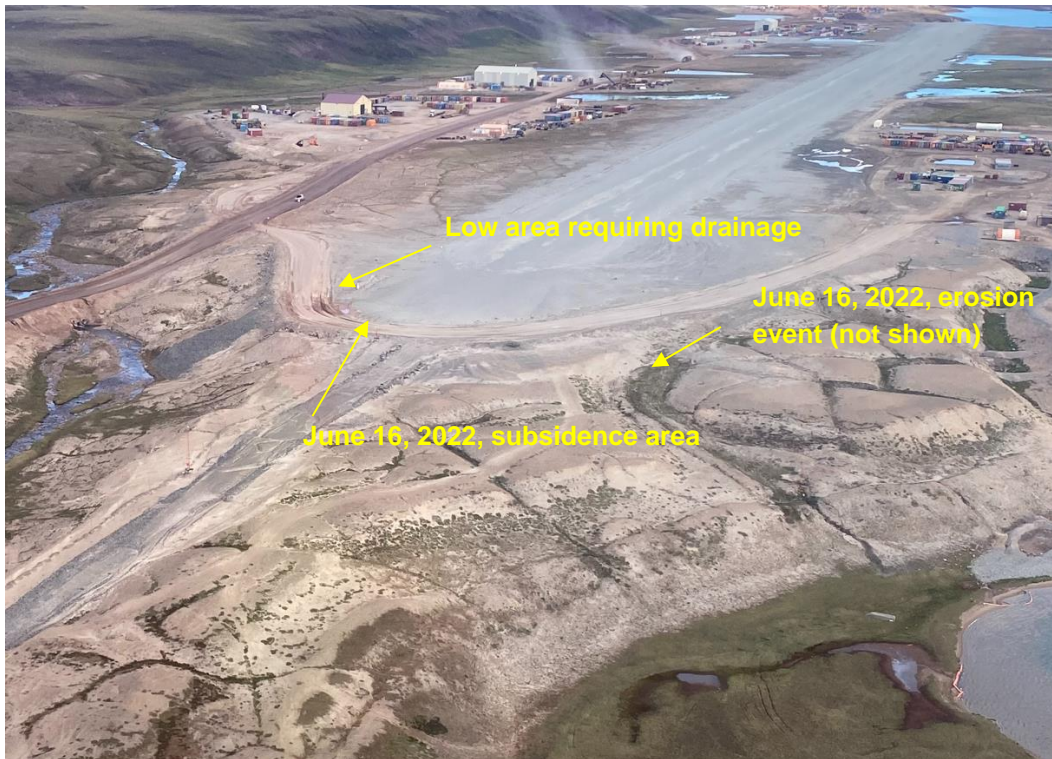
**Photo 1**

Area 1 is the area at the northwest end of the airstrip (Photo 1). Runoff from the northwestern portion of the airstrip currently collects at a low spot along the outer edge of the access road, as shown on Photo 1. This runoff cannot drain away because of the safety berm located along the outer bank of the access road that circles the end of the airstrip.

**Location of issues within Area 1**

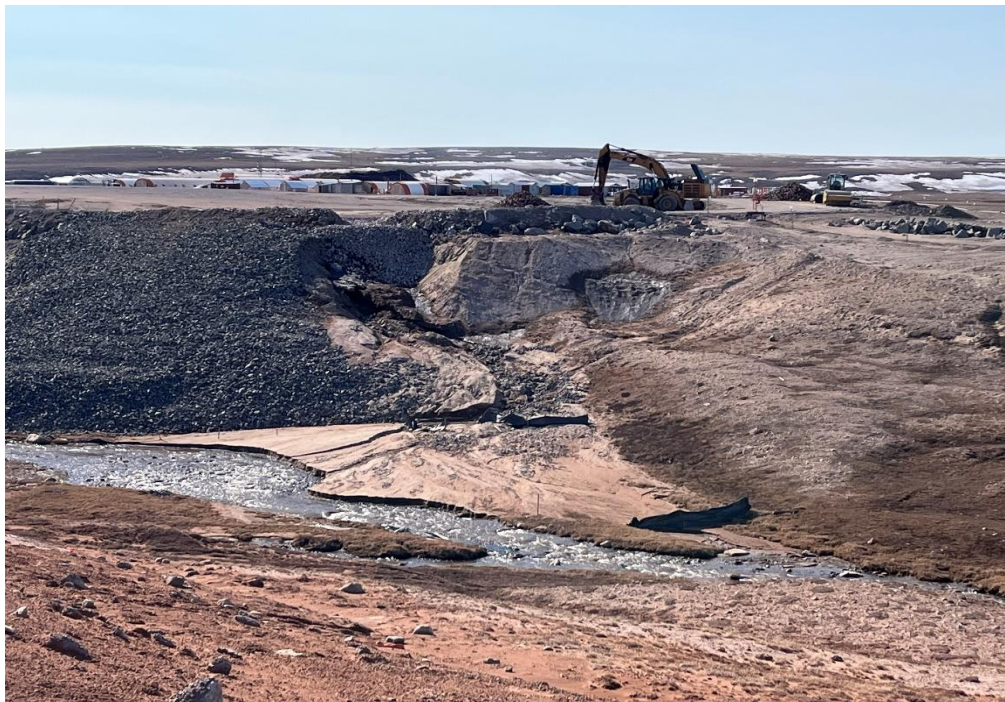
**Photo 2**

Breaching the safety berm is not a viable option, as the ground on the other side of the berm slopes steeply down to Camp Lake Tributary 1 (CLT-1). Water that has escaped the safety berm in the past has eroded the existing steep slope and has discharged sediment into the stream (Photos 2 and 3).

**Eroded slope beneath the low area requiring drainage**

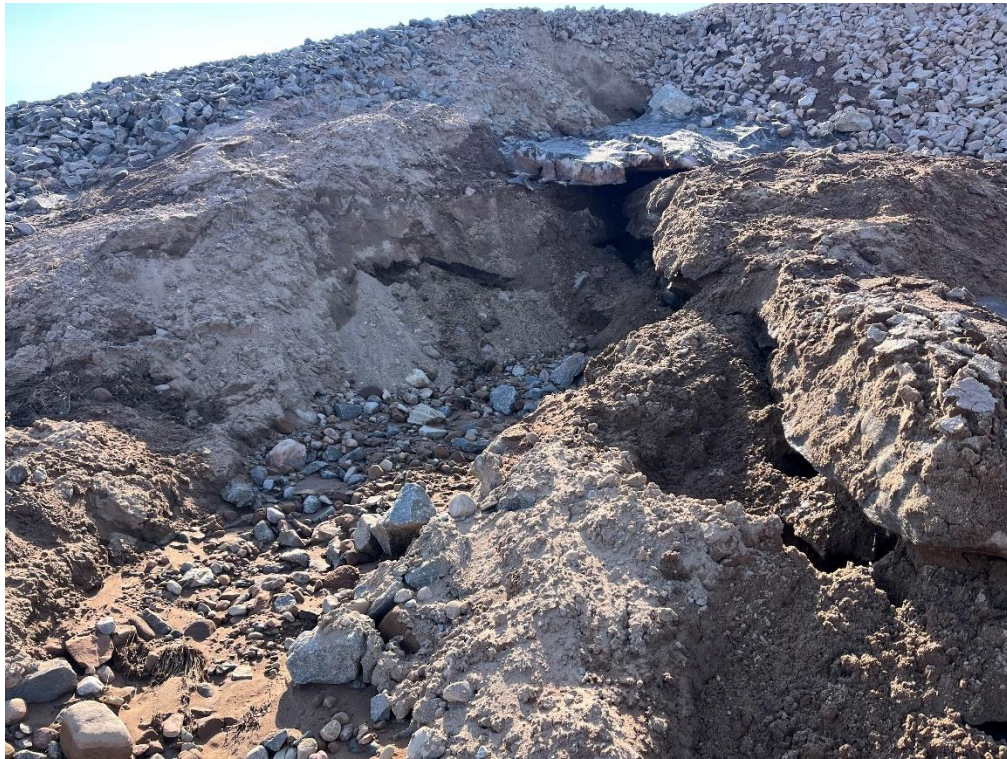
**Photo 3**      **Eroded slope beneath the low area requiring drainage**

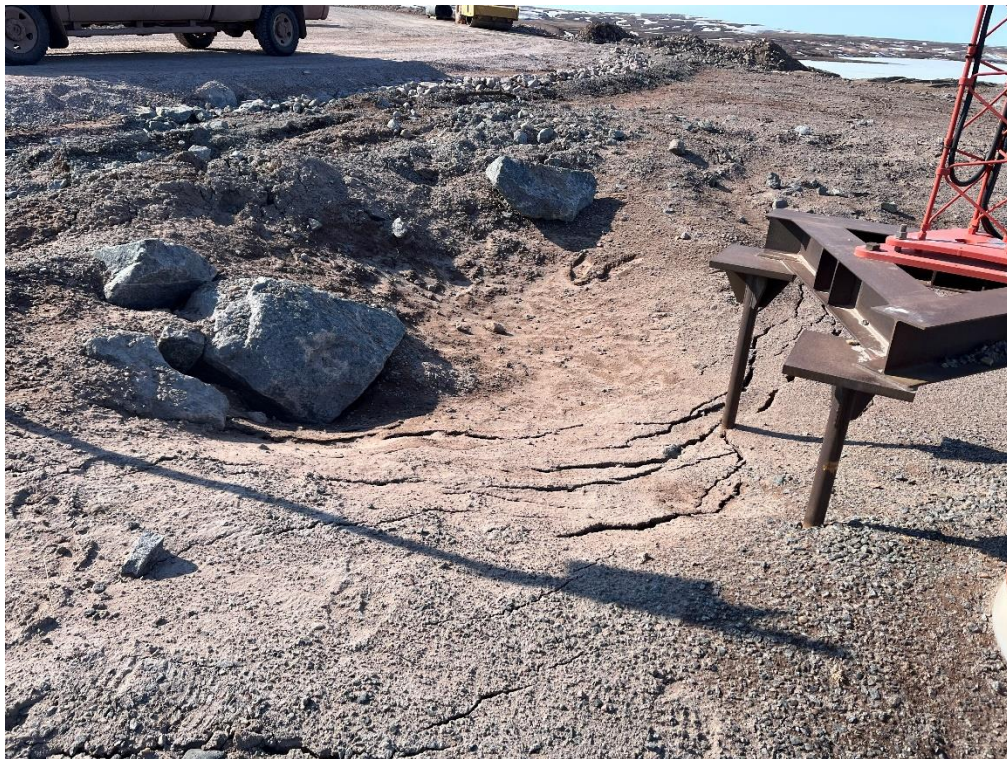
More recently, an area of subsidence has formed just north of the access road (Photos 1, 4, and 5). This area of subsidence has been partially backfilled with coarse rockfill and appears to have increased in size following a recent rainfall event. One possibility is that water has been seeping downward in this area, possibly through coarse rockfill used as backfill around the airstrip lighting standard and/or the roadbed, and this water may be melting the ice-rich soils known to exist in the general area. The subsidence area

**Photo 4**      **Subsidence north of the access road and adjacent airstrip lighting**

should be backfilled with 3/4" minus fill rather than coarse fill to help limit infiltration of runoff into this location until further investigation (i.e., excavation by hand) and remediation can be completed.

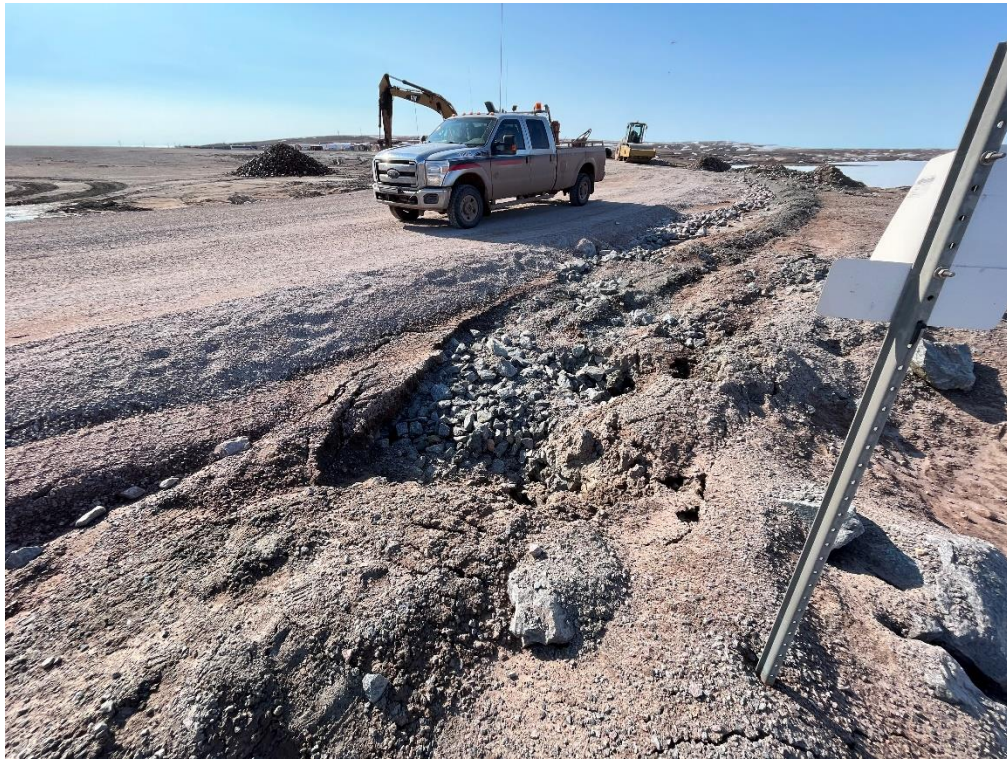
**Photo 5      Subsidence north of the access road and adjacent airstrip lighting**

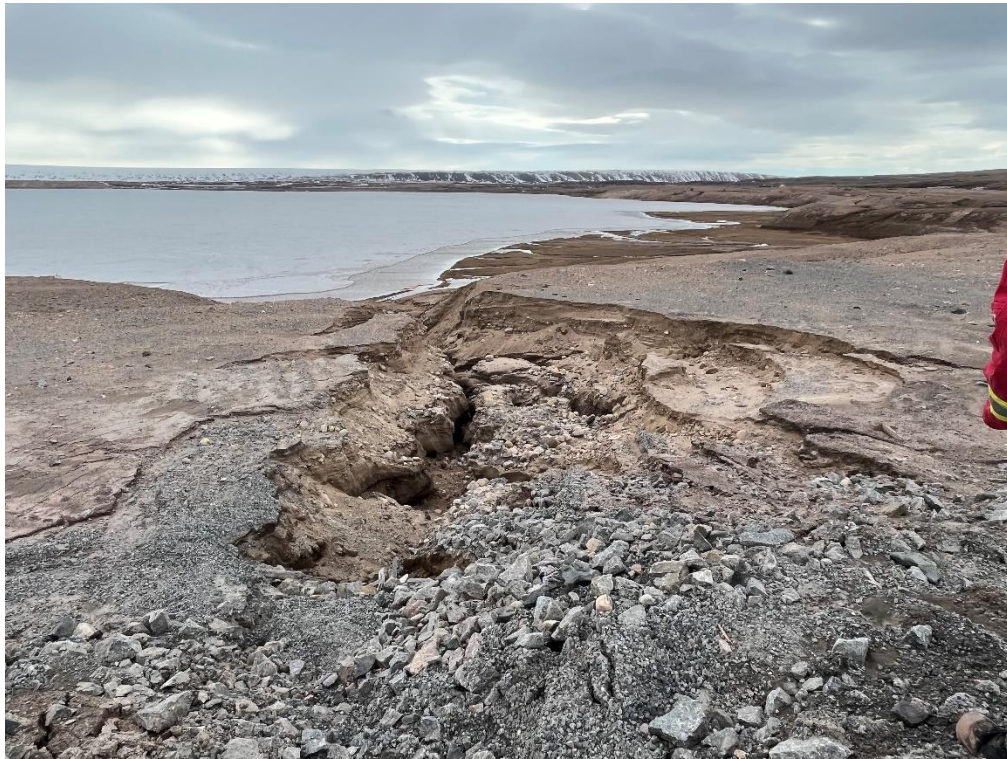
Additionally, on June 16, 2022, following a 30-hour rainfall event, a portion of the bank located between the access road around the north end of the airstrip and Camp Lake eroded (Photos 6 and 7), releasing sediment which was deposited over the shore of Camp Lake. An approximately 0.5 m thick massive ice lens was visible in the resultant erosion cavity before it was backfilled, and the slope rehabilitated.

**Photo 6      Erosion event on June 16, 2022**

This event and the recommended short-term remediation measures, have been documented separately (KP, 2022). Remediation of the eroded area has resulted in establishing a drainage ditch constructed with compacted foundation fill, non-woven geotextile, and surficial riprap. The ditch has been incorporated into the longer-term water management strategy described herein.

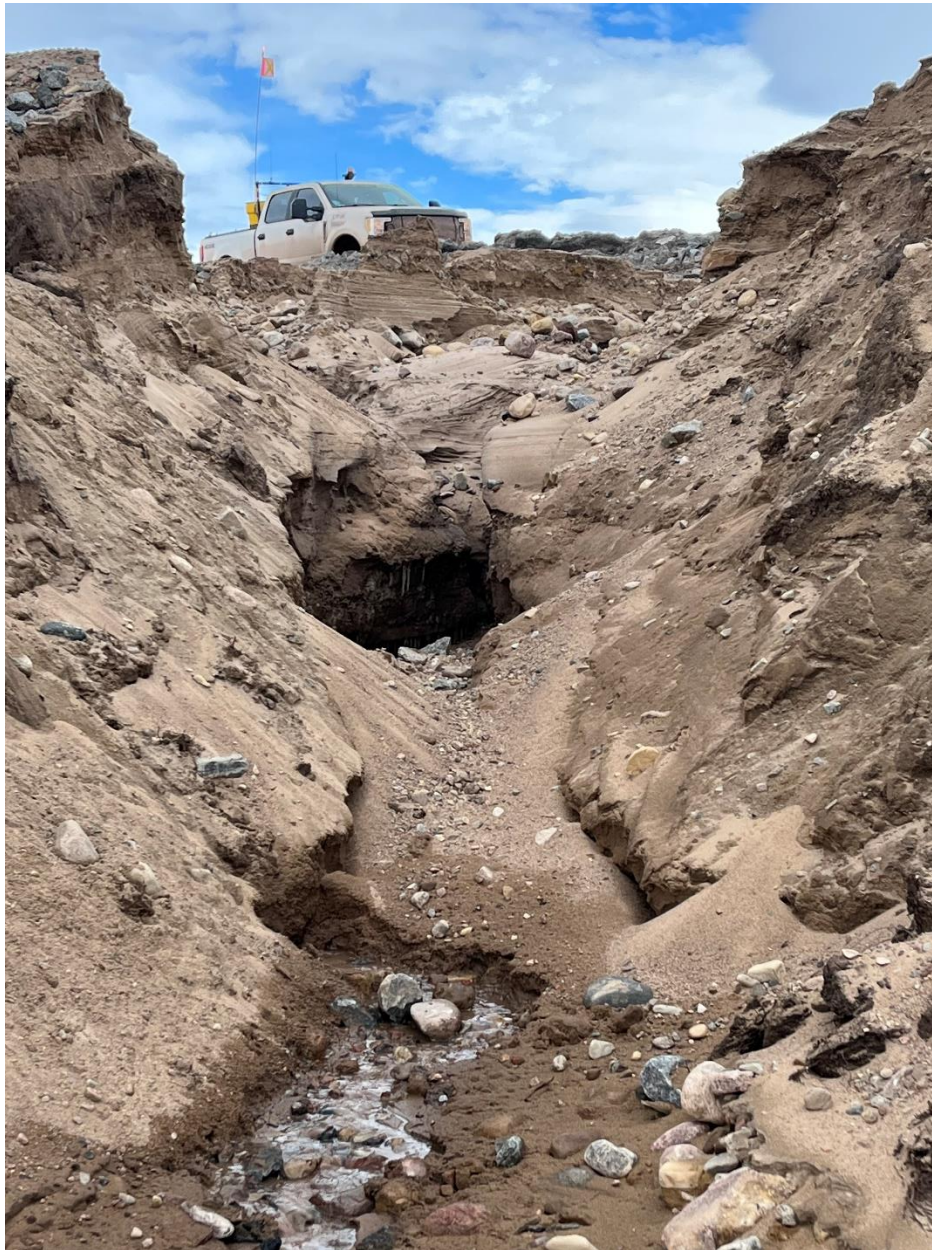
**Photo 7**      **June 16, 2022, erosion cavity; not visible in photo, an ice lens was visible**

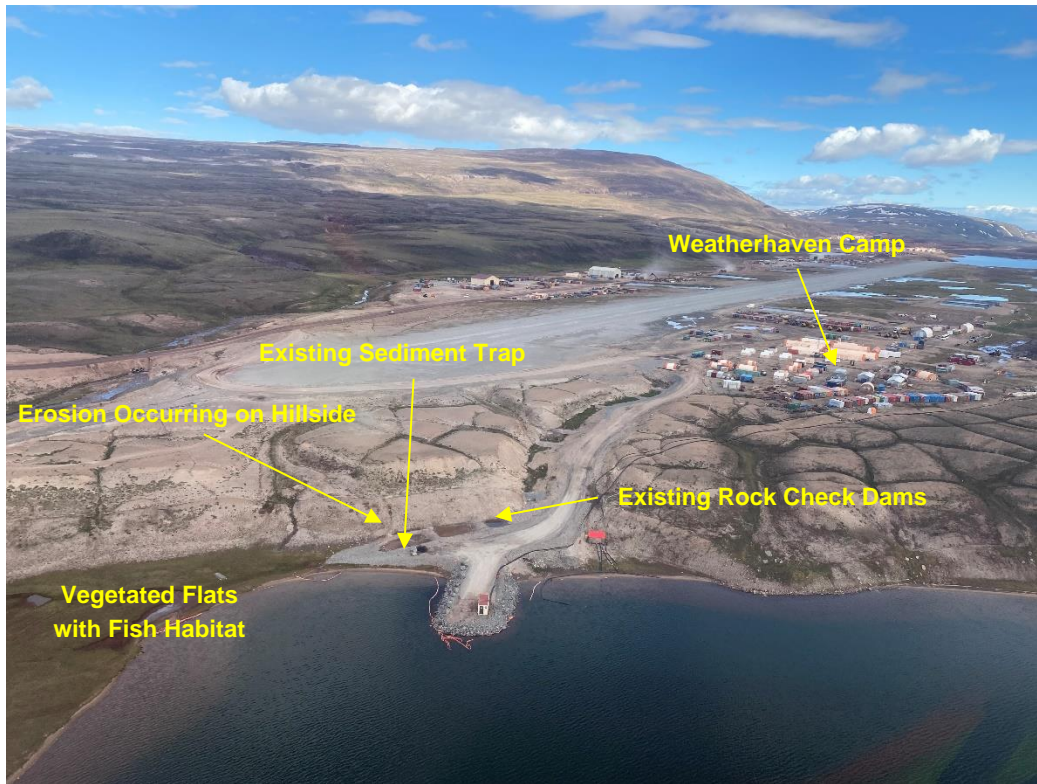
The Camp Lake Jetty Area is shown on Photo 8. Runoff from the west side of the Weatherhaven Camp has historically reported to the small valley where the access road to the Camp Lake Jetty is located.

**Photo 8      Camp Lake Jetty Area**

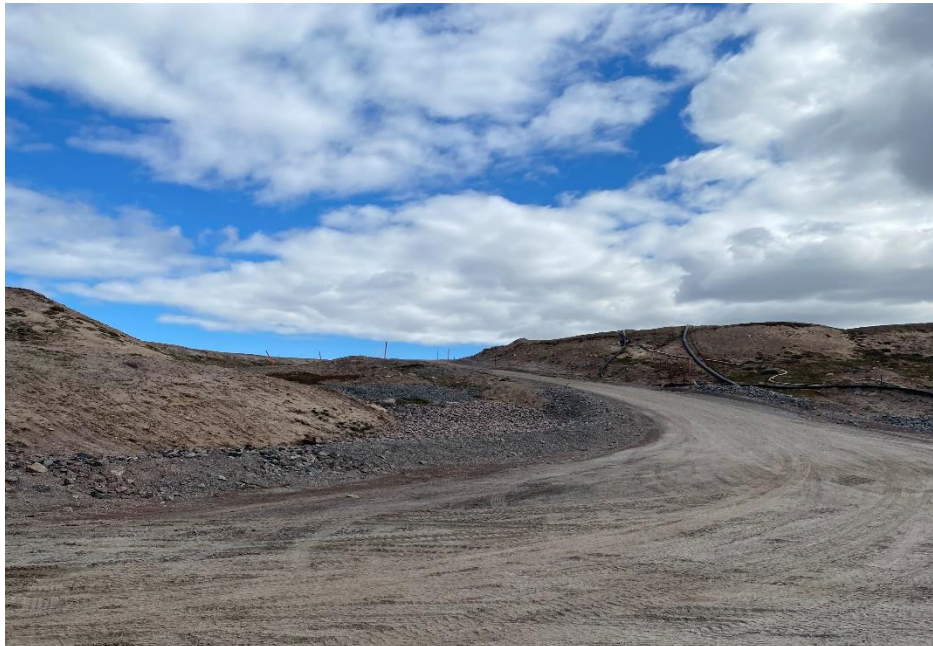
The current erosion and sediment control measures present include rock check dams along the side of the jetty road and an existing sediment trap at the bottom of the road (Photo 8). A safety berm has been constructed along the north side of the jetty access road (Photo 9), thereby preventing runoff along the road from draining into the rock check dams. As a result, the rock check dams receive minimal runoff and thus are reported to be operating effectively as-is, according to Baffinland. Also, the existing rock check dams are not anticipated to settle the TSS in the runoff to adequate levels. Secondly, the runoff from the road reports directly to Camp Lake, resulting in increased TSS in the lake (Photo 10).

**Photo 9      Camp Lake Jetty Road with Safety Berm**

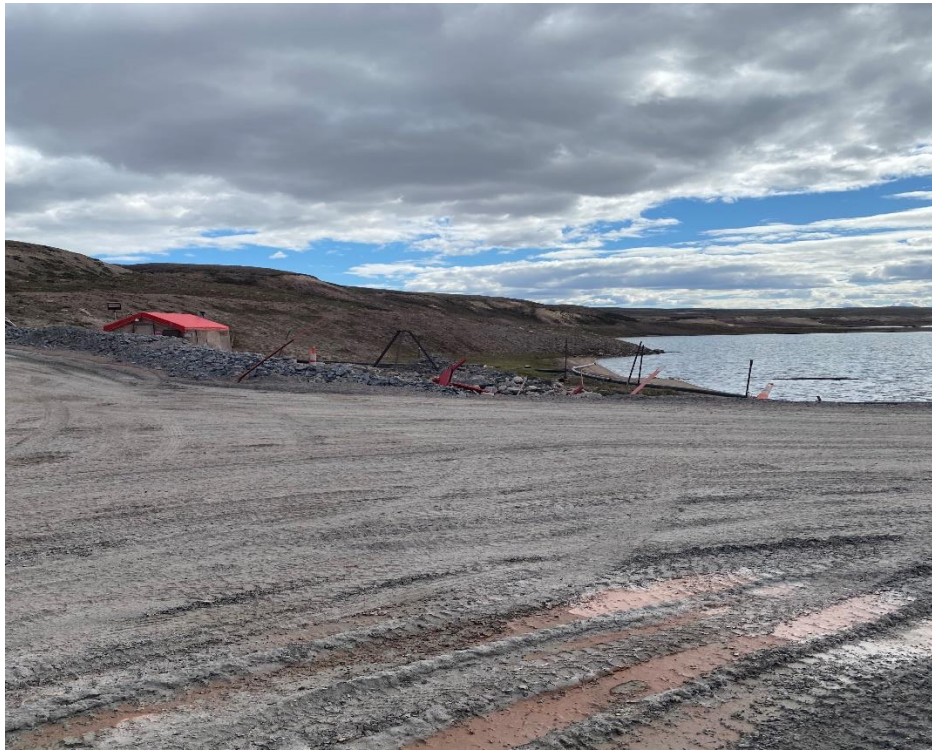
**Photo 10 Bottom of Camp Lake Jetty**

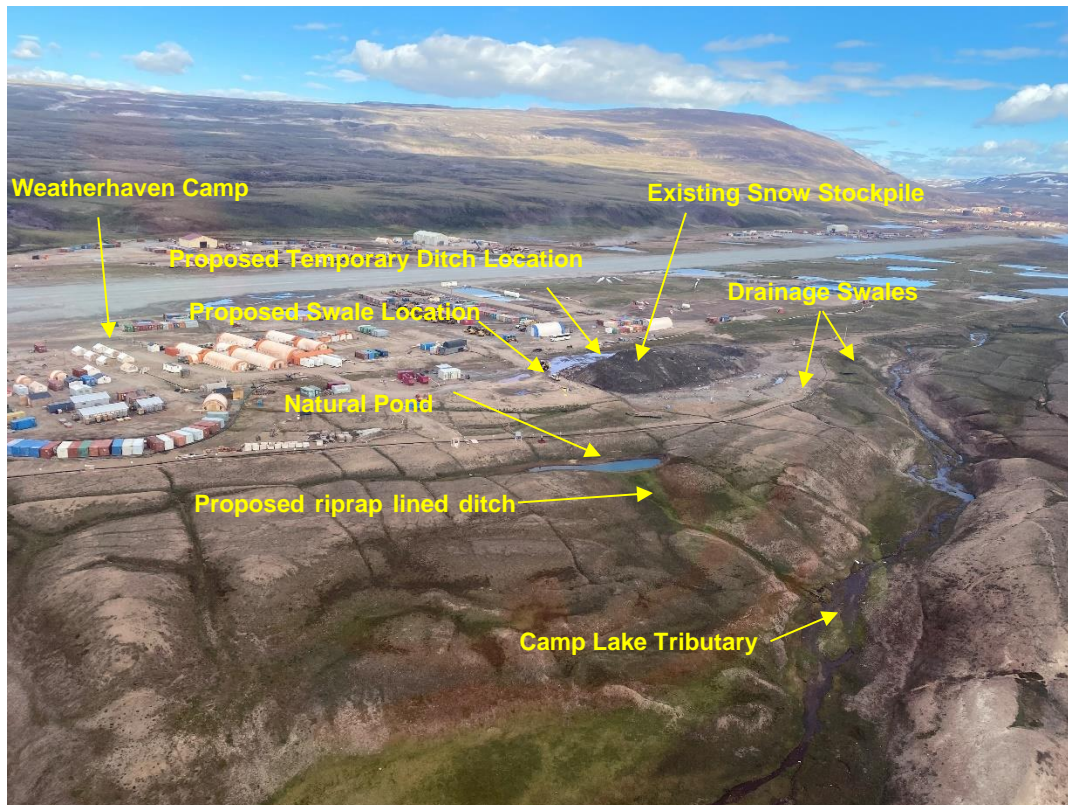
In the WMP, KP proposed constructing a sedimentation pond on the west side of the Weatherhaven Camp snow stockpile. During the July 2021 site visit, it was noted that the topography north of the snow stockpile would prevent runoff from the Weatherhaven Camp from reporting to such a pond (Photo 11). For this reason, the pond proposed in the WMP for this area is no longer recommended.

**Photo 11 Weatherhaven Camp and Snow Stockpile Area**

- Runoff from the north half of the stockpile will be directed through the swales towards the natural drainages located southeast of the snow stockpile and flow by gravity towards the Camp Lake tributary (Photo 11).

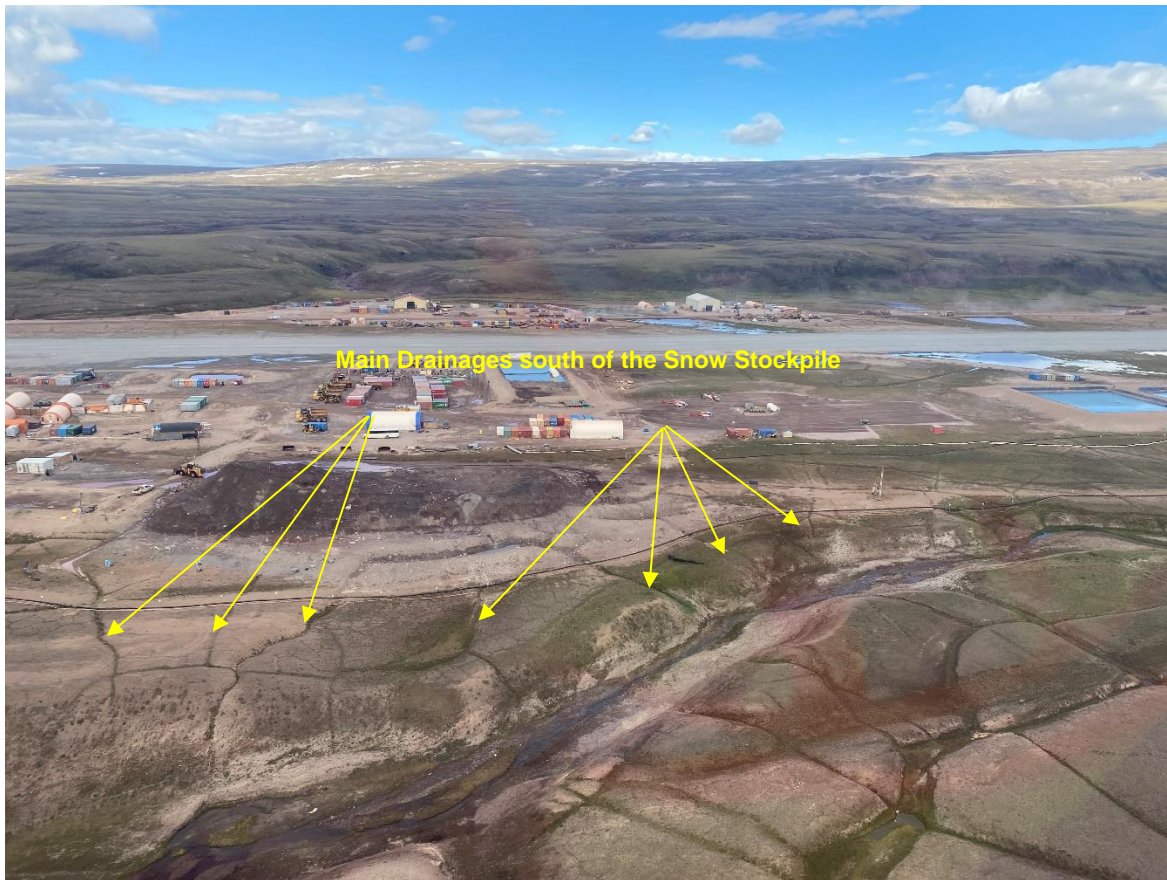
Currently runoff from the northern half of the stockpile reports to and forms ponds in a number of low lying areas around the stockpile, or drains towards the Weatherhaven Camp (Photo 11). The southern half of the snow stockpile drains along natural swales located south of the snow stockpile (Photo 12).

**Photo 12      Drainages South of the Snow Stockpile**

- **Rock check dams** - The rock check dams will be installed along the existing drainages that connect the south and east sides of the snow stockpile to the Camp Lake Tributary (Photo 12).
