REPORT ON

Geomorphology and Soils - Meliadine Access Road Meliadine Gold Project, Nunavut

Project Number: 09-1426-0015/3700

Doc. No.: 046 Ver. 0

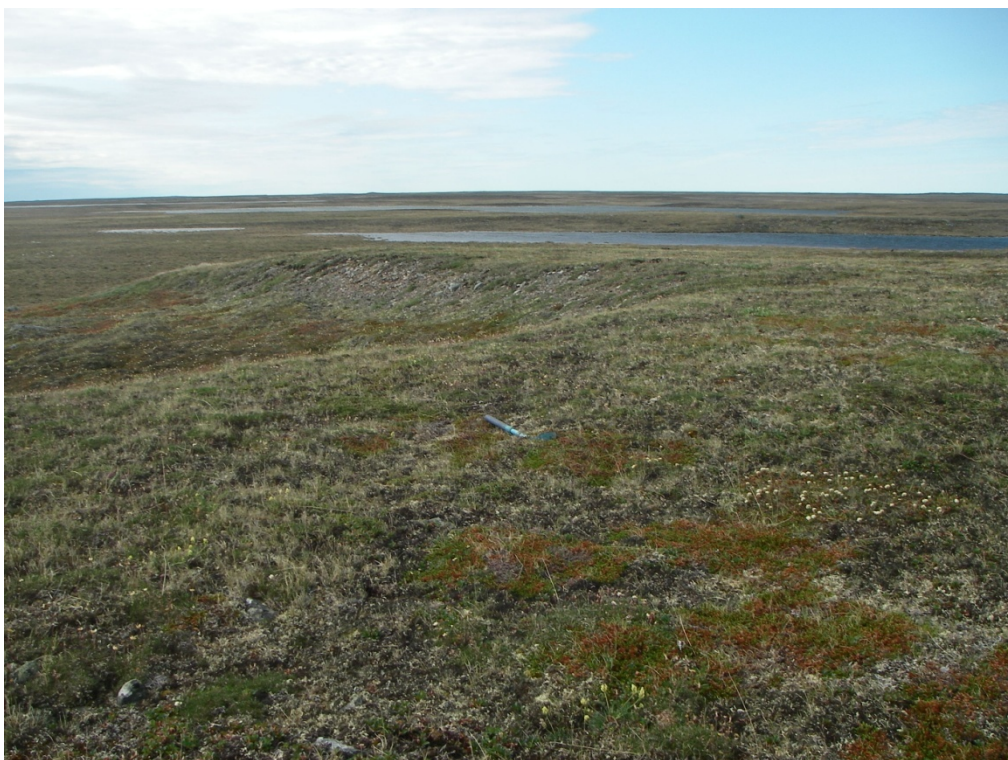
Photograph 1: Terrain type 1- Well-drained beach ridge or berm near waypoint T021

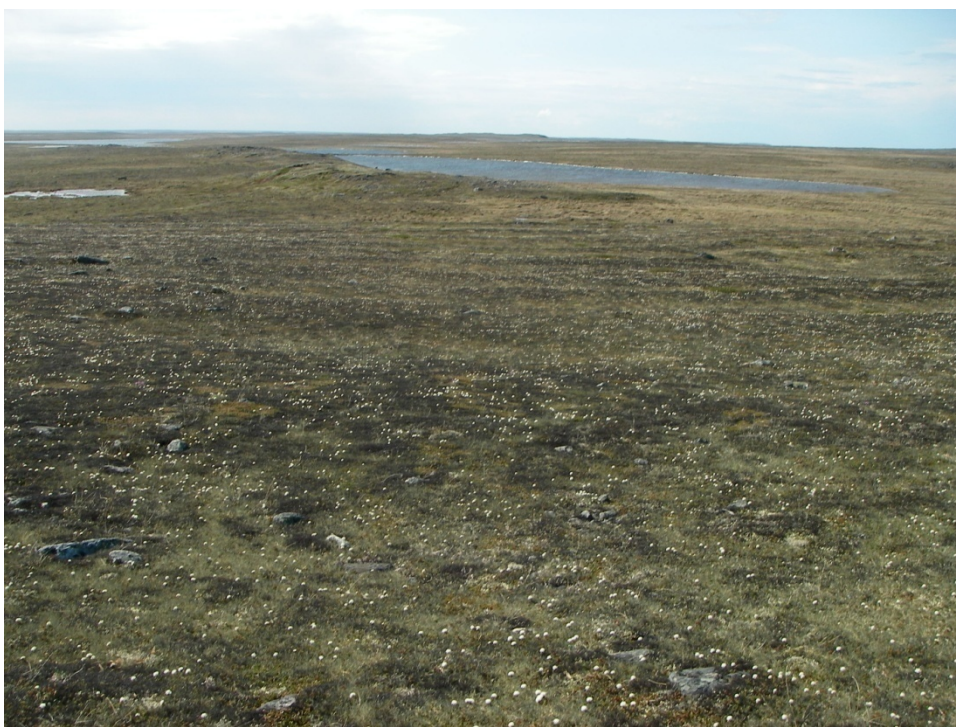
Photograph 2: Terrain type 2A. Flight of well to moderately well-drained, low, subdued beach ridges.

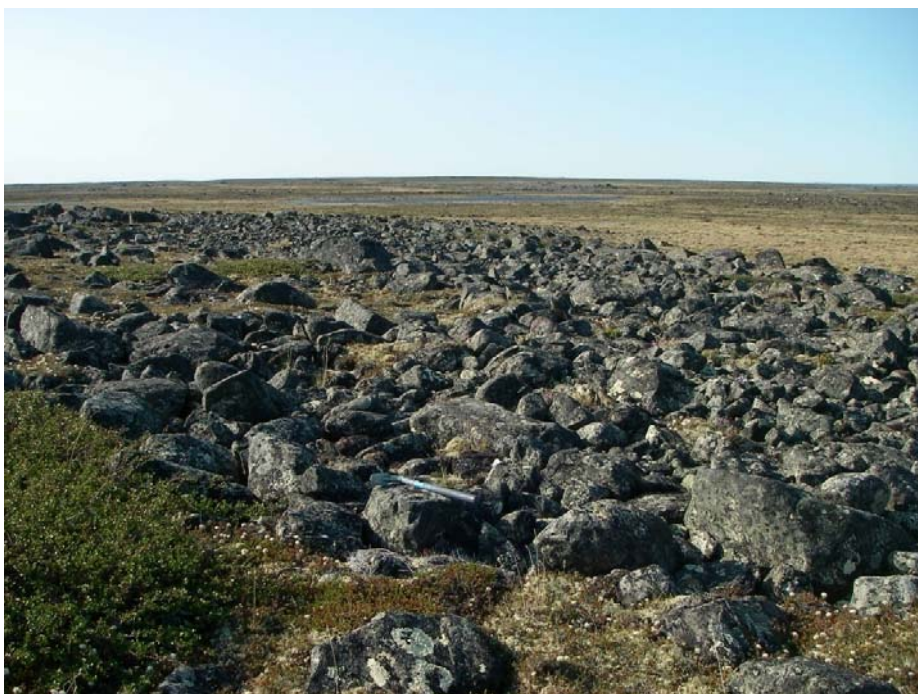
Photograph 29: Terrain type 8. Well-drained, weathered (frost-shattered) bedrock (felsenmeer).

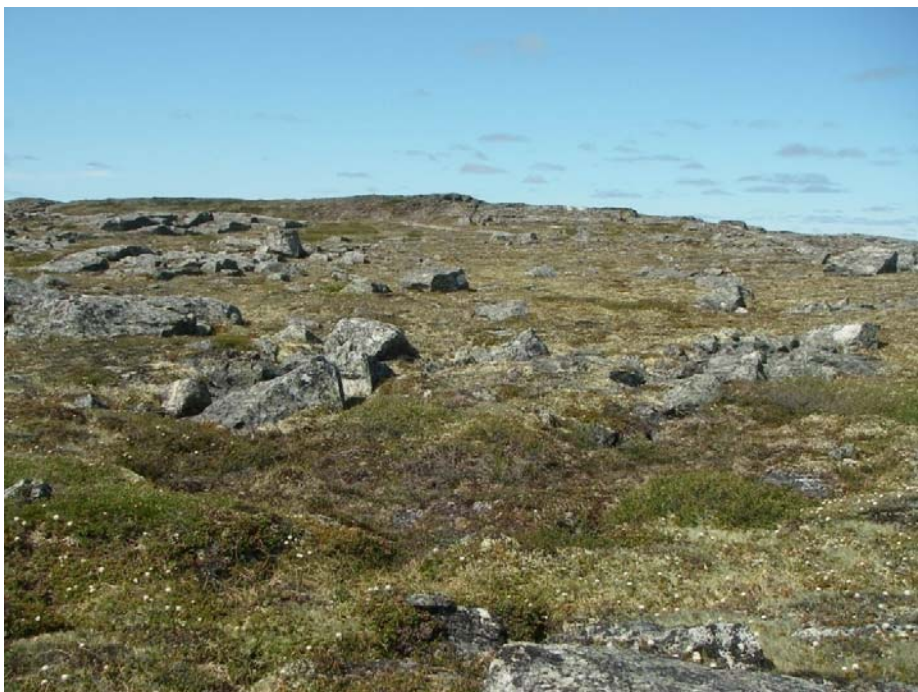
Photograph 30: Terrain type 9A. Well-drained weathered bedrock and lesser washed morainal and/or marine sediments, and minor bedrock outcrops.

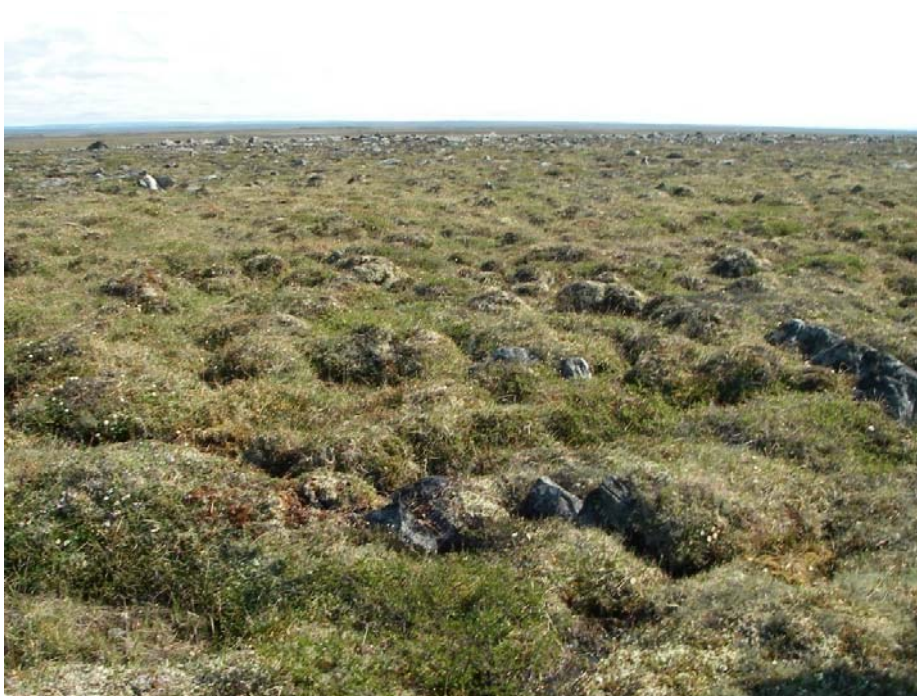
Photograph 36: Terrain type 12C. Imperfectly to poorly drained washed till or marine sediments, lesser weathered bedrock.

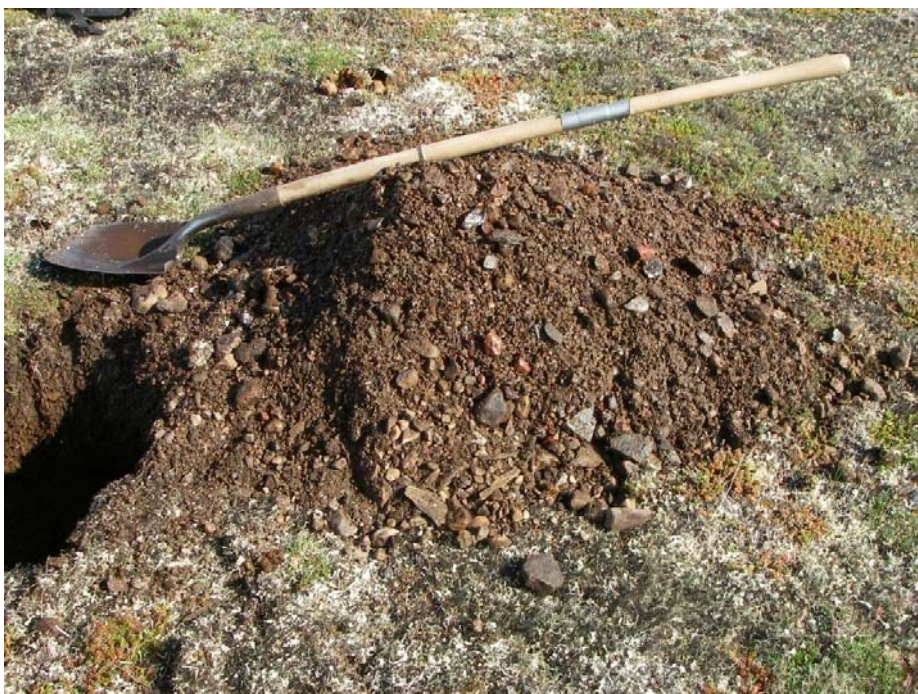
Photograph 11: Sample site G5A, beach terrace near waypoint R160.

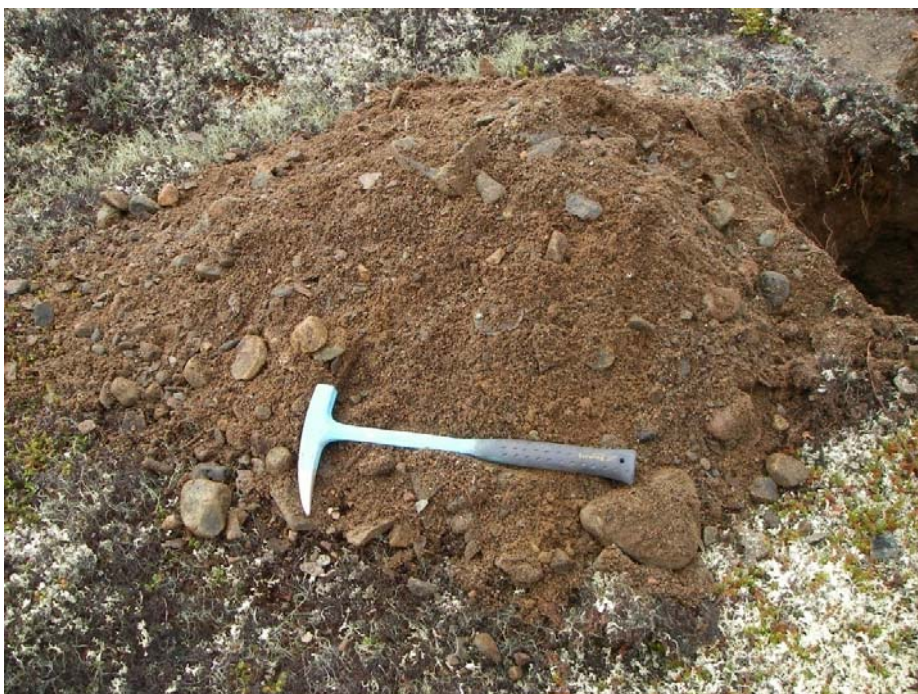
Photograph 15: Sample site G6c, mid slope of beach ridge, near waypoint R062

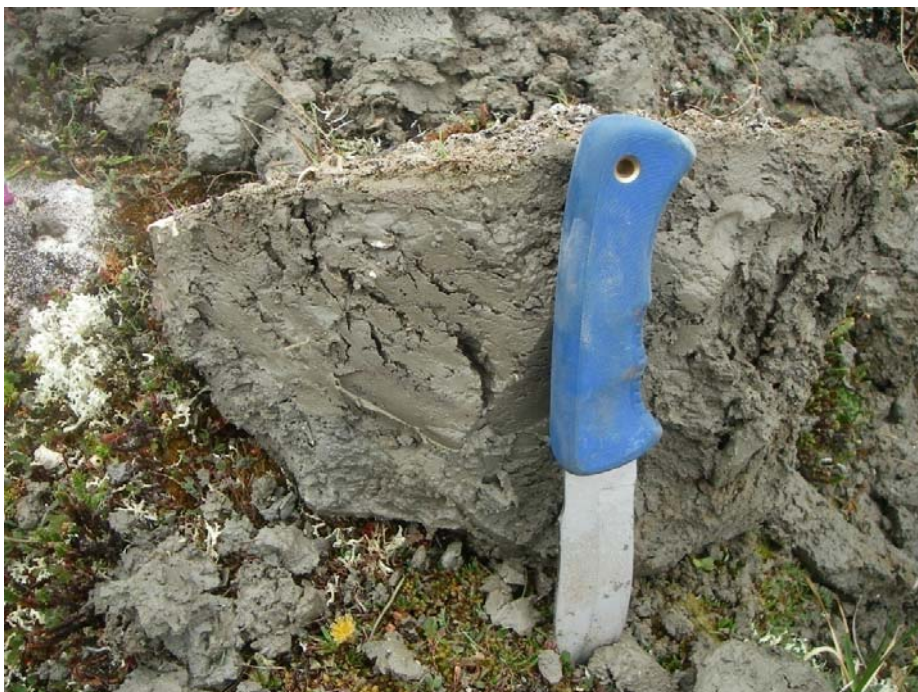
Photograph 16: Sample site T1, poorly drained soils along the crest of a low, subdued morainal ridge, near waypoint R012.
