APPENDIX F
WATERCOURSE CROSSING ASSESSMENT DATA SHEETS

Bulk Sample Road Watercourse Crossing Assessment

Baffinland Iron Mines
Mary River Project
Watercourse Crossing Assessment

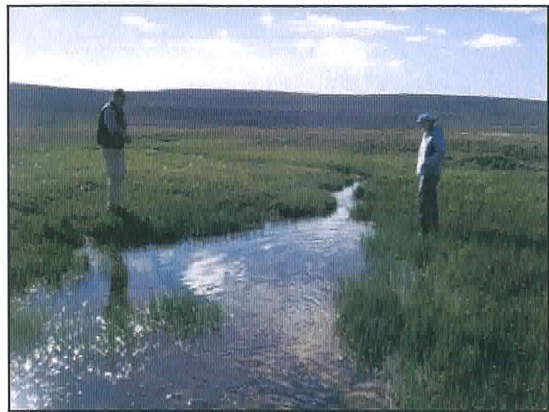
Figure 1: Downstream view from proposed crossing showing abundant pool habitat and vegetation.

Location				
Site:	CV-60	Watercourse Name:	Unknown River	
UTM:	17W 0527621 / 7930342			
Site Description		Potential Fish Utilization		
Watershed Size: 5.257 km ² Regulated: No Channelized: No Bankfull Width: 12.0 m Wetted Width: 3.6 m Riffle-Crest Depth: 0.12 m Pool Depth: 0.62 m Residual Pool Depth: 0.50 m Bankfull Depth: 0.62 m Bank Height: N/A D₉₅: N/A D: <0.001 m Confinement: Unconfined Channel Morphology: Riffle-Pool Channel Gradient: 0° Turbidity: 0.00 FTU Side Slope R – 5%; L – 5% Approach: R – 95%; L – 95% Bank Stability: Low-Moderate Erosion Potential: Low-Moderate Undercut Banks: Some	Mesohabitat Composition: Pool – 90%; Riffle – 10% Substrate Composition: Sand – 90%; Gravel – 10% Stream Cover: Undercut – 5%; In- and Overstream Vegetation – 20% Riparian Vegetation: Moss, grasses, willows Aquatic Vegetation: None Unique Features: None Summary: This is a medium-sized, low-velocity waterbody with predominantly sand substrate. The banks have moderate erosion potential and there is relatively abundant vegetative cover.	Arctic Char

Spawning:	Unlikely	
		Migration:	Unlikely	
		Rearing:	Yes	
		Overwintering:	None	
		Ninespine Stickleback		
		Spawning:	Possible	
		Migration:	Possible	
		Rearing:	Possible	
		Overwintering:	None	
	Fish Habitat Quality		Comments	
	Important		This waterbody has abundant pool habitat for juvenile char. Many small char were observed or captured during fisheries studies. There is likely little to no use by adult char. Though not captured ninespine stickleback may also use this creek as both a feeding and refuge area.

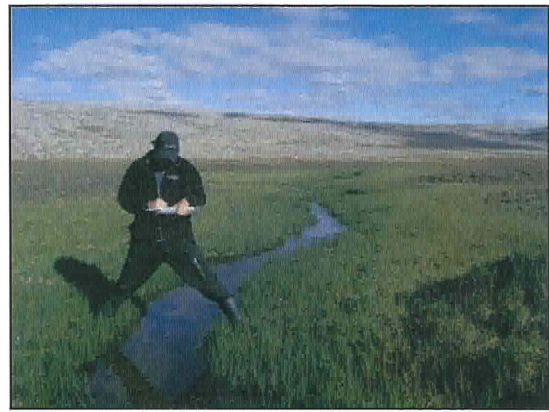
Figure 2: Upstream view from proposed crossing showing more pool habitat.

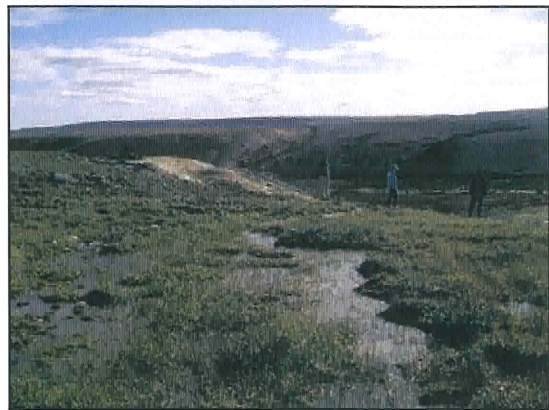
Figure 1: Downstream view from proposed crossing showing riffle habitat with steep drop where the field crew is standing.

Location			
Site:	CV-55	Watercourse Name:	Unknown River
UTM:	17W 0528842 / 7927584		
Site Description		Potential Fish Utilization	
Watershed Size:	0.036 km ²	Arctic Char	
Regulated:	No	Spawning:	None
Channelized:	No	Migration:	None
Bankfull Width:	3.2 m	Rearing:	None
Wetted Width:	1.1 m	Overwintering:	None
Riffle-Crest Depth:	0.01 m	Ninespine Stickleback	
Pool Depth:	N/A	Spawning:	None
Residual Pool Depth:	N/A	Migration:	None
Bankfull Depth:	N/A	Rearing:	None
Bank Height:	N/A	Overwintering:	None
D ₉₅ :	0.32 m	Comments	
D:	0.01 m		
Confinement:	Unconfined	Although habitat at the proposed crossing may be marginally suitable for juvenile char, there is a steep drop downstream. This site is, therefore, likely inaccessible from further downstream. In addition, there are no suitable overwintering locations upstream.	
Channel Morphology:	Cascade-Riffle		
Channel Gradient:	7 ⁰		
Turbidity:	0.00 FTU		
Side Slope	R – 7%; L – 7%

Approach:	R – 93%; L – 93%		
Bank Stability:	Moderate		
Erosion Potential:	Moderate		
Undercut Banks:	None		
Fish Habitat Quality		Comments	
None

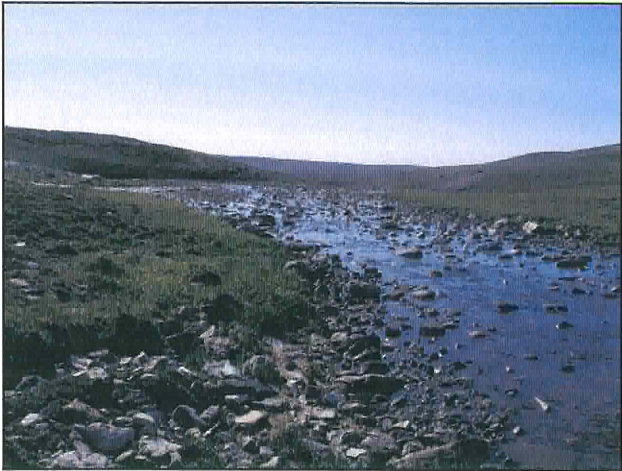
Figure 1: Downstream view from proposed crossing showing riffle habitat with cobble substrate.

Location					
Site:		CV-40		Watercourse Name:	
UTM:		17W 0535175 / 7920305		Unknown River	
Site Description				Potential Fish Utilization	
Watershed Size: 12.021 km ² Regulated: No Channelized: No Bankfull Width: 19.0 m Wetted Width: 12.0 m Riffle-Crest Depth: 0.11 m Pool Depth: N/A Residual Pool Depth: N/A Bankfull Depth: 0.34 m Bank Height: 0.23 m D₉₅: 1.16 m D: 0.001 m Confinement: Partially Confined Channel Morphology: Riffle-Pool Channel Gradient: 2.5 ⁰ Turbidity: 0.00 FTU Side Slope R – 7%; L – 7% Approach: R – 93%; L – 93% Bank Stability: Low-Moderate Erosion Potential: Moderate Undercut Banks: None		Mesohabitat Composition: Riffle – 95%; Pool – 5%		Arctic Char	
		Substrate Composition: Cobble – 80%; Boulder – 10%; Sand – 3%; Gravel – 3%		Spawning: Unlikely	
		Stream Cover: Boulders – 10%		Migration: Unlikely	
		Riparian Vegetation: Moss, grasses		Rearing: Possible	
		Aquatic Vegetation: Algae		Overwintering: None

Unique Features: None			
		Summary: This is a large-sized waterbody consisting almost exclusively of riffles and cobble habitat. The banks have moderate erosion potential and boulders represent the only available cover.

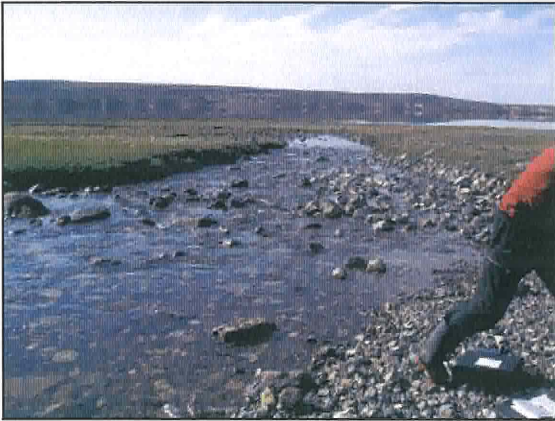
Figure 1: Downstream view from proposed crossing showing riffle-pool habitat, cobble substrate, and Camp Lake.

Location					
Site:		CV-225		Watercourse Name:	
UTM:		17W 0557406 / 7915137		Unknown River	
Site Description				Potential Fish Utilization	
Watershed Size: 12.180 km ² Regulated: No Channelized: No Bankfull Width: 31.0 m Wetted Width: 7.0 m Riffle-Crest Depth: 0.12 m Pool Depth: 0.28 m Residual Pool Depth: 0.16 m Bankfull Depth: 0.83 m Bank Height: 0.55 m D₉₅: 0.86 m D: 0.03 m Confinement: Partially Confined Channel Morphology: Riffle-Pool Channel Gradient: 3 ⁰ Turbidity: 0.00 FTU Side Slope R – 1%; L – 1% Approach: R – 99%; L – 99% Bank Stability: Low-Moderate Erosion Potential: Moderate Undercut Banks: None		Mesohabitat Composition: Riffle – 60%; Pool – 40%		Arctic Char	
		Substrate Composition: Cobble – 75%; Gravel – 15%; Boulders – 10%		Spawning: Unlikely	
		Stream Cover: Boulders – 10%		Migration: Unlikely	
		Riparian Vegetation: Grasses and moss		Rearing: Yes	
		Aquatic Vegetation: None		Overwintering: None

Unique Features: None			
		Summary: This is a large-sized waterbody consisting of riffle-pool habitat with mostly cobble substrate. The banks have moderate erosion potential and boulders are the only significant available cover.

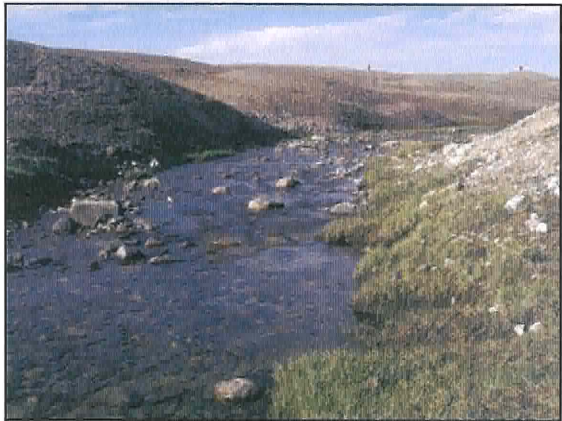
Figure 1: Downstream view from proposed crossing showing riffle-pool habitat and cobble substrate.

Location					
Site:		BG-01		Watercourse Name:	
UTM:		17W 0557991 / 7914918		Unknown River	
Site Description				Potential Fish Utilization	
Watershed Size: 5.612 km ² Regulated: No Channelized: No Bankfull Width: 5.0 m Wetted Width: 5.0 m Riffle-Crest Depth: 0.18 m Pool Depth: 0.30 m Residual Pool Depth: 0.12 m Bankfull Depth: 0.58 m Bank Height: 0.40 m D₉₅: 0.80 m D: 0.06 m Confinement: Confined Channel Morphology: Riffle-Pool Channel Gradient: 3.5 ⁰ Turbidity: 0.00 FTU Side Slope R – 1%; L – 1% Approach: R – 99%; L – 99% Bank Stability: Low-Moderate Erosion Potential: Moderate-High Undercut Banks: None		Mesohabitat Composition: Riffle – 95%; Pool – 5%		Arctic Char	
		Substrate Composition: Cobble – 70%; Boulders – 20%; Gravel – 5%; Sand – 5%		Spawning: Unlikely	
		Stream Cover: Boulders – 20%		Migration: Unlikely	
		Riparian Vegetation: Arctic cotton, moss, willows, and grasses		Rearing: Yes	
		Aquatic Vegetation: None		Overwintering: None

Unique Features: None			
		Summary: This is a medium-sized waterbody consisting largely of riffle habitat with cobble substrate. The banks have moderate-high erosion potential and boulders are the only significant available cover.			
Fish Habitat Quality				Ninespine Stickleback	
		Spawning: Unlikely		Spawning: Unlikely	
		Migration: Unlikely		Migration: Unlikely	
		Rearing: Unlikely		Rearing: Unlikely	
		Overwintering: None		Overwintering: None	
				Comments	
				Site is upstream of Camp Lake and has suitable habitat for juvenile char to rear or take refuge from larger char in the lake. It is unlikely spawning occurs in this tributary since water levels are relatively low during the fall, however it cannot be ruled out completely. Several small char were captured during fisheries investigations of this creek. The habitat is less suitable for sticklebacks.

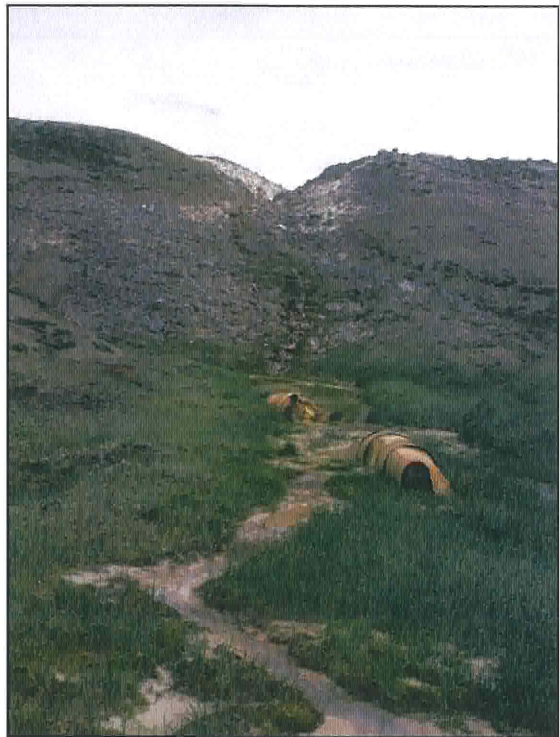
Figure 1: Upstream view from proposed crossing showing nearly dry habitat and empty fuel drums.

Location					
Site:		BG-16		Watercourse Name:	
UTM:		17W 0550742 / 7917611		Unknown River	
Site Description				Potential Fish Utilization	
Watershed Size: 0.064 km ² Regulated: No Channelized: No Bankfull Width: N/A Wetted Width: N/A Riffle-Crest Depth: N/A Pool Depth: N/A Residual Pool Depth: N/A Bankfull Depth: N/A Bank Height: N/A D₉₅: N/A D: N/A Confinement: N/A Channel Morphology: N/A Channel Gradient: N/A Turbidity: N/A Side Slope: N/A Approach: N/A Bank Stability: N/A Erosion Potential: N/A Undercut Banks: N/A		Mesohabitat Composition: N/A		Arctic Char	
		Substrate Composition: N/A		Spawning: None	
		Stream Cover: N/A		Migration: None	
		Riparian Vegetation: N/A		Rearing: None	
		Aquatic Vegetation: N/A		Overwintering: None	
		Unique Features: N/A			
		Summary: This is an extra small-sized waterbody that is steep and nearly dry at the time of sampling. It is likely only a spring run-off stream.		Ninespine Stickleback

Spawning: None	
				Migration: None	
				Rearing: None	
		Overwintering: None			
Fish Habitat Quality				Comments	
None				This site is a tributary of BG-17 and likely only contributes runoff to the much larger BG-17. There appears to be little available fish habitat and, therefore little to no importance for fish populations. There are also empty fuel drums rusting in the stream.

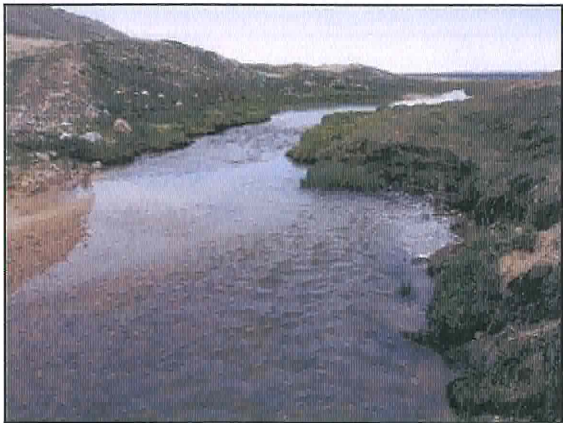
Figure 1: Downstream view from proposed crossing showing riffle-pool habitat, cobble/gravel/sand substrate.

Location					
Site:		BG-17		Watercourse Name:	
UTM:		17W 0550703 / 7917643		Unknown River	
Site Description				Potential Fish Utilization	
Watershed Size: 13.767 km ² Regulated: No Channelized: No Bankfull Width: 9.0 m Wetted Width: 8.0 m Riffle-Crest Depth: 0.19 m Pool Depth: 0.30 m Residual Pool Depth: 0.11 m Bankfull Depth: 0.95 m Bank Height: 0.65 m D₉₅: 0.10 m D: 0.06 m Confinement: Partially Confined Channel Morphology: Riffle-Pool Channel Gradient: 1 ⁰ Turbidity: 22.95 FTU Side Slope R – 10%; L – 10% Approach: R – 90%; L – 90% Bank Stability: Low Erosion Potential: High Undercut Banks: Some		Mesohabitat Composition: Riffle – 50%; Pool – 50%		Arctic Char	
		Substrate Composition: Cobble – 40%; Gravel – 30%; Sand – 30%		Spawning: None	
		Stream Cover: Instream Vegetation – 3%		Migration: Possible	
		Riparian Vegetation: Grasses, moss, thrift, small plants, and willows		Rearing: Yes	
		Aquatic Vegetation: Submerged grasses		Overwintering: None

Unique Features: None			
		Summary: This is a large-sized waterbody with abundant riffle and pool habitat and a mixture of cobble, gravel, and sand substrate. The banks have high erosion potential. There is some flooded vegetation provding potential cover.

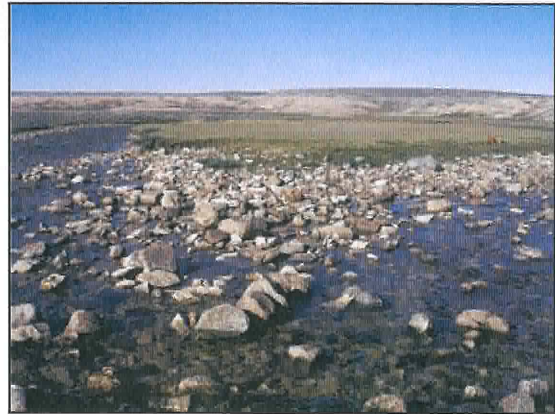
Figure 1: Downstream view from proposed crossing showing riffle habitat with cobble substrate. The river forks around an island at this point.

Location					
Site:		BG-50		Watercourse Name:	
UTM:		17W 0529334 / 7926845		Unknown River	
Site Description				Potential Fish Utilization	
Watershed Size: 180.263 km ² Regulated: No Channelized: No Bankfull Width: 77.0 m Wetted Width: 61.0 m Riffle-Crest Depth: 0.20 m Pool Depth: N/A Residual Pool Depth: N/A Bankfull Depth: 0.70 m Bank Height: 0.50 m D₉₅: 1.56 m D: 0.02 m Confinement: Unconfined Channel Morphology: Riffle Channel Gradient: 1 ⁰ Turbidity: 0.00 FTU Side Slope R – 5%; L – 5% Approach: R – 95%; L – 95% Bank Stability: High Erosion Potential: Low Undercut Banks: None		Mesohabitat Composition: Riffle – 100%		Arctic Char	
		Substrate Composition: Cobble – 80%; Boulders – 20%		Spawning: Possible	
		Stream Cover: Boulders – 20%; In- and Overstream Vegetation – 40%		Migration: Possible	
		Riparian Vegetation: Moss, grasses, willows		Rearing: Yes	
		Aquatic Vegetation: None		Overwintering: None

Unique Features: None		Ninespine Stickleback	
		Summary: This is an extra large-sized waterbody consisting of riffles and primarily cobble substrate. The banks have low erosion potential and there is relatively abundant rocky cover.		Spawning: Possible but Unlikely	
				Migration: Possible but Unlikely	
				Rearing: Possible but Unlikely	
				Overwintering: None	
		Comments			
		Fish Habitat Quality		The river forks around an island at the crossing. Although aquatic habitat is abundant at the proposed crossing, water velocities may be too consistently high for significant use by juvenile char. Only a single young char was captured during fisheries studies. However, since this crossing is a relatively short distance upstream of a lake, fall spawning and possibly summer foraging by adults may also occur. This habitat is likely unsuitable for stickleback.	
		Important

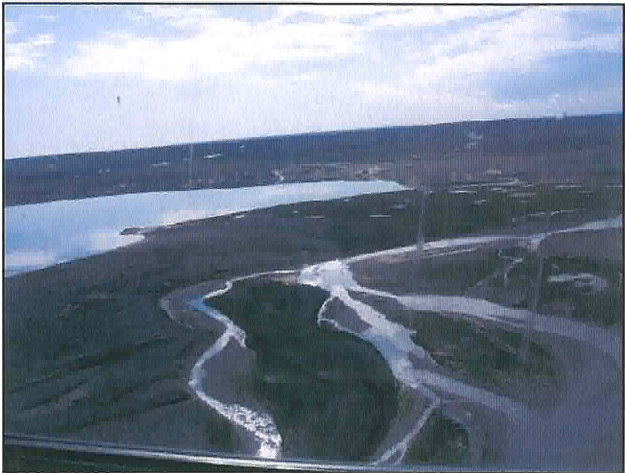
Figure 1: Downstream aerial view from proposed crossing showing riffle-pool habitat and multiple wetted channels.

Location					
Site:		CV-223		Watercourse Name:	
UTM:		17W 0555817 / 7914691		Unknown River	
Site Description				Potential Fish Utilization	
Watershed Size: 59.240 km ² Regulated: No Channelized: No Bankfull Width: 195.0 m Wetted Width: 117.0 m Riffle-Crest Depth: 0.27 m Pool Depth: 0.30 m Residual Pool Depth: 0.03 m Bankfull Depth: 1.40 m Bank Height: 1.1 m D₉₅: 0.49 m D: 0.03 m Confinement: N/A (braided channel) Channel Morphology: Riffle-Pool Channel Gradient: 1 ⁰ Turbidity: 8.67 FTU Side Slope R – 15%; L – 15% Approach: R – 85%; L – 85% Bank Stability: Low Erosion Potential: High Undercut Banks: None		Mesohabitat Composition: Riffle – 50%; Pool – 50%		Arctic Char	
		Substrate Composition: Cobble – 60%; Gravel – 30%; Boulders – 10%		Spawning: Possible	
		Stream Cover: Boulders – 10%		Migration: Possible	
		Riparian Vegetation: Grasses, moss, and willows		Rearing: Yes	
		Aquatic Vegetation: Algae		Overwintering: None

Unique Features: None			
		Summary: This is an extra large-sized waterbody with abundant riffle and pool habitat with cobble and gravel substrate. The banks have high erosion potential. Boulders are the only significant available cover. The channel is braided with three wetted channels measuring 18 m, 35 m, and 64 m wide.

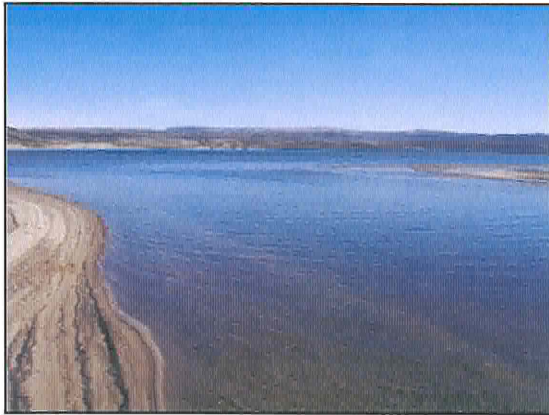
Figure 1: Downstream view from proposed crossing showing flat, sandy habitat with large, unnamed lake visible.

Location			
Site:	CV-217		Watercourse Name: Unknown River
UTM:	17W 0542218 / 7922157		
Site Description		Potential Fish Utilization	
Watershed Size: 153.045 km ² Regulated: No Channelized: No Bankfull Width: 162.0 m Wetted Width: 124.0 m Flat Depth: 0.42 m Pool Depth: N/A Residual Pool Depth: N/A Bankfull Depth: 7.37 m Bank Height: 6.95 m D₉₅: 0.05 m D: <0.001 m Confinement: Partially Confined Channel Morphology: Flat Channel Gradient: 0° Turbidity: 0.00 FTU Side Slope R – 15%; L – 15% Approach: R – 85%; L – 85% Bank Stability: Low Erosion Potential: High Undercut Banks: None	Mesohabitat Composition: Flat – 100% Substrate Composition: Sand – 60%; Gravel – 40% Stream Cover: None Riparian Vegetation: Small intermittent patches of small plants, willows and grasses Aquatic Vegetation: None Unique Features: None Summary: This is an extra large-sized waterbody consisting almost exclusively of flat habitat with fine substrates. The banks have high erosion potential and there is no significant cover.		Arctic Char

Spawning: Unlikely
			Migration: Yes
			Rearing: Possible
			Overwintering: Possible
			Ninespine Stickleback
			Spawning: Possible
			Migration: Possible
			Rearing: Yes
			Overwintering: Possible
		Fish Habitat Quality	Comments
		Important	This waterbody, which is the major outlet of a large lake, is unlike most crossings along the bulk transport road. It is deep and relatively slow-moving and may not freeze entirely during winter, thus allowing for potential overwintering. However, a lack of cover and fine substrates are not ideal conditions for juveniles in a river that is accessible to adult char. Therefore juvenile use is likely limited and possibly migratory only. Spawning may occur near the crossing or further upstream so this area could be important during fall. In addition, this habitat is more suitable for stickleback use and one was captured during fisheries investigations.

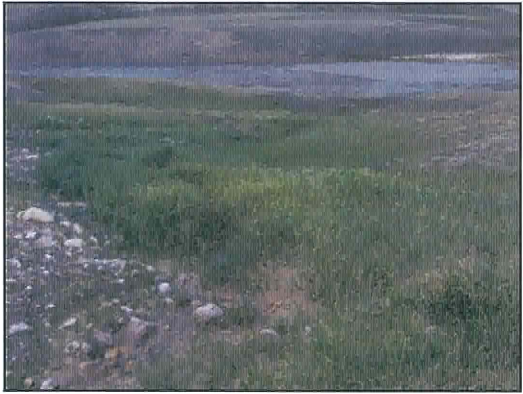
Figure 1: Downstream view from proposed crossing with Phillips Creek visible. Riffle habitat type with predominantly sand/gravel substrate.

Location						
Site: CV-156		Watercourse Name: Unknown River				
UTM: 17W 0507580 / 7970389						
Site Description			Potential Fish Utilization			
<div>Watershed Size: 0.066 km²</div> <div>Regulated: No</div> <div>Channelized: No</div> <div>Bankfull Width: 0.60 m</div> <div>Wetted Width: 0.26 m</div> <div>Riffle Crest Depth: 0.03 m</div> <div>Residual Pool Depth: N/A</div> <div>Bankfull Depth: 0.10 m</div> <div>Bank Height: 0.07 m</div> <div>D₉₅: 0.16 m</div> <div>D: 0.001 m</div> <div>Confinement: Unconfined</div> <div>Channel Morphology: Riffle</div> <div>Channel Gradient: 15⁰</div> <div>Turbidity: 0.00 FTU</div> <div>Side Slope: R – 5%; L – 5%</div> <div>Approach: R – 95%; L – 95%</div> <div>Bank Stability: Moderate-High</div> <div>Erosion Potential: Low-Moderate</div> <div>Undercut Banks: None</div>	<div>Mesohabitat Composition: Riffle – 100%</div> <div>Substrate Composition: Sand – 75%; Gravel – 20%; Cobble – 5%</div> <div>Stream Cover: In- and Overstream vegetation – 2%;</div> <div>Riparian Vegetation: Grasses</div> <div>Aquatic Vegetation: Submerged grasses</div> <div>Unique Features: None</div> <div>Summary: This is an extra small, nearly waterless stream with predominantly sand substrate and low-moderate erosion potential. There is relatively little significant cover.</div>		<div>Arctic Char</div> <div>Spawning: No</div> <div>Migration: No</div> <div>Rearing: No</div> <div>Overwintering: No</div>

<div>Ninespine Stickleback</div> <div>Spawning: No</div> <div>Migration: No</div> <div>Rearing: No</div> <div>Overwintering: No</div>		
				<div>Comments</div> <div>This waterbody is likely significant only as a spring runoff stream. Even at peak flows, the gradient is likely too steep and water levels too low to offer useful habitat even for stickleback or young-of-the-year char from nearby Phillips Creek.</div>		
				<div>

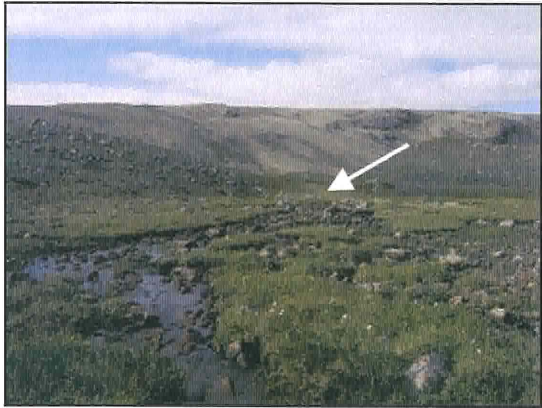
Figure 1: Downstream view from proposed crossing. Riffle-pool habitat type with predominantly cobble/sand substrate. Falls begin at the arrow.

Location			
Site:	CV-146	Watercourse Name:	Unknown River
UTM:	17W 0508786 / 7968870		
Site Description		Potential Fish Utilization	
Watershed Size:	1.021 km ²	Arctic Char	
Regulated:	No	Spawning:	No
Channelized:	No	Migration:	No
Bankfull Width:	2.40 m	Rearing:	No
Wetted Width:	2.40 m	Overwintering:	No
Pool Depth:	0.18 m	Ninespine Stickleback	
Residual Pool Depth:	0.08 m	Spawning:	No
Bankfull Depth:	0.18 m	Migration:	No
Bank Height:	0.00 m	Rearing:	No
D ₉₅ :	0.57 m	Overwintering:	No
D:	0.001 m	Comments	
Confinement:	Unconfined	This waterbody is likely significant only as a spring runoff stream. Though the gradient at the proposed crossing is low, there is a set of falls downstream before this creek enters Phillips Creek. In addition, this creek dries up approximately 200 m further upstream from the crossing. Although the habitat may be suitable for small fish, there appears to be no access from areas where overwintering is possible.

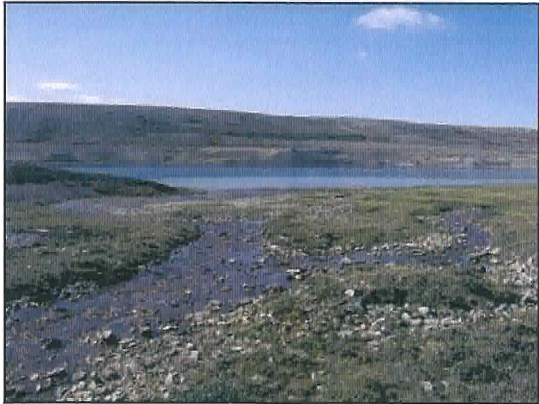
Figure 1: Downstream view from proposed crossing showing cascade-riffle habitat.

Location			
Site:	CV-104		Watercourse Name: Unknown River
UTM:	17W 0521732 / 7952787		
Site Description		Potential Fish Utilization	
Watershed Size: 5.198 km ² Regulated: No Channelized: No Bankfull Width: 6.0 m Wetted Width: 6.0 m Riffle-Crest Depth: 0.06 m Residual Pool Depth: N/A Bankfull Depth: 0.31 m Bank Height: 0.25 m D₉₅: 0.26 m D: 0.02 m Confinement: Unconfined Channel Morphology: Cascade-Riffle Channel Gradient: 8° Turbidity: 0.00 FTU Side Slope: R – 1%; L – 1% Approach: R – 99%; L – 99% Bank Stability: Moderate-High Erosion Potential: Low-Moderate Undercut Banks: None	Mesohabitat Composition: Cascade – 50%; Riffle – 50% Substrate Composition: Cobble – 80%; Gravel – 15%; Boulders – 5%; Stream Cover: Boulders – 5%; In- and Overstream Vegetation - 5% Riparian Vegetation: Grasses, willows, fireweed Aquatic Vegetation: Algae Unique Features: None Summary: This is a medium-sized stream characterized by cascades. Substrate is predominantly cobble and the banks have low-moderate erosion potential. Cover is relatively limited.	Arctic Char

Spawning: Unlikely
			Migration: Unlikely
			Rearing: Yes
			Overwintering: Unlikely
			Ninespine Stickleback
			Spawning: Unlikely
			Migration: Unlikely
			Rearing: Unlikely
			Overwintering: Unlikely
		Fish Habitat Quality	
		Marginal	
		Comments	
		This waterbody has suitable habitat for juvenile and young-of-the-year char. A few YOY char were observed during fisheries investigations. The lack of calm, slow-flowing water may prevent extensive use by char or stickleback. Juvenile char from Phillips Creek likely use this creek for feeding and refuge during the open water season.

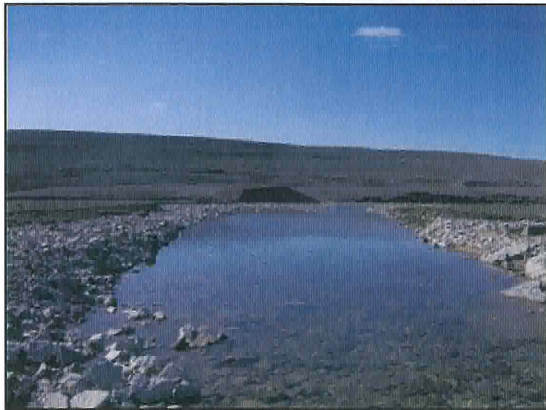
Figure 1: Downstream view from proposed crossing showing pool habitat.

Location			
Site:	CV-99	Watercourse Name:	Unknown River
UTM:	17W 0521811 / 7948819		
Site Description		Potential Fish Utilization	
Watershed Size:	28.559 km ²	Arctic Char	
Regulated:	No	Spawning:	Possible
Channelized:	No	Migration:	Possible
Bankfull Width:	24.0 m	Rearing:	Yes
Wetted Width:	8.0 m	Overwintering:	Unlikely
Riffle-Crest Depth:	0.15 m	Ninespine Stickleback	
Pool Depth:	0.51 m	Spawning:	Possible
Residual Pool Depth:	0.36 m	Migration:	Possible
Bankfull Depth:	0.44 m	Rearing:	Possible
Bank Height:	0.12 m	Overwintering:	Unlikely
D ₉₅ :	0.88 m	Comments	
D:	0.04 m	This waterbody has suitable habitat for several life cycle stages of char though it is likely used primarily for rearing of young fish. Many YOY and juvenile char were observed and captured during fisheries investigations. Reduced turbidity may prevent extensive use by stickleback.	
Confinement:	Moderately Confined		
Channel Morphology:	Riffle-Pool

Channel Gradient:	1 ⁰		
Turbidity:	0.00 FTU	Important	
Side Slope	R – 5%; L – 5%		
Approach:	R – 95%; L – 95%		
Bank Stability:	High		
Erosion Potential:	Low	Fish Habitat Quality	
Undercut Banks:	None

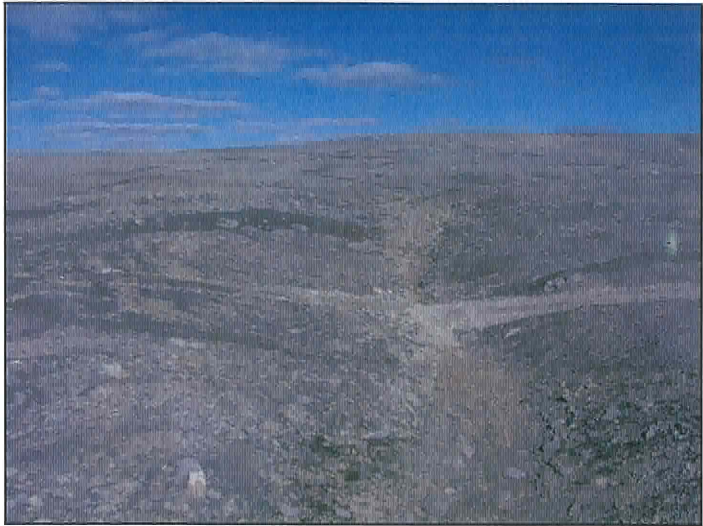
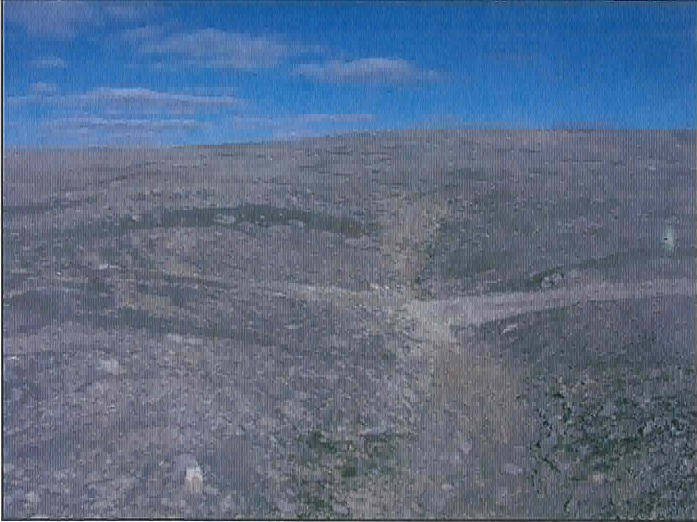
Figure 1: Aerial view of proposed crossing showing a dry cobble/gravel creek bed.

Location					
Site:		CV-95		Watercourse Name:	
UTM:		17W 0522618 / 7945799		Unknown River	
Site Description				Potential Fish Utilization	
Watershed Size:		0.119 km ²		Arctic Char	
Regulated:		No		Spawning:	
Channelized:		No		Migration:	
Bankfull Width:		N/A		Rearing:	
Wetted Width:		N/A		Overwintering:	
Riffle-Crest Depth:		N/A			
Pool Depth:		N/A		Ninespine Stickleback	
Residual Pool Depth:		N/A		Spawning:	
Bankfull Depth:		N/A		Migration:	
Bank Height:		N/A		Rearing:	
D ₉₅ :		N/A		Overwintering:	
D:		N/A			
Confinement:		N/A			
Channel Morphology:		N/A			
Channel Gradient:		N/A			
Turbidity:		N/A			
Side Slope		N/A			
Approach:		N/A			
Bank Stability:		N/A			
Erosion Potential:		N/A			
Undercut Banks:		N/A

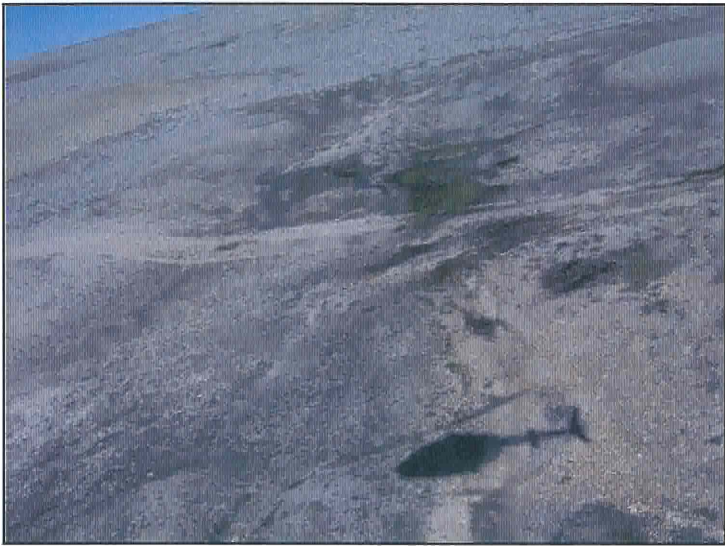
Figure 1: Aerial view of proposed crossing showing an almost completely dry cobble/gravel creek bed.

Location				
	Site: CV-93		Watercourse Name: Unknown River		
	UTM: 17W 0523116 / 7944890				
	Site Description			Potential Fish Utilization	
	<div><div>Watershed Size: 0.880 km²</div><div>Regulated: No</div><div>Channelized: No</div><div>Bankfull Width: N/A</div><div>Wetted Width: N/A</div><div>Riffle-Crest Depth: N/A</div><div>Pool Depth: N/A</div><div>Residual Pool Depth: N/A</div><div>Bankfull Depth: N/A</div><div>Bank Height: N/A</div><div>D₉₅: N/A</div><div>D: N/A</div><div>Confinement: N/A</div><div>Channel Morphology: N/A</div><div>Channel Gradient: N/A</div><div>Turbidity: N/A</div><div>Side Slope: N/A</div><div>Approach: N/A</div><div>Bank Stability: N/A</div><div>Erosion Potential: N/A</div><div>Undercut Banks: N/A</div></div>		Arctic Char		
			Spawning: None		
			Migration: None		
			Rearing: None		
			Overwintering: None		
			Ninespine Stickleback		
Spawning: None					
Migration: None

Rearing: None					
Overwintering: None					
Fish Habitat Quality			Comments		
None			This waterbody is ephemeral and provides no suitable fish habitat. Even during high water in spring there is not likely any fish use. There is a cliff downstream of the crossing that would represent a significant barrier to fish passage even if water levels were sufficient.		
Baffinland Iron Mines Mary River Project Watercourse Crossing Assessment

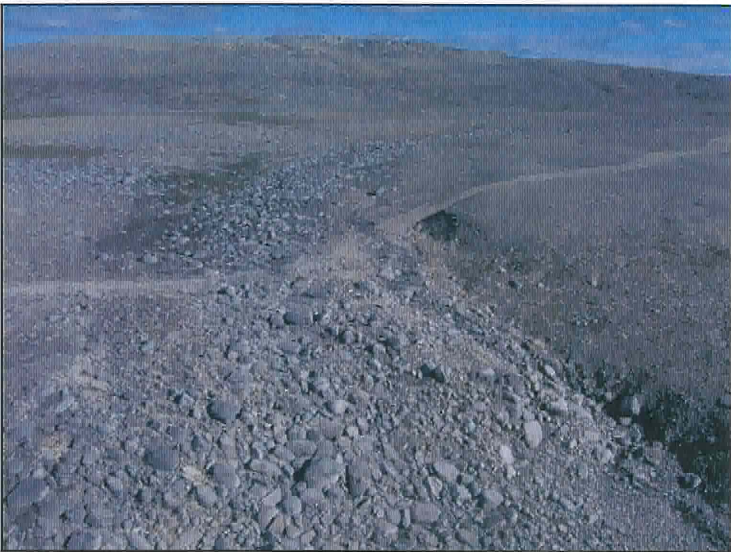
Figure 1: Aerial view of proposed crossing showing a completely dry cobble/gravel creek bed.

Location				
	Site: CV-92		Watercourse Name: Unknown River		
	UTM: 17W 0523106 / 7944186				
	Site Description			Potential Fish Utilization	
	<div><div><div>Watershed Size: 3.453 km²</div><div>Regulated: No</div><div>Channelized: No</div><div>Bankfull Width: N/A</div><div>Wetted Width: N/A</div><div>Riffle-Crest Depth: N/A</div><div>Pool Depth: N/A</div><div>Residual Pool Depth: N/A</div><div>Bankfull Depth: N/A</div><div>Bank Height: N/A</div><div>D₉₅: N/A</div><div>D: N/A</div><div>Confinement: N/A</div><div>Channel Morphology: N/A</div><div>Channel Gradient: N/A</div><div>Turbidity: N/A</div><div>Side Slope: N/A</div><div>Approach: N/A</div><div>Bank Stability: N/A</div><div>Erosion Potential: N/A</div><div>Undercut Banks: N/A</div></div><div><div>Mesohabitat Composition: N/A</div><div>Substrate Composition: N/A</div><div>Stream Cover: N/A</div><div>Riparian Vegetation: N/A</div><div>Aquatic Vegetation: N/A</div><div>Unique Features: N/A</div><div>Summary: This is a medium waterbody that was completely dry at the time of sampling in August. It is probably only a spring run-off stream</div></div></div>			Arctic Char

Spawning: None	
				Migration: None	
				Rearing: None	
				Overwintering: None	
				Ninespine Stickleback	
Spawning: None					
Migration: None					
Rearing: None					
Overwintering: None					
			Comments		
			This waterbody is ephemeral and provides no suitable fish habitat. Even during high water in spring there is not likely any fish use.		
			<div>

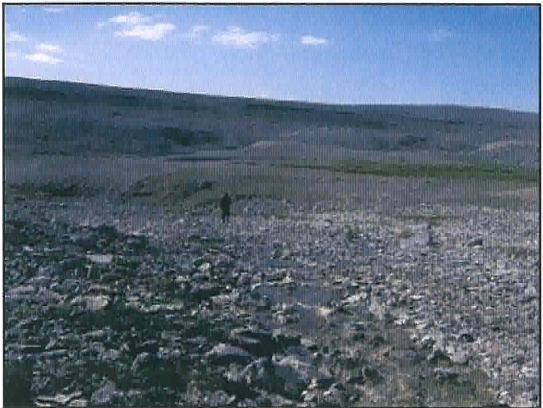
Figure 1: Downstream view from proposed crossing showing cascade habitat with cobble and boulders.

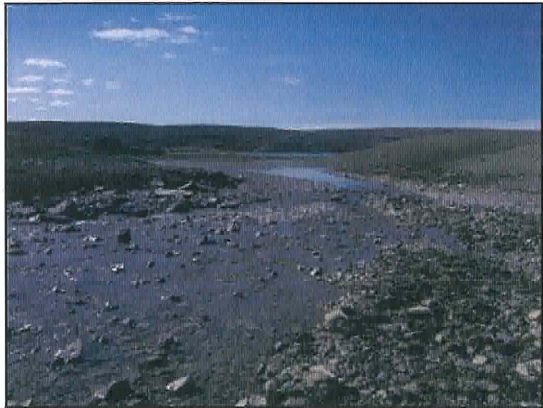
Figure 1: Downstream view from proposed crossing showing riffle-pool habitat with cobble and boulders.

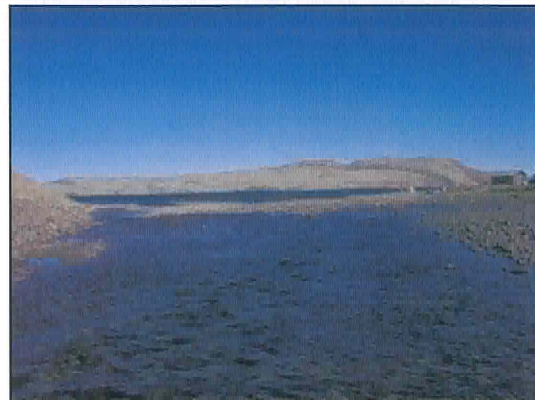
Figure 1: Downstream view from proposed crossing with Milne Inlet visible in the distance. Riffle-run habitat type with cobble/boulder substrate.

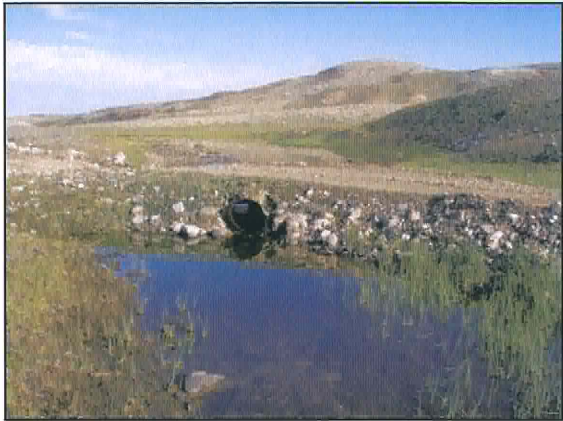
Figure 1: Downstream view from proposed crossing showing pool habitat and existing culvert.

Aquatic Vegetation: Algae, submerged grasses			
	Unique Features: Fuel drum culvert at crossing	Ninespine Stickleback		
	Summary: This is a small-sized waterbody consisting largely of pool habitat with cobble substrate. The banks have moderate erosion potential and there is a variety of available cover.	Spawning: Unlikely		
		Migration: Unlikely		
		Rearing: Unlikely		
		Overwintering: None		
	Fish Habitat Quality		Comments	
	Important		Abundant pools with some larger substrates represent ideal habitat for juvenile char. Several young char were captured during fisheries investigations. There is probably little use by adult char or by sticklebacks.

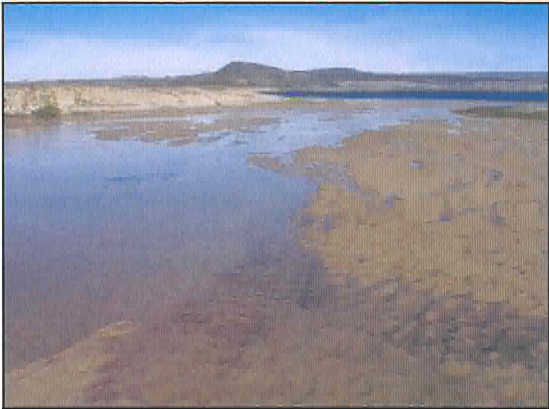
Figure 1: Downstream view from proposed crossing showing flat, shallow, sandy habitat and exposed sand bar preventing access to large lake.
