RE: NUNAVUT WATER BOARD 2015 ANNUAL REPORT, KIVALLIQ ENERGY CORPORATION
- ANGILAK PROPERTY, NWB Water Licence No.: 2BE-ANG1318

NUNAVUT WATER BOARD ANNUAL REPORT 2015
Nunavut Water Board Licence No.: 2BE-ANG1318

RE: 2015 Remediation Update – NU Spill Report #14-234, Angilak Property, Kivalliq Energy Corp.

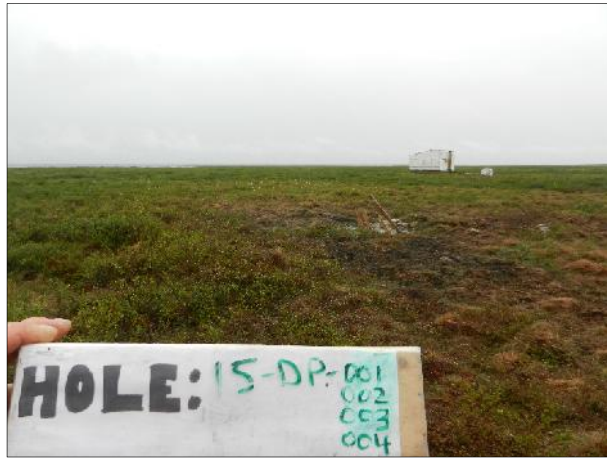
15-DP-001, 15-DP-002, 15-DP-003, 15-DP-004
492900 E 6932165 N UTM NAD 83 Z14
July 5, 2015 to July 14, 2015

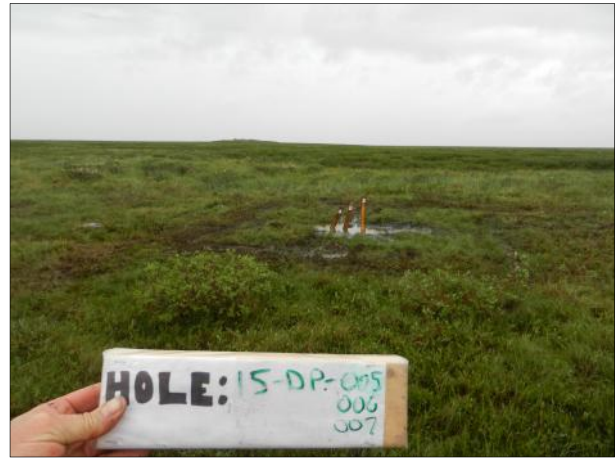
15-DP-005, 15-DP-006, 15-DP-007
492859 E 6932136 N UTM NAD 83 Z14
July 15 2015 to July 20, 2015

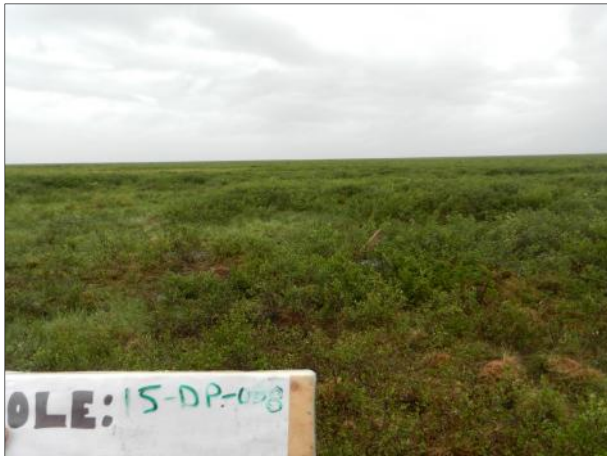
15-DP-008
4927876 E 6932138 N UTM NAD 83 Z14
July 24 2015 to July 25 2015

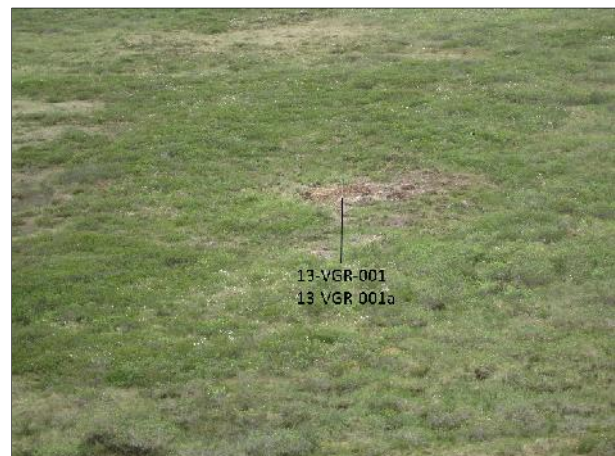
13-VGR-001 and 13-VGR-001a
495658 E 6943912 N UTM NAD 83 Z14
May 03 2013 to July 03 2015

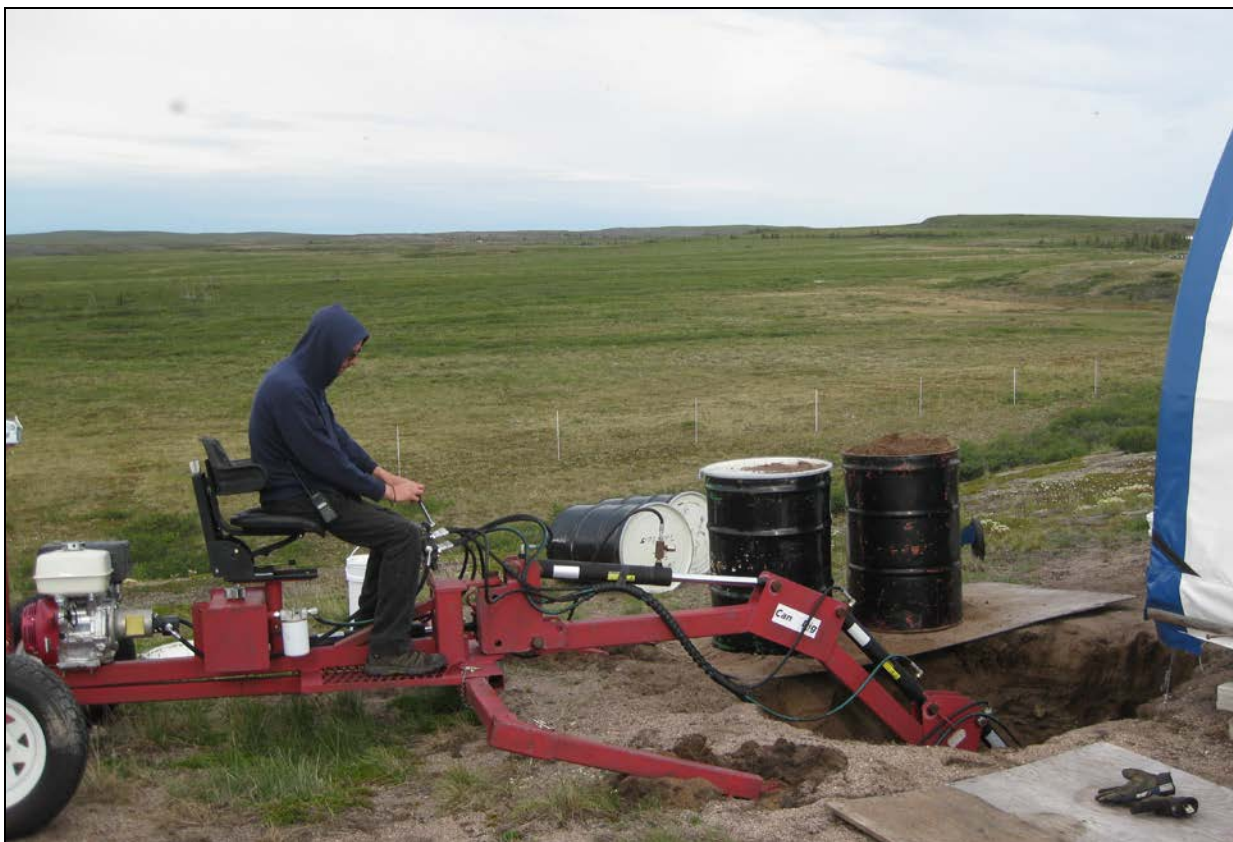
During a wind storm in the spring of 2014 a diesel fuel drum was knocked over at the Nutaaq Camp while the camp was unoccupied. The spill was reported on June 23, 2014, within 24 hours of its discovery (NU Spill Report 14-234).

Figure 1: Can-Dig Excavator Removal of 4 Drums of Contaminated Soil to Permafrost - 2015

Nutaaq Camp was open from June 10 to July 27, 2015 and further remediation was conducted in 2015. Four additional 205-litre drums of contaminated soil were excavated to a depth of 1.4 metres (4.5 feet) using a Can-Dig mini excavator at which point permafrost was encountered (Figures 1-6). Sand from the upper permafrost horizon was scrapped off using a shovel and no fuel odours were detected (Figure 4). The pit has been left open to the air for the last two years to allow for evaporation to occur. Upon closure and winterization of camp, the excavated spill site was covered for safety and to prevent a cave in due to snow (Figure 6). The resulting 14 drums of contaminated soil will be removed from camp and disposed of at an authorized facility.

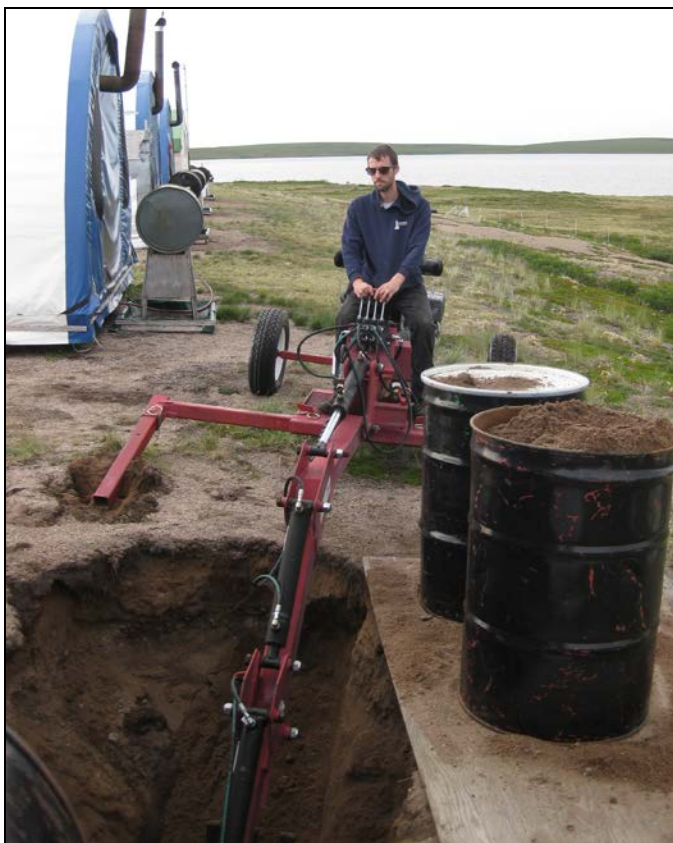
Figure 2: Excavating the Spill Site - Looking South – 2015

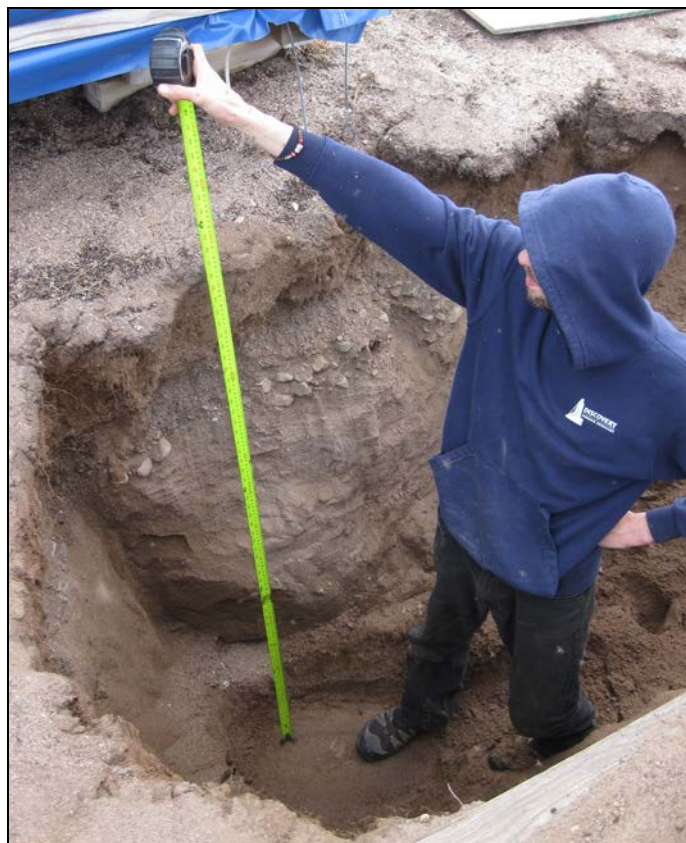
Figure 3: Excavated Pit – 1.4 metres to Frozen Permafrost Layer

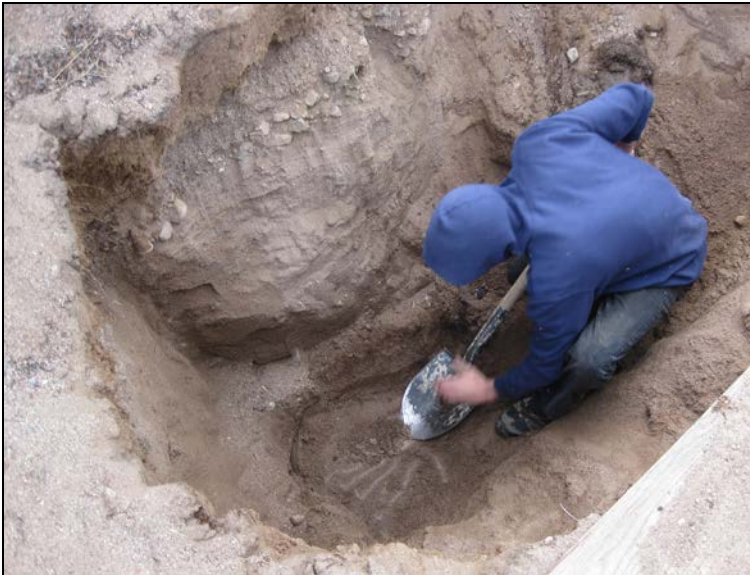
Figure 4: Scrapping Non-Contaminated Sands from Upper Permafrost Horizon

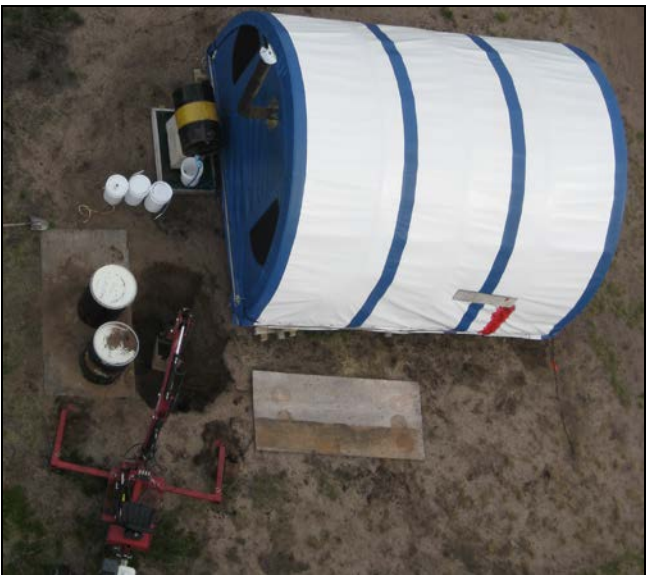
Figure 5: Arial View: The Excavated Spill Site behind Tent

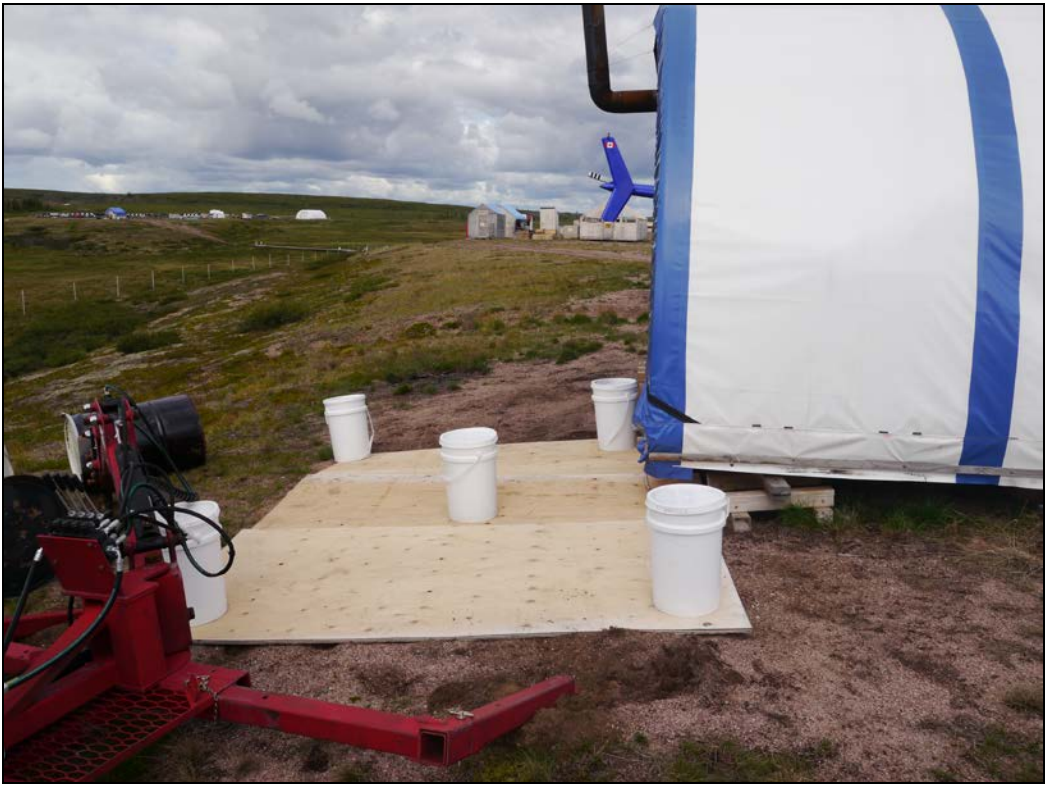
Figure 6: The Excavated Spill Site Covered for Winter

To prevent future spills from occurring, tents were re-secured and fuel drums behind the tents were taken off their stands and placed upright in the tents for winterization as per regular seasonal closure

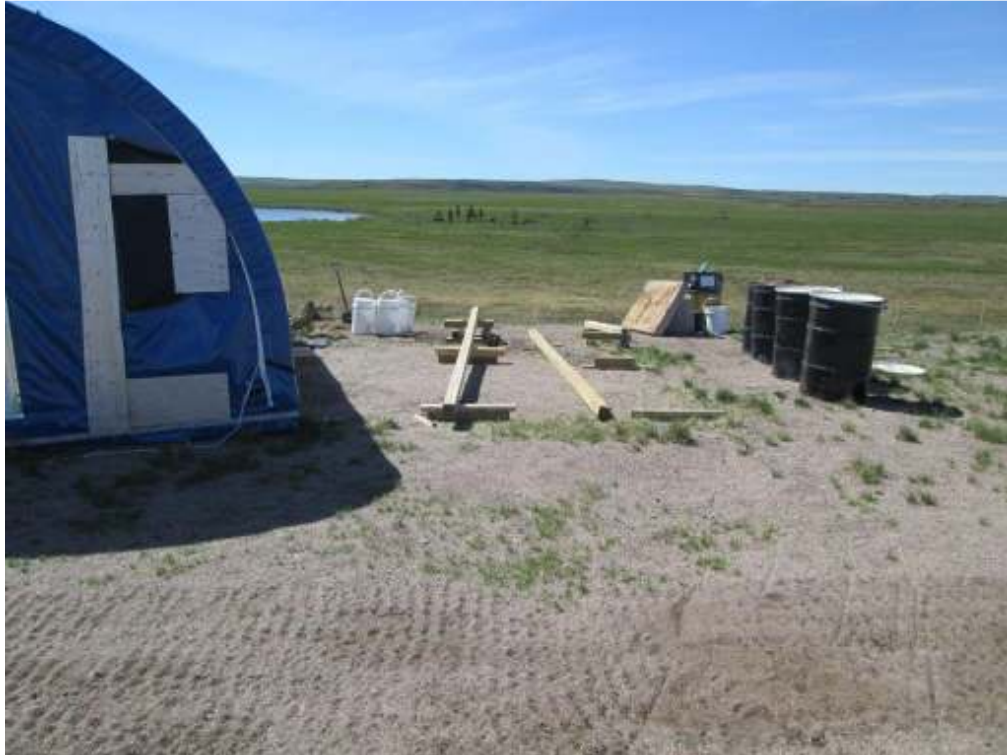
The Nutaaq Camp is situated on a flat top sand esker approximately 8 metres above the surrounding tundra. Two workers sent to inspect the camp in June 2014 noted that tent W5 was lifted off its foundations by wind and moved 4 metres south. An adjacent fuel drum (containing P50 diesel) was knocked over. The impact cracked a fuel valve connection causing a portion of the fuel in the drum to leak. A surface stain of approximately one square metre was noted. The spill did not enter any water body or drainage. The nearest water body, Nutaaq Lake, is approximately 200 metres west of the spill site.

Photo 1: Tent W5 Shifted 4m South From Tent Footings (note: Nutaaq Lake 200m West)

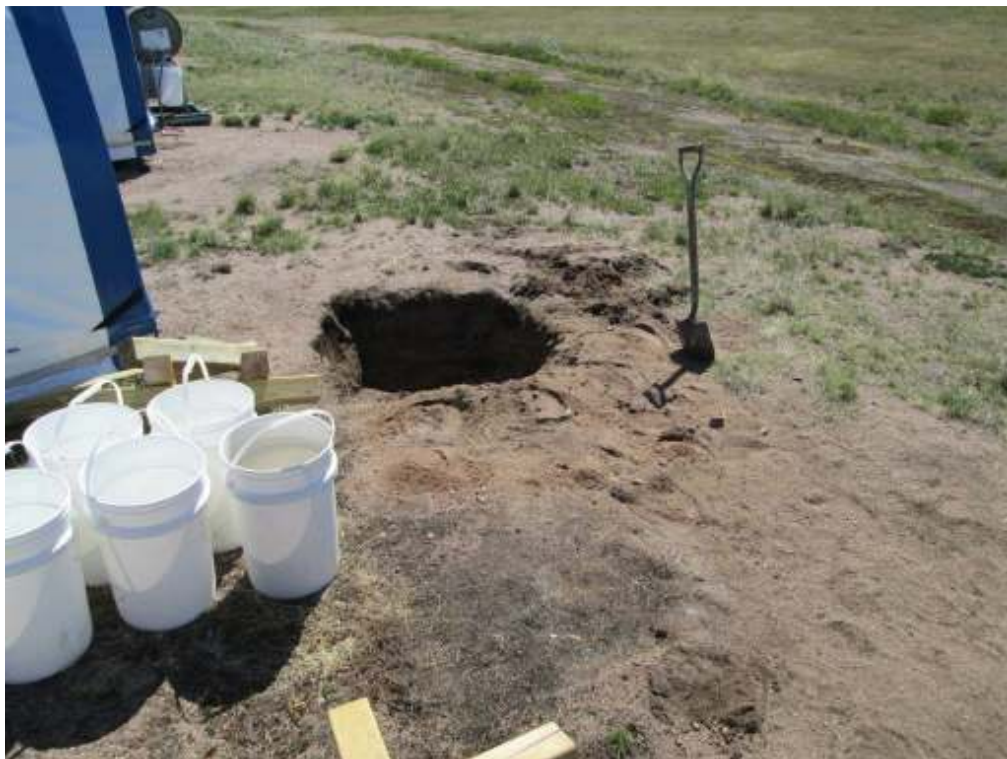
Photo 2: Spill Location and Excavated Pit

As mentioned on the 2BE-ANG1318 Water Licence Inspection Form July 22, 2014, Kivalliq Energy has followed a Remedial Action Plan that has addressed the monitoring of the spill until remediation is complete. Remediation in 2014 included excavation of contaminated soils to a depth of approximately one metre by workers using shovels. Contaminated soil was contained in ten 205-litre drums.
