SABINA SILVER CORPORATION

HACKETT RIVER CAMP

ABANDONMENT AND RESTORATION PLAN

Prepared by
Scott Burgess, P.Geo.

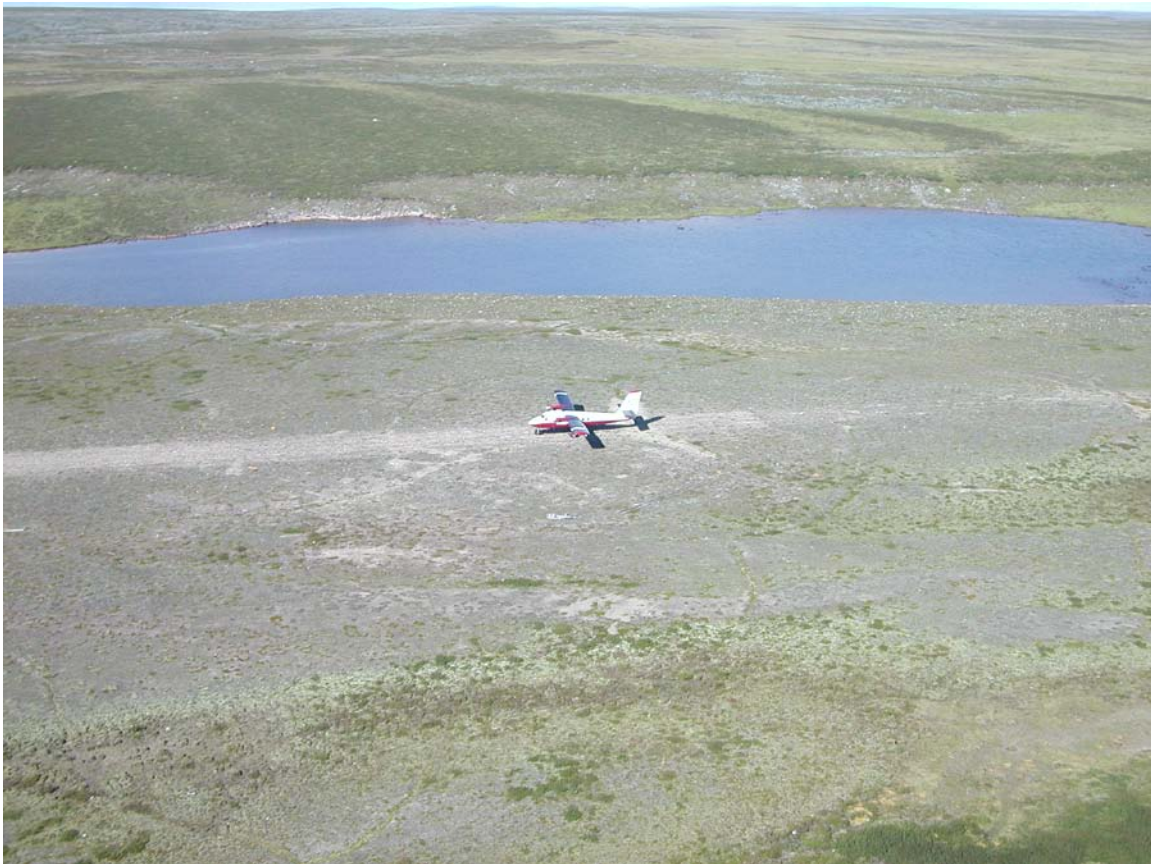
Virtually all of the scrap metal and rusty drill steel was shipped out to Yellowknife for disposal or recycling in 2004 and 2005. The esker strip is clean of any old equipment and drill steel. The only things at the airstrip now are a couple of rows of orange garbage bags used to mark the alignment of the esker airstrip.

Photo of Esker Airstrip (View from the South), August 6, 2006.

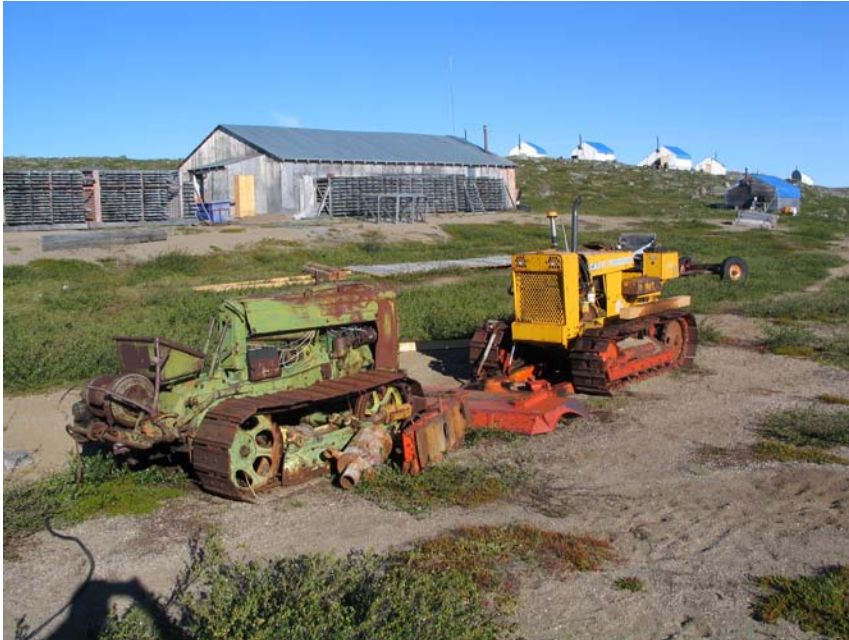
Two abandoned small bulldozers and a wheeled drill rod wagon were found in camp in 2004. The following photo shows the 2 small bulldozers and a rod wagon. Both tracked machines and the rod wagon were dismantled and were shipped to Yellowknife in 2005. Some of the pieces were salvaged in Yellowknife while other pieces were sent for metal recycling.

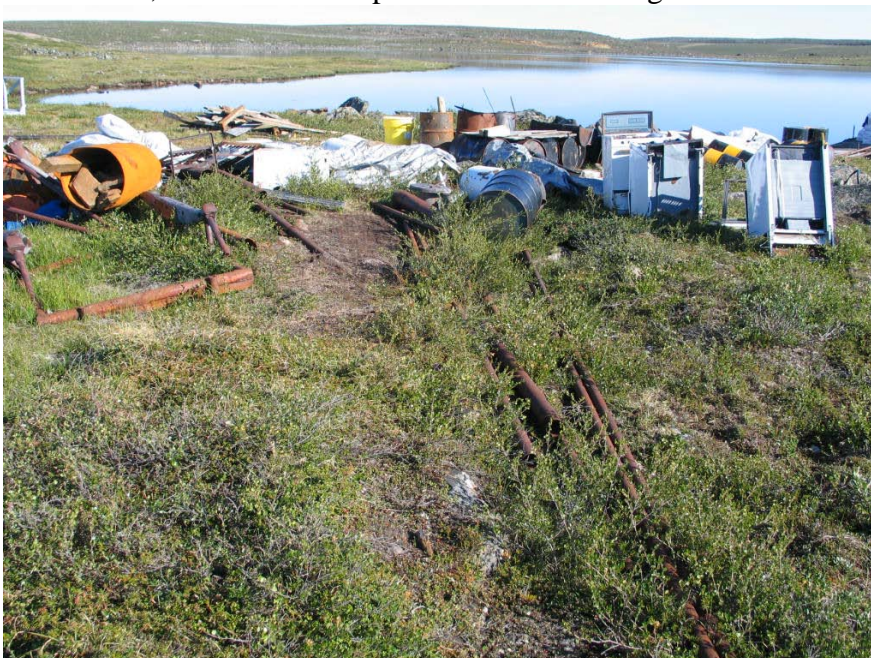
The following photo shows the pile of scrap metal filled drums and kitchen appliances found on site in 2004. Most of the scrap metal in the following photo was shipped back to Yellowknife for disposal or recycling in 2004, 2005 and 2006. The remainder was flown out in 2007, and all new scrap is flown out as it is generated.
