# **Attachment B**

## **Photolog**

Gartner Lee

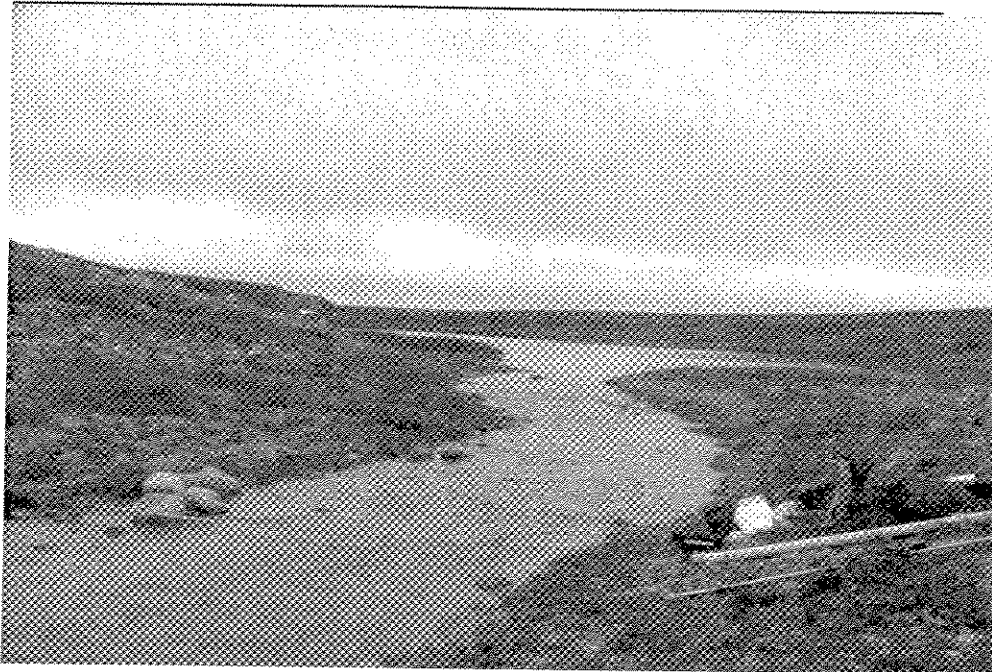
PHOTOGRAPH 1

Typical drainage channel with moderate flow at time of site visit. This is the outlet of Upper Sunken Lake, looking northwest towards Upper Sunken Lake.

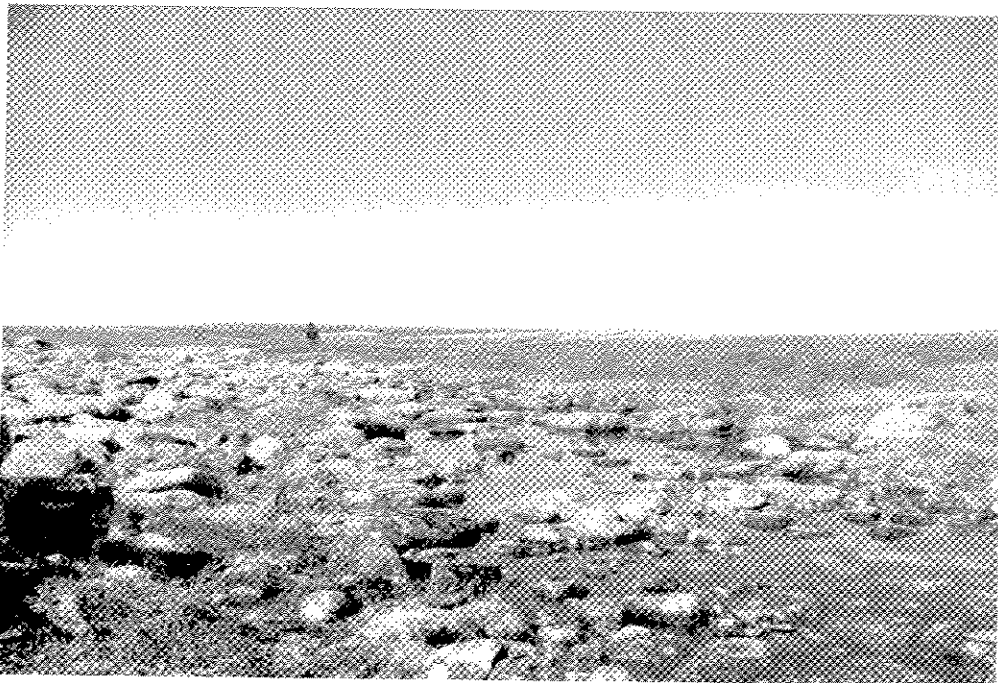
PHOTOGRAPH 2

This is a typical inflow and outflow of the lakes and rivers at time of site visit. This photo typifies Mara Inflow #2, looking towards the southeast.

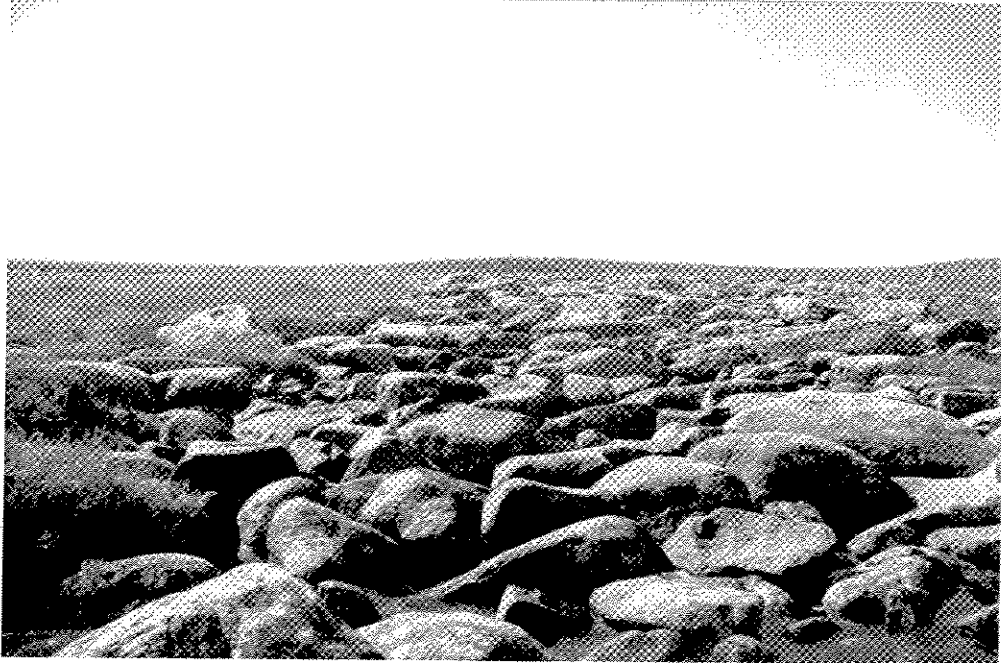
PHOTOGRAPH 3

Mara Inflow #1 looking east. Very little flow at time of visit.

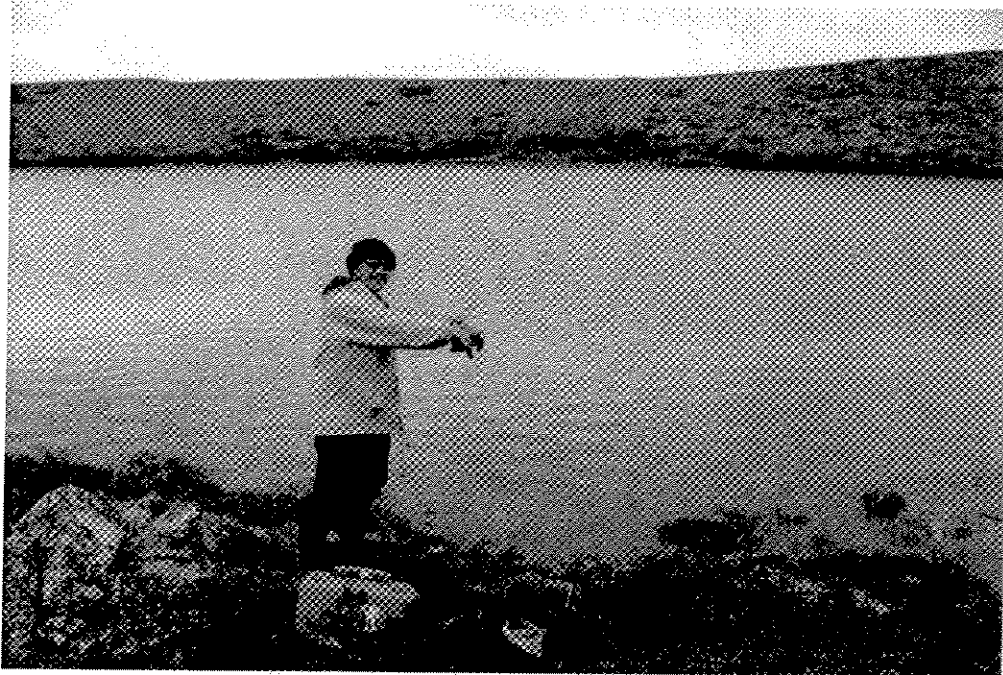
PHOTOGRAPH 4

Upper Sunke Lake, looking south. Jeff Kadlun graciously points to the exact sample location.

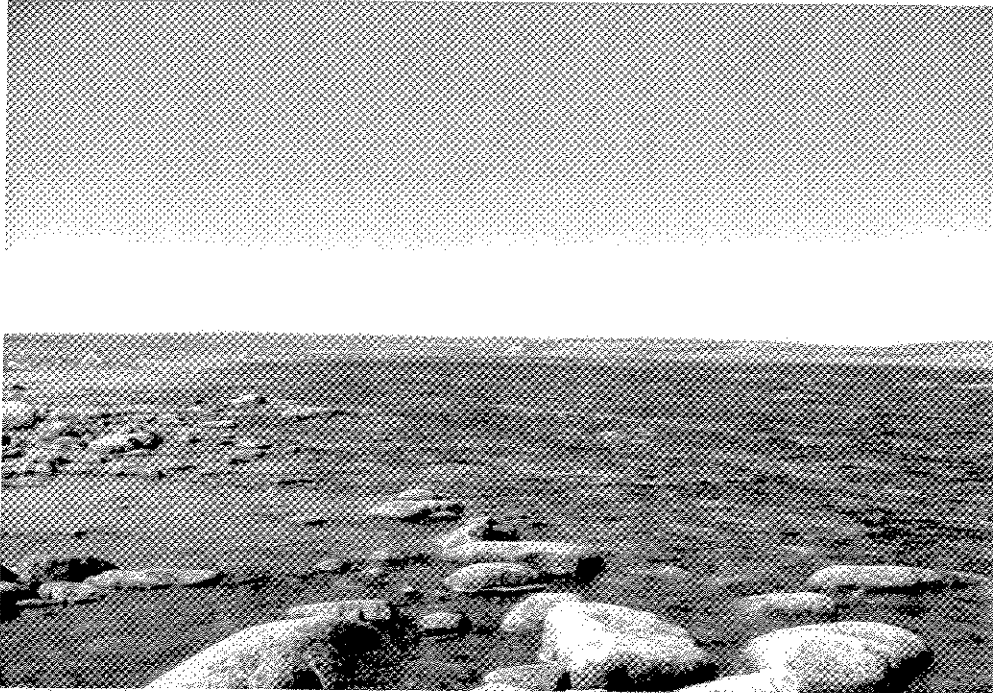
PHOTOGRAPH 5

Mara River (downstream sample location) south side looking downstream.

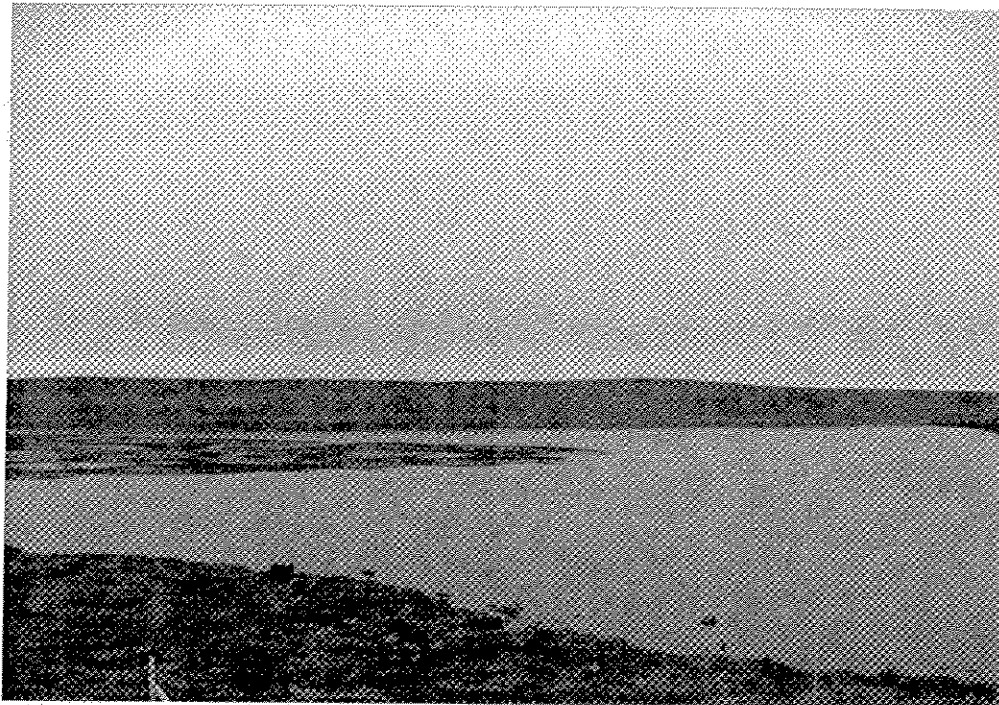
PHOTOGRAPH 6

Camp Lake looking due north looking away from camp. Sample location at bottom left.
