Interim Closure and Reclamation Plan
Ulu Gold Project
(including Hood River, Roma and other licensed projects)

Kitikmeot Region, Nunavut

NOVEMBER 2025

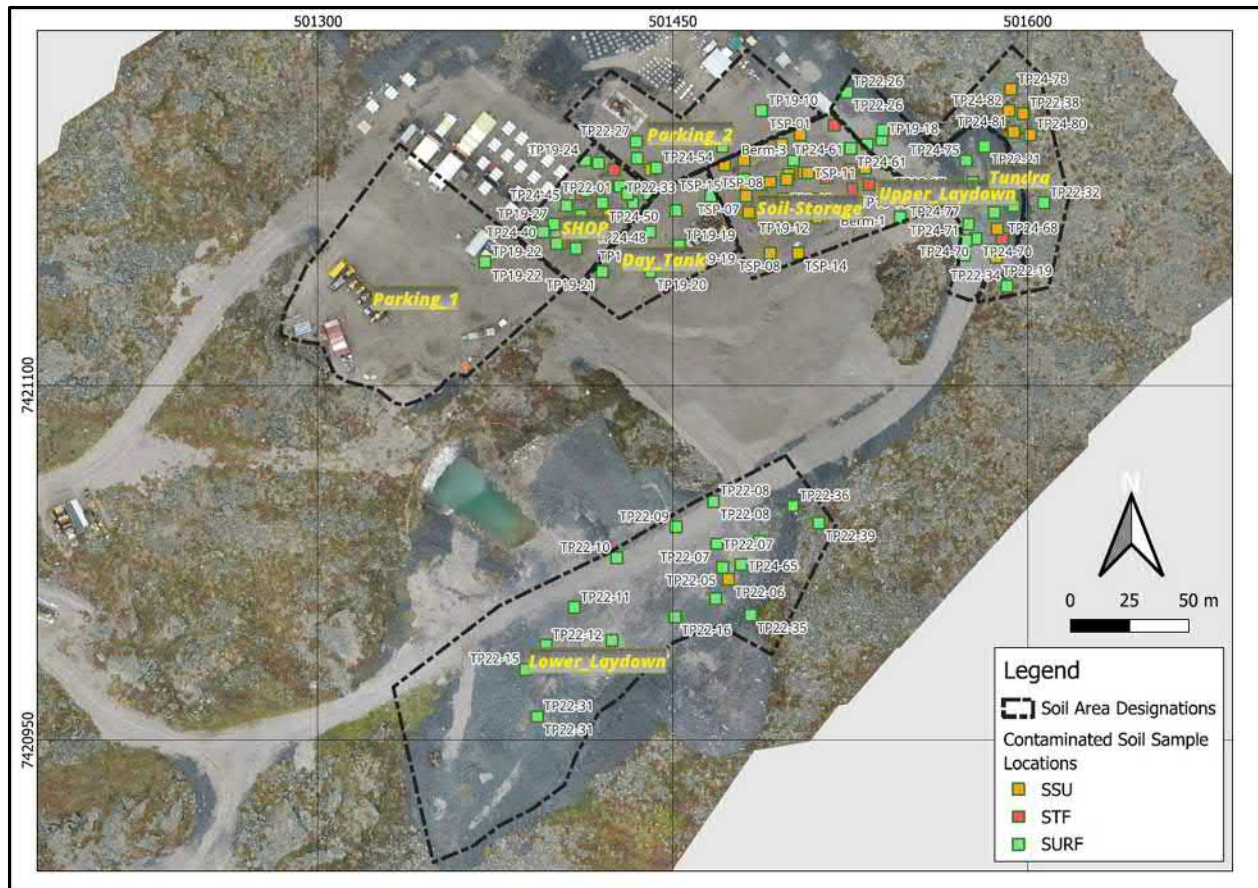
Figure 8: Current areas under study for PHC contamination; SSU = sub-surface reuse criteria met, STF = to be placed in STF, SURF = surface re-use criteria met.

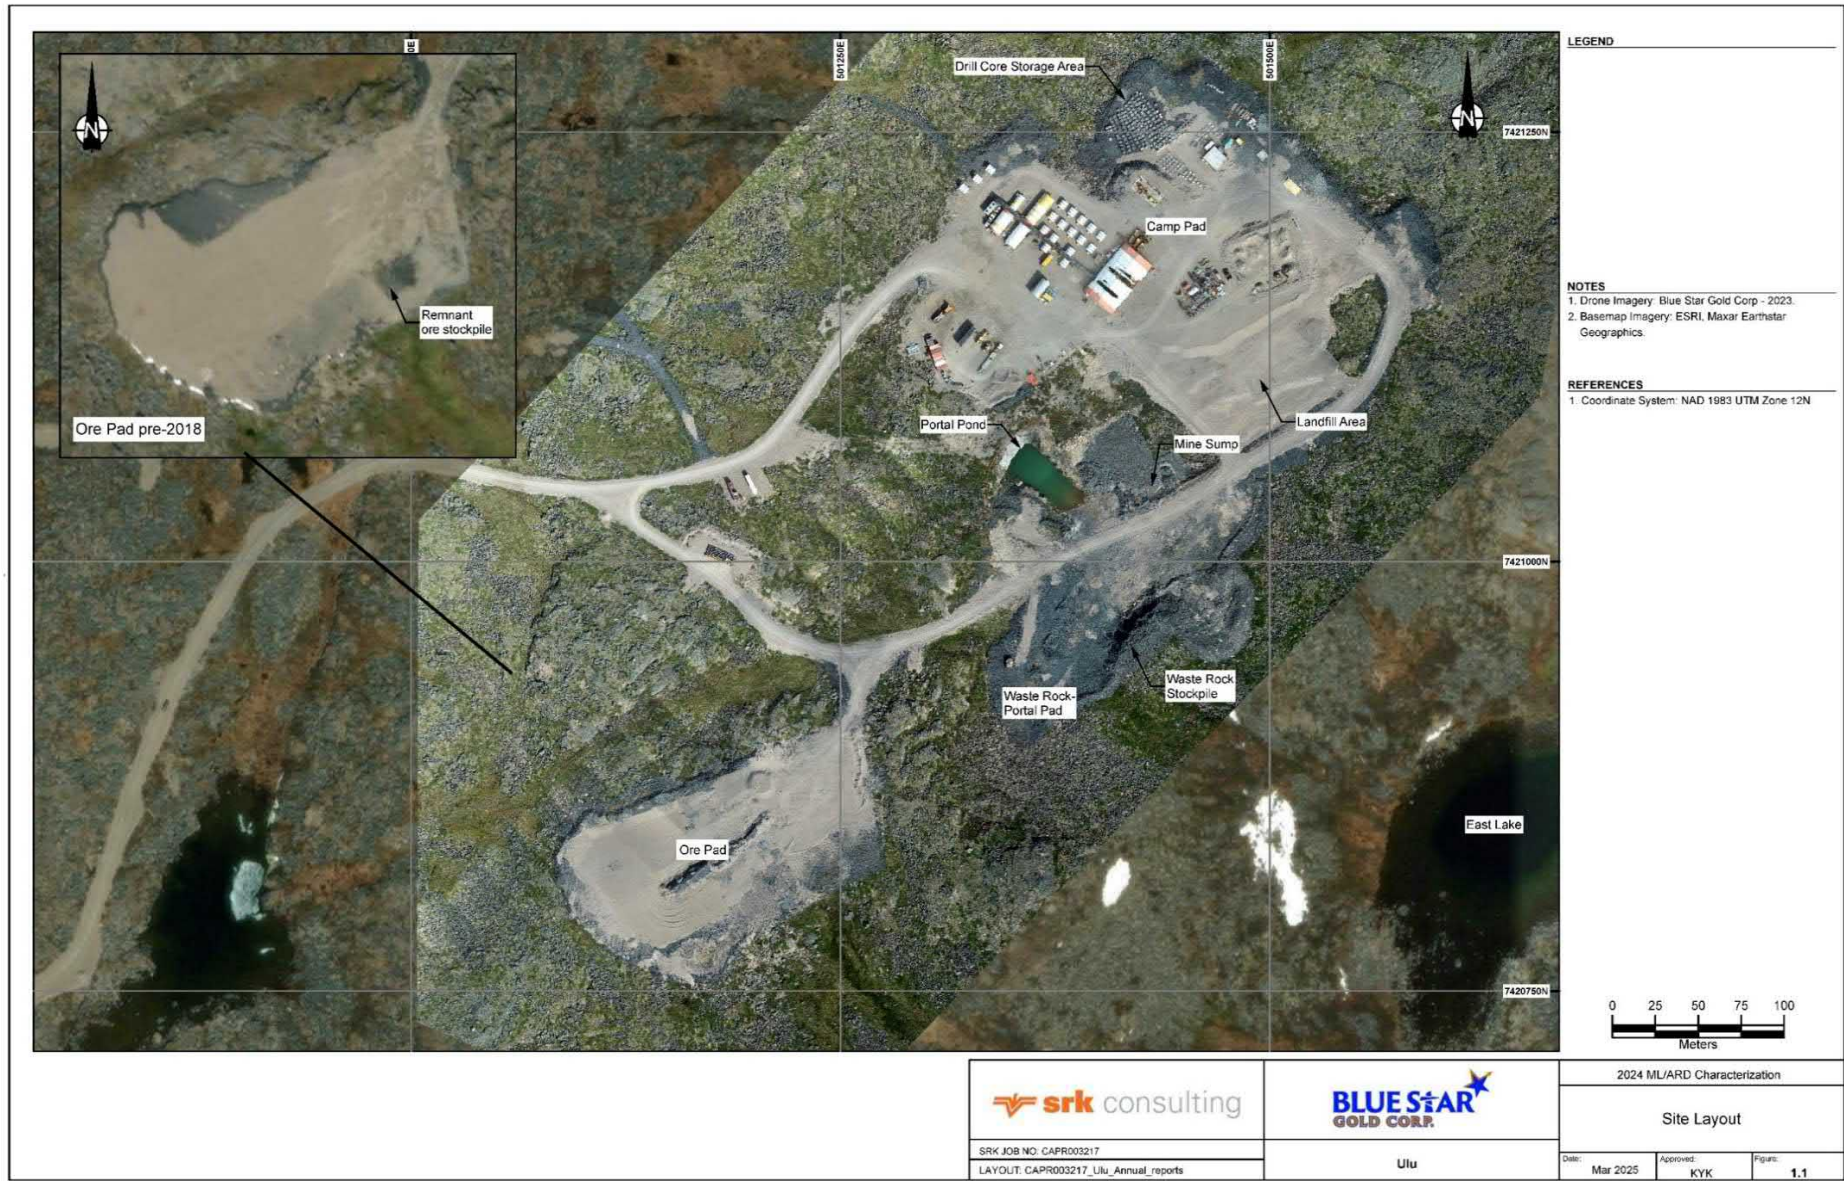
Figure 1: Site layout prior to reclamation activity at ore pad (pre-2024)

During August and September 2024, acid generating waste rock from within the northwest edge of the ore pad, and residual waste rock lying on the tundra that was exposed in 2020, was relocated by Blue Star onto the ore pad, as part of initial consolidation works in preparation for covering for interim management. The rock was added to the existing temporary stockpile at the center of the ore pad.

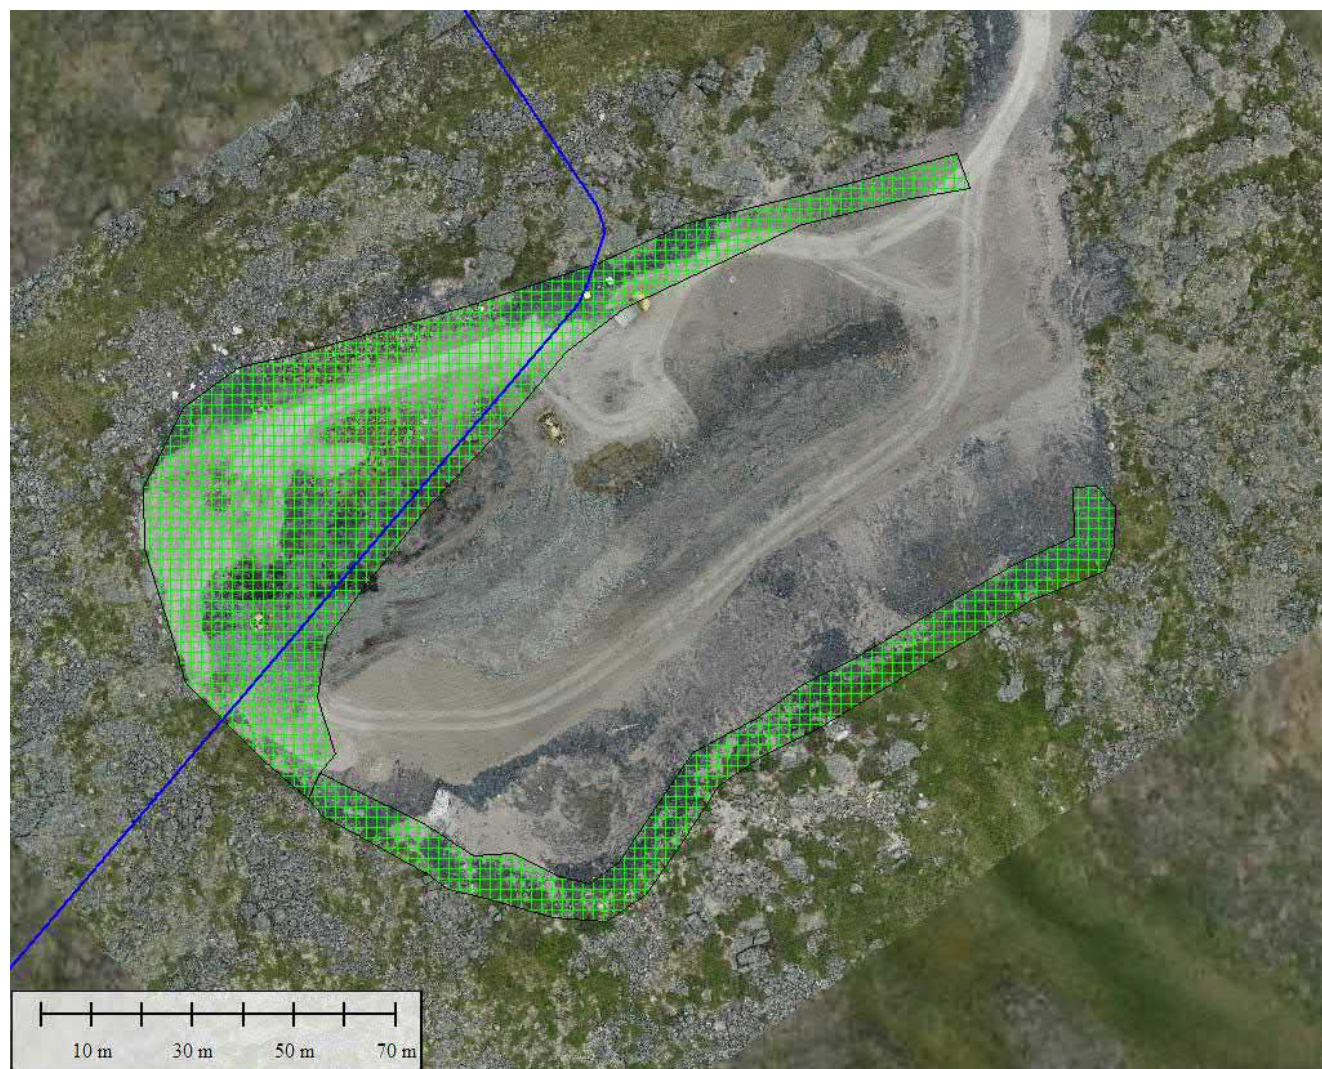
Figure 3: Waste rock remaining on northern portion of ore pad as of August 18, 2025 (facing east from center).
