November 6, 2019

File: 3AM-IQA1626

Reference: Crown-Indigenous Relations and Northern Affairs Canada (CIRNAC)/Nunavut Water Board (NWB) comments on the City of Iqaluit's 2018 Annual Report for Water Licence No. 3AM-IQA126

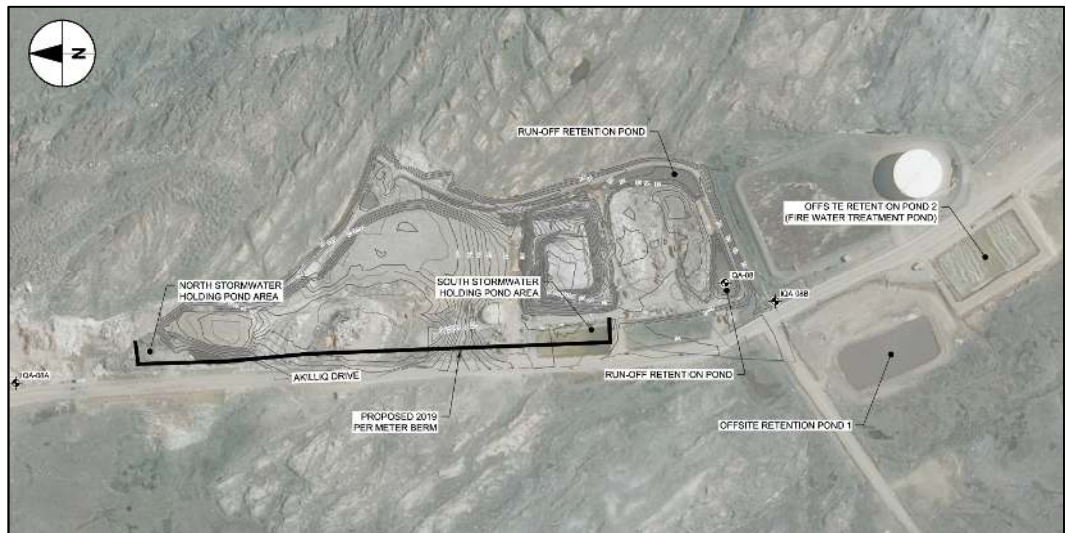
- 1. West 40 Landfill:** The missing containment pond was drained due to a fire in 2014 at the Landfill. The previous location of the containment pond is now being used as a disposal area at the landfill. The proposed Wood Waste Processing area was built but did not cover the containment pond. The Wood Waste Processing area also burnt down in 2014 and was not re-built. Site drainage at the West 40 Landfill is presently being managed as per the approved Landfill O&M manual, and Environmental Monitoring Program and QA/QC Plan – see Figure 1 below for reference.

Figure 1 - West40 Landfill Containment Ponds
