Cape Dorset Sewage Lagoon Feasibility Study

Final Report

Prepared for: Government of Nunavut Community and Government Services

Project No. 1101 26033

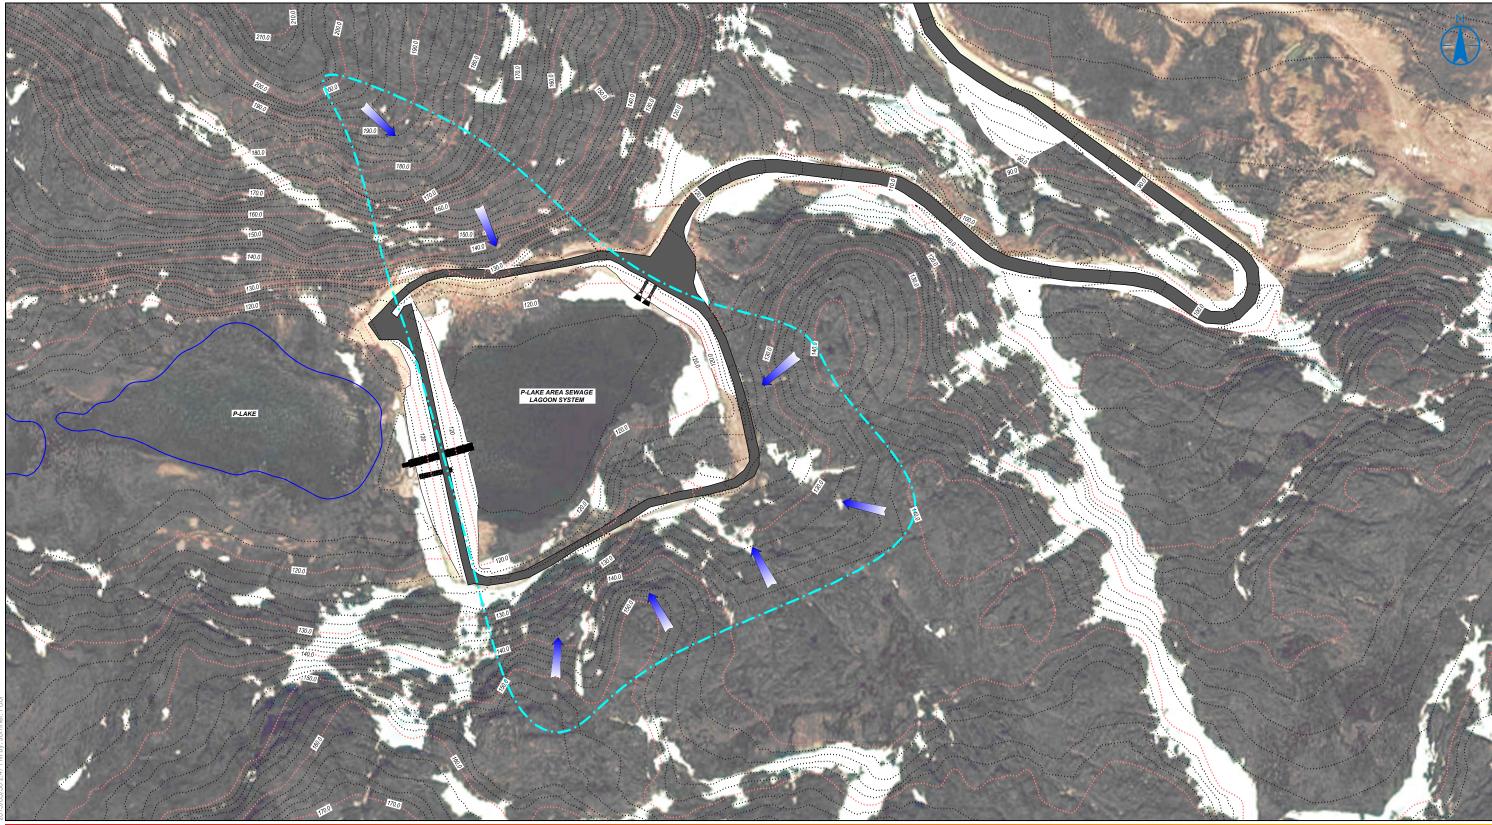
3.1

- Road is too steep and narrow and has an unsafe hairpin turn; trucks are likely to slide while driving up or down the incline.
- Erosion of the road is occurring during spring melt.
- Extensive snow accumulation and drifting occurs over the road in winter.
- Visibility along the road is poor at times after dark.

In addition to the access road, the safety of the service road around the lagoon has been questioned due to steep slopes at the southeast section and erosion caused by spring runoff.

Many of the aforementioned road issues are noted on Figure 3.1.

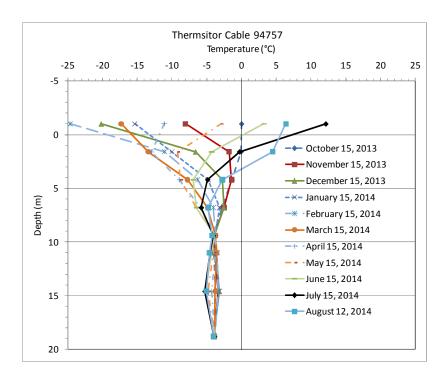
Figure B1: Ground temperature data from thermistor cable 94757

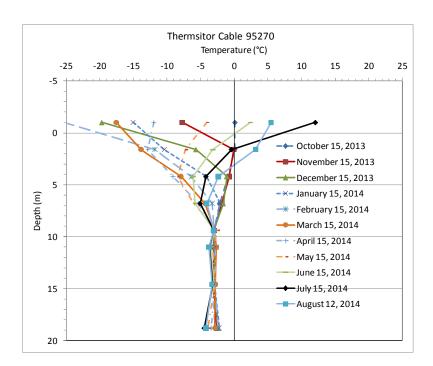
Figure B2: Ground temperature data from thermistor cable 95270

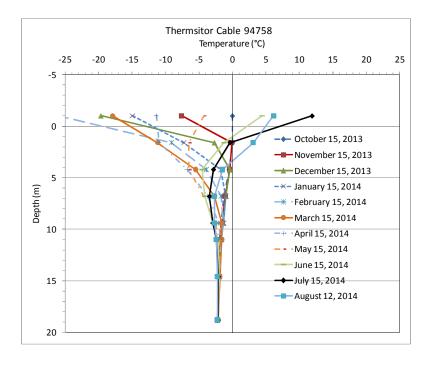
Figure B3: Ground temperature data from thermistor cable 94758

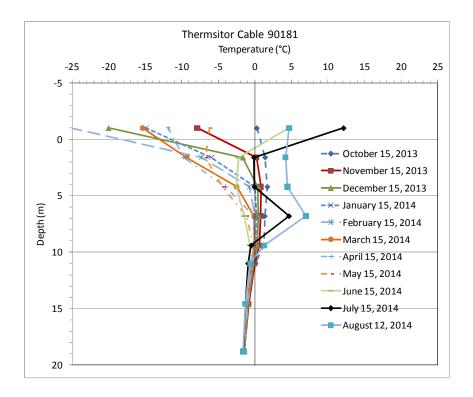
Figure B3: Ground temperature data from thermistor cable 90181

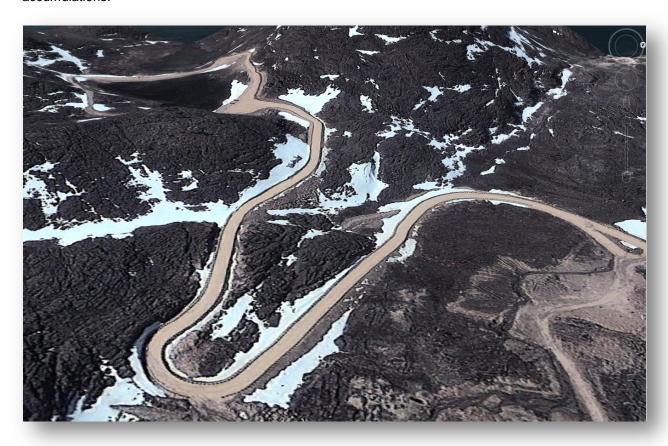
The topography of a region plays a significant role in the formation of snow drift accumulations. As seen in Figure 2, the majority of the access road is situated on the downwind side of the hills that encompass the wastewater lagoon for the prevailing westerly winds. Wind is accelerated as it passes over hills resulting in scouring of snow from the windward side of hills and deposition in the low pressure zones on the leeward side of the hills. While the position of the road with respect to the topography is the primary factor in the undesirable drift formations that occur, it is not expected that a re-orientation of the access road will prove to be beneficial. In any orientation that maintains a reasonable slope, the road will still need to run along the leeward side of one of the hills and thus would experience similar drifting accumulations.

Figure 2 – View of the existing access road looking west (Image courtesy of GoogleEarth_{TM})
