PROJECT: GEOTECHNICAL INVESTIGATION FOR  
P-LAKE SEWAGE LAGOON, CAPE DORSET

TITLE: DYKE TEMPERATURES AFTER  
20 YEARS OF OPERATION

## **Appendix B**

Plates: Select Photographs

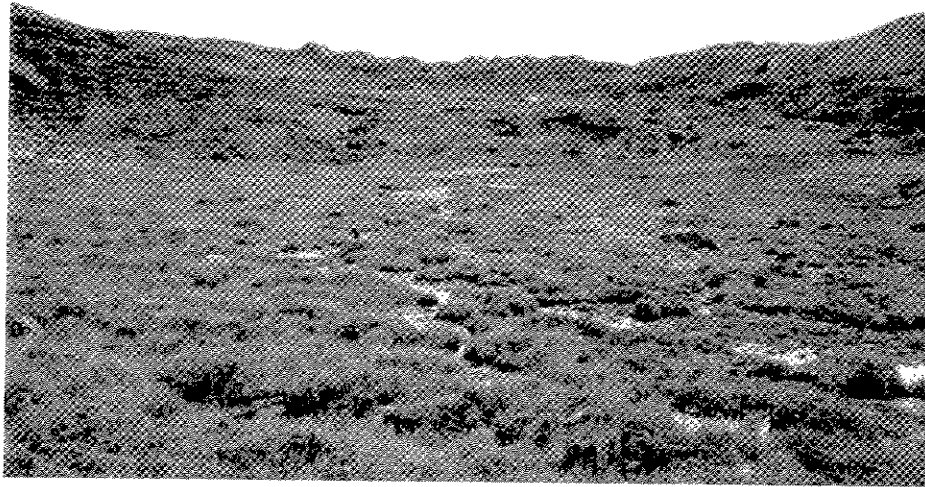
**Photograph 1: Lagoon Impoundment, looking west.**

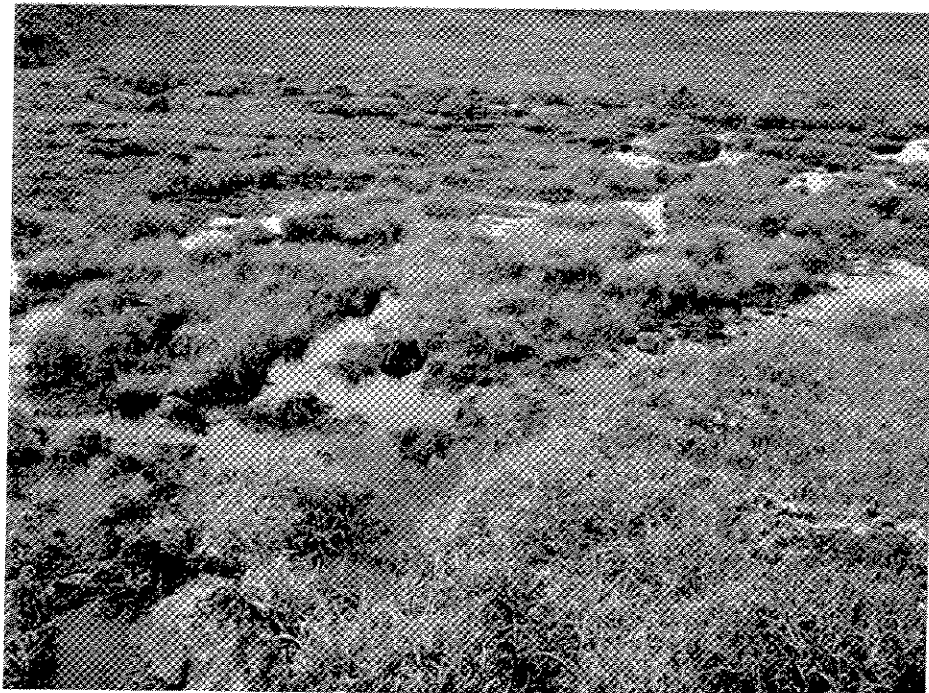
**Photograph 2: Lagoon Impoundment, looking northwest  
from southeast corner**

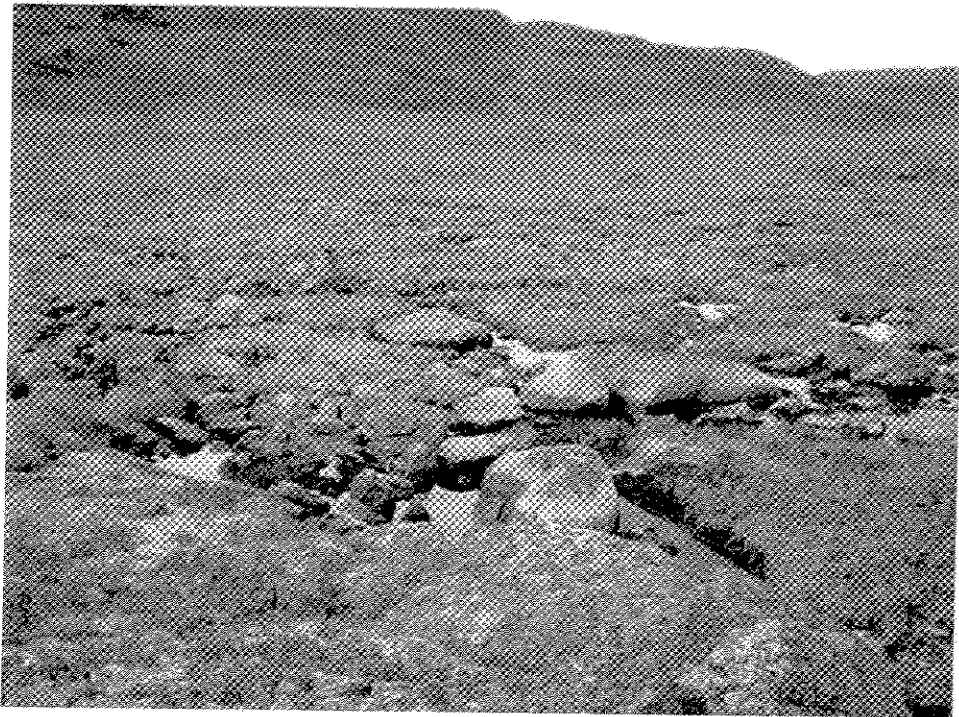
**Photograph 3: Lagoon Impoundment, looking north from center.**

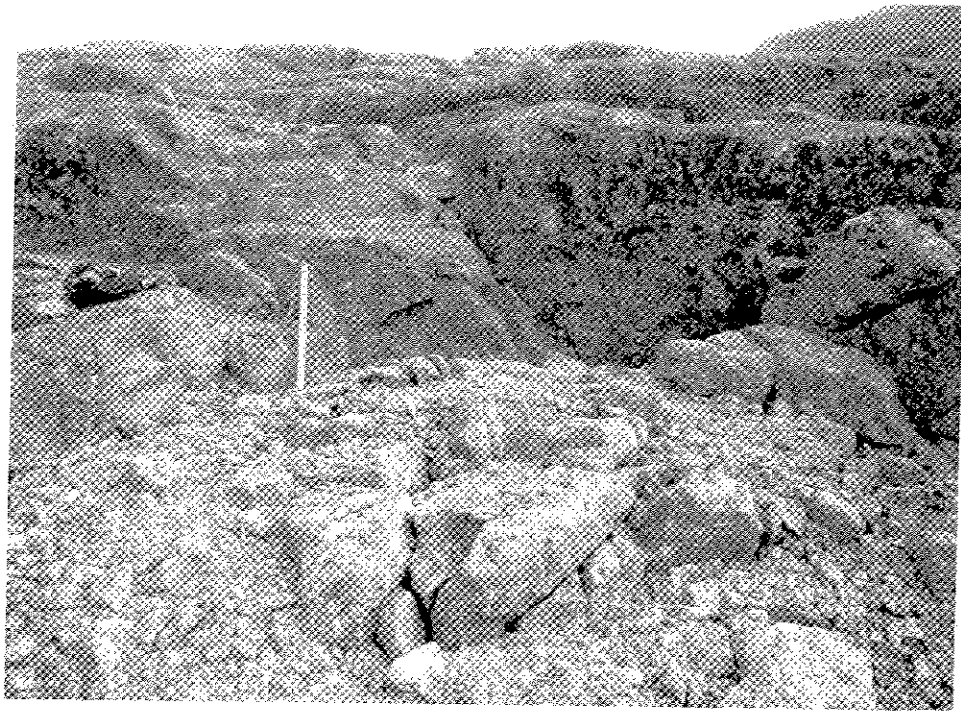
**Photograph 4: Southeast corner of Lagoon Impoundment**

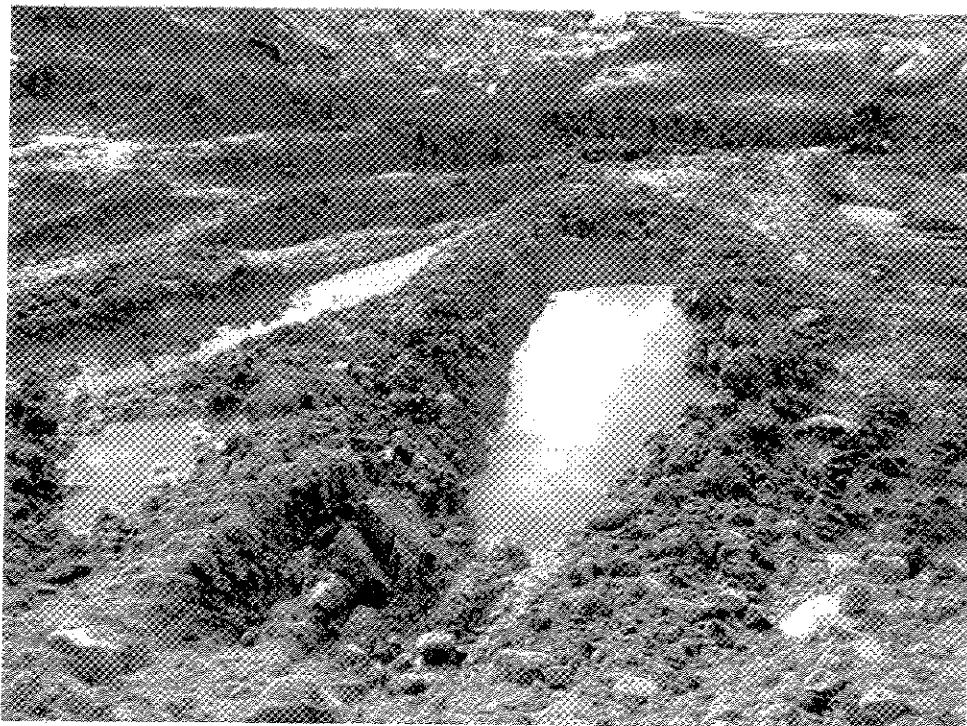
**Photograph 5: Potential clay borrow material near community dump.**

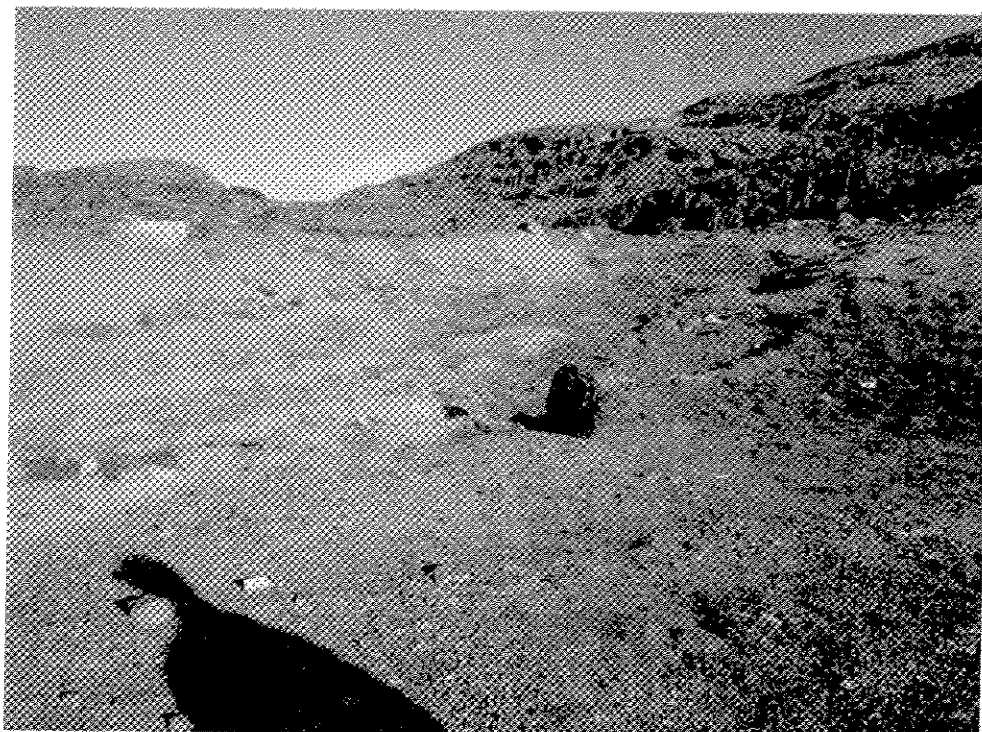
**Photograph 6: Potential clay borrow material near airport.**
