Environmental Assessment Screening under CEAA

Sewage Wetland Upgrade for the Hamlet of Whale Cove, Nunavut

Appendix B: Site Photographs included with Final Report

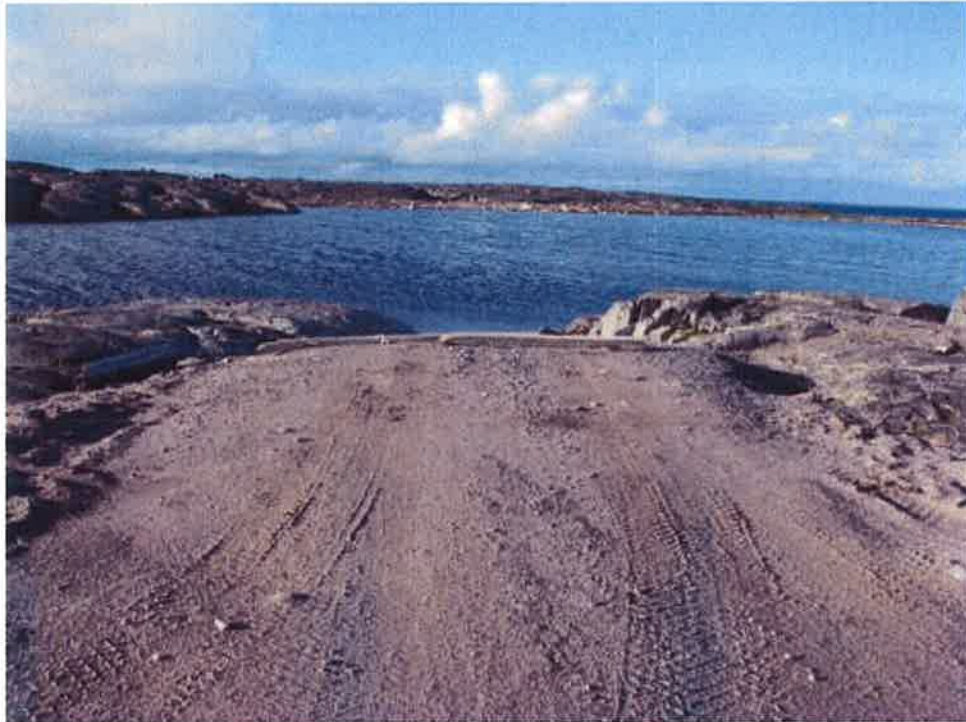
Photograph No. 1: Sewage Lagoon Inlet (East Berm)

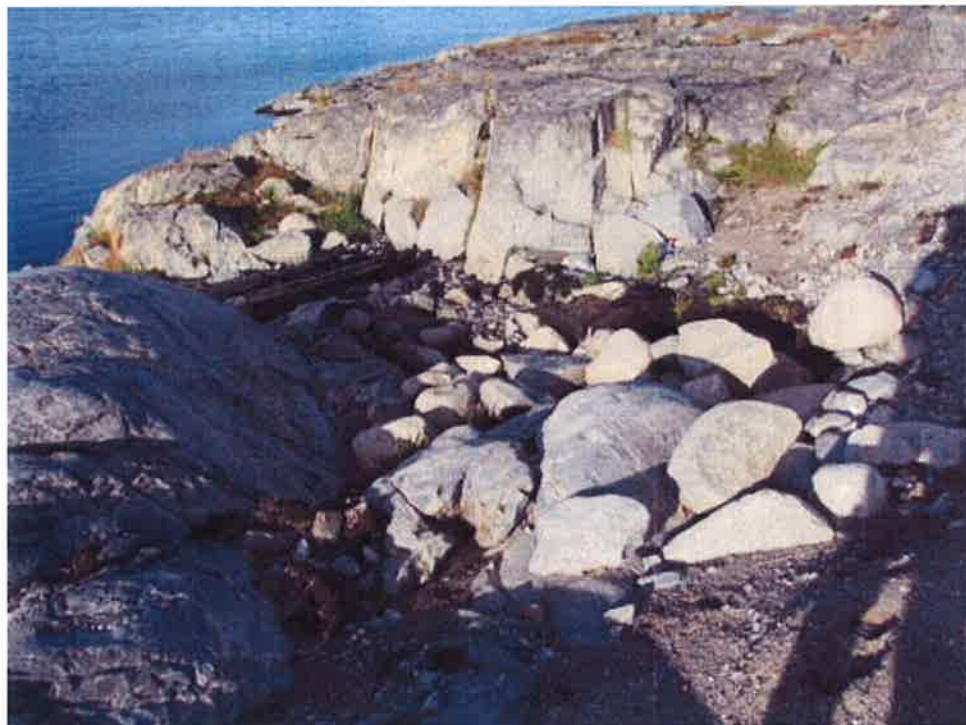
Photograph No. 2: Sewage Lagoon Inlet Channel (East Berm)

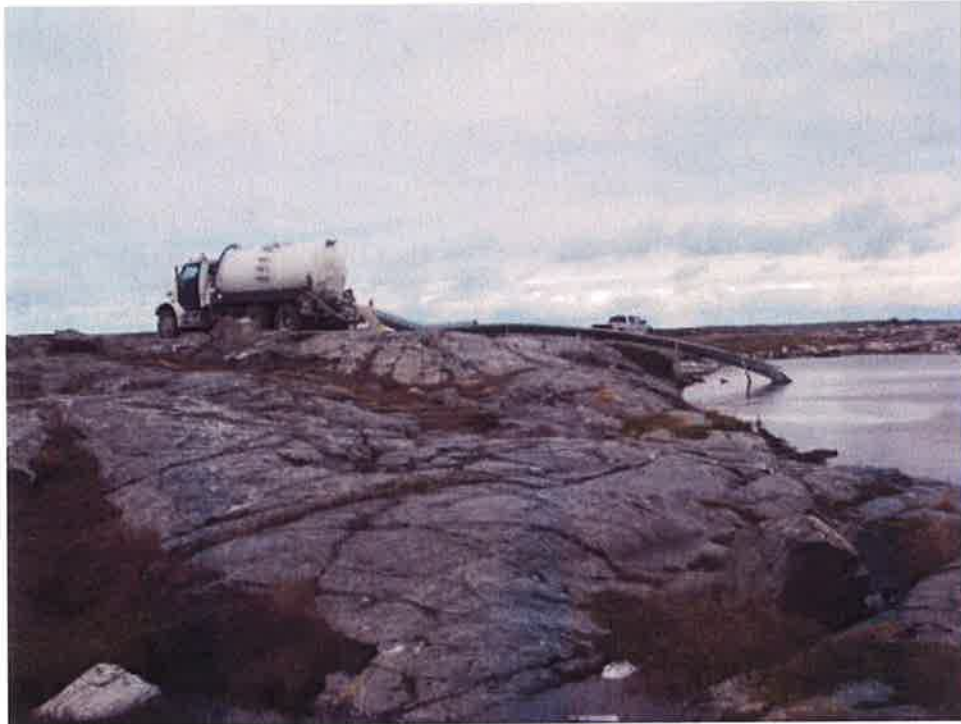
Photograph No. 3: Sewage Deposit into Sewage Lagoon

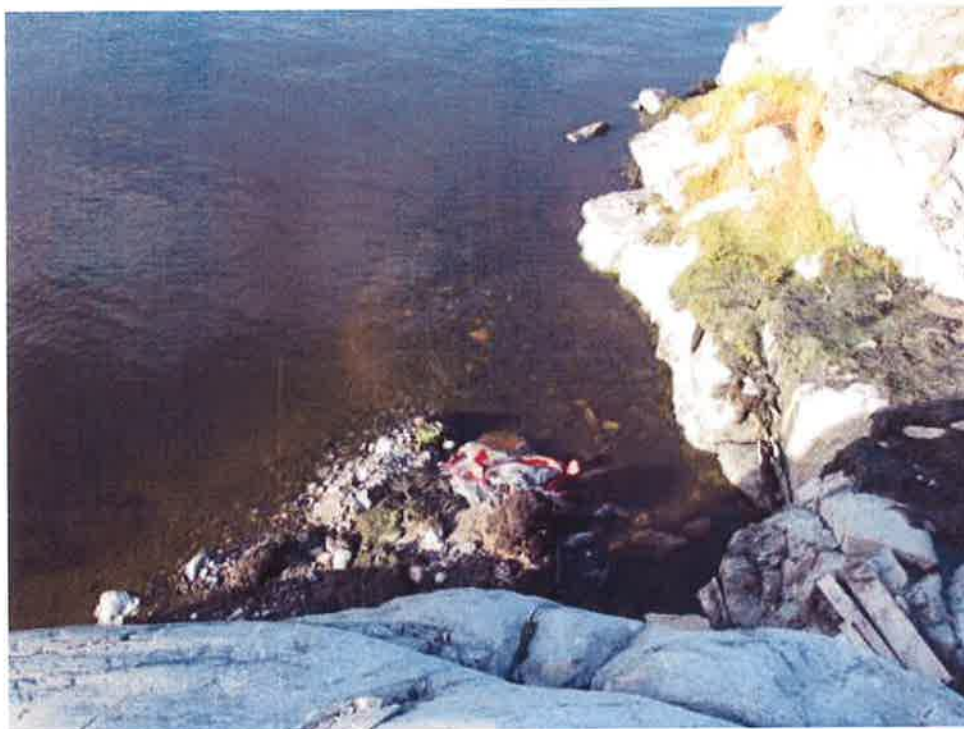
Photograph No. 4: Base of Sewage Inlet Channel (East Berm)

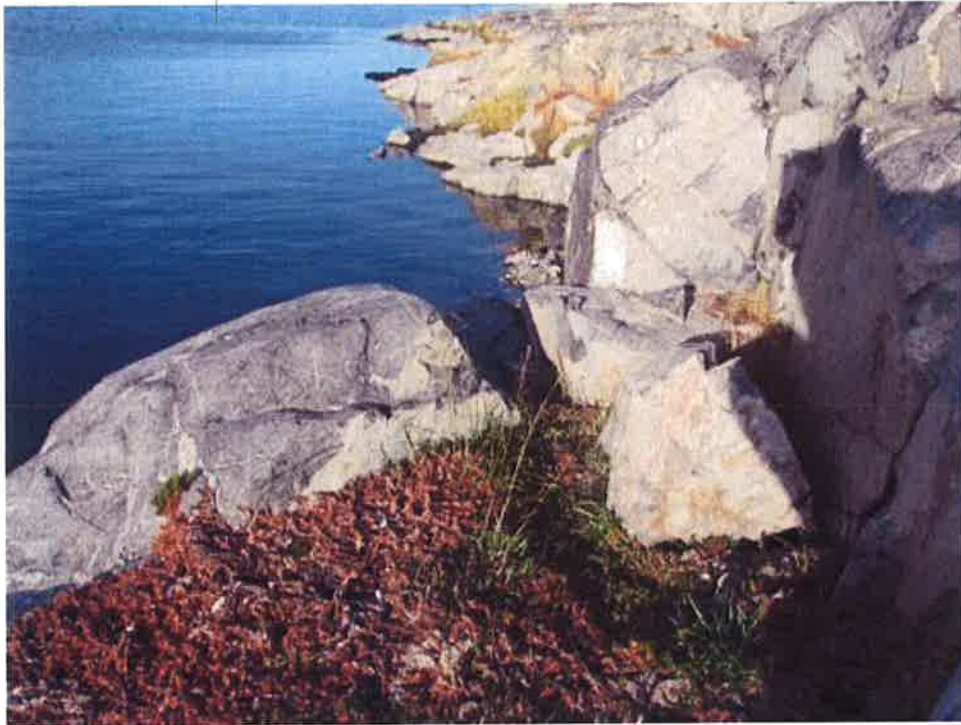
Photograph No. 5: Typical Shoreline of Sewage Lagoon

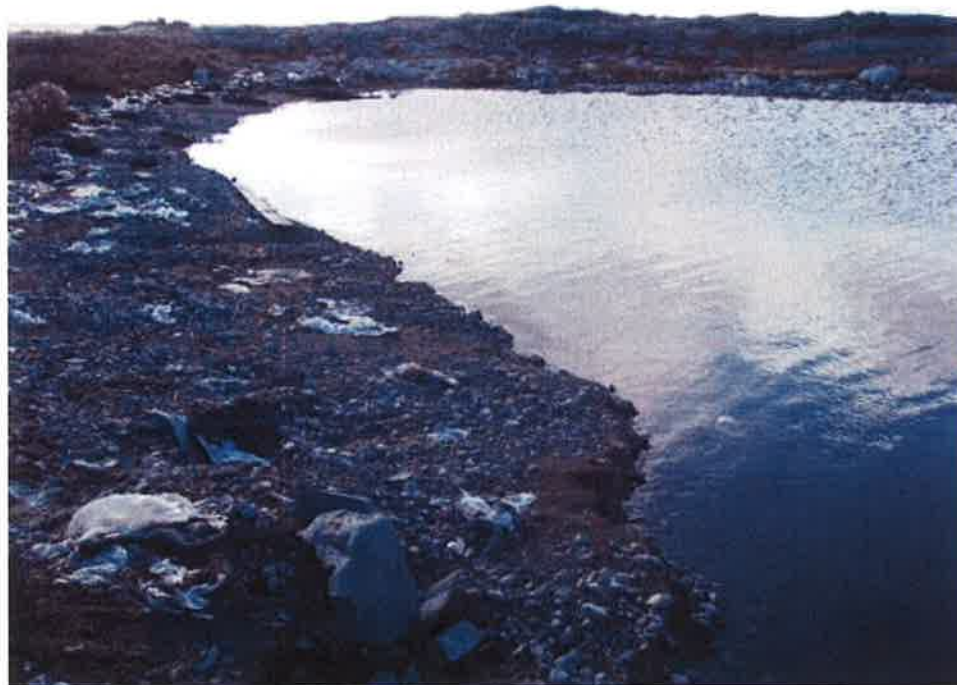
Photograph No. 8: Shoreline of Sewage Lagoon (South of Inlet)

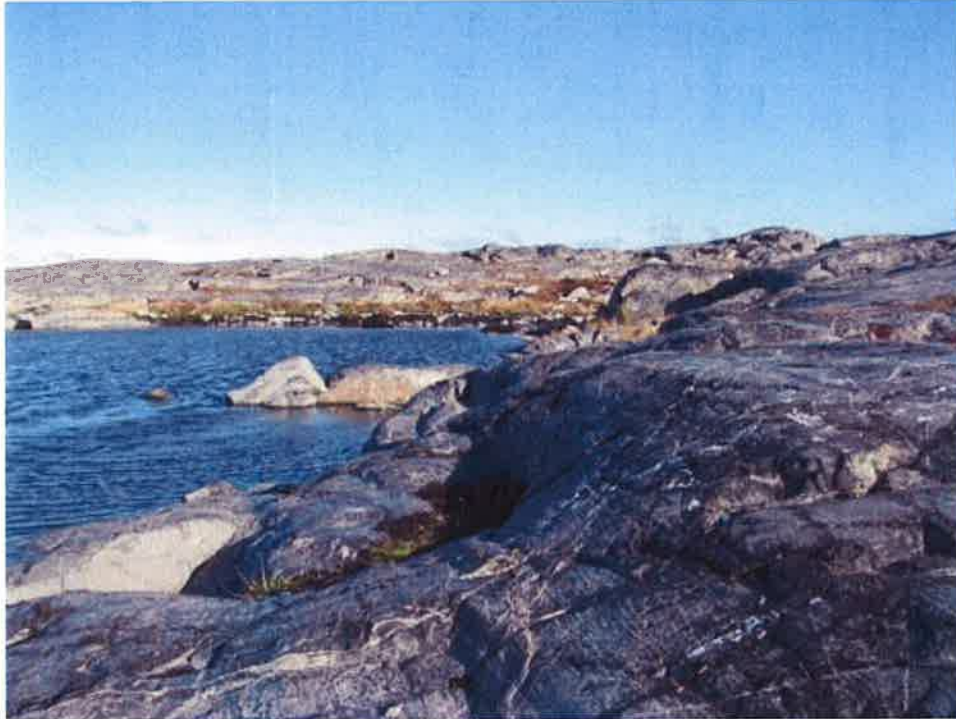
Photograph No. 11: Shoreline of Sewage Lagoon made up of Rock Outcrops with Various Patches of Low-Lying Vegetation

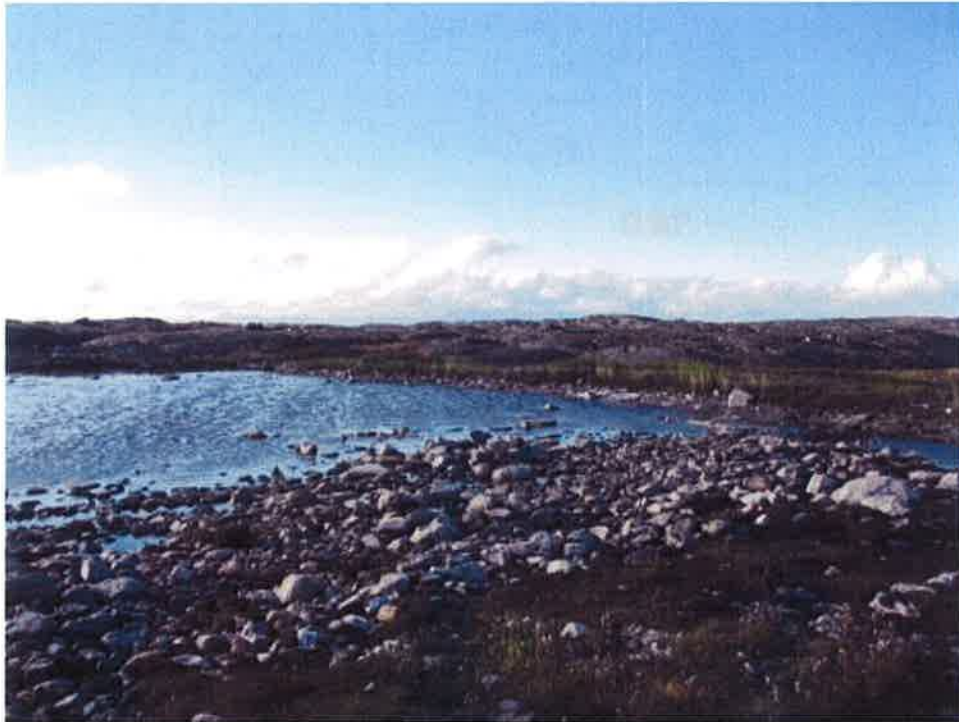
Photograph No. 13: West End of Sewage Lagoon; West Berm Visible (with Tall Grasses)

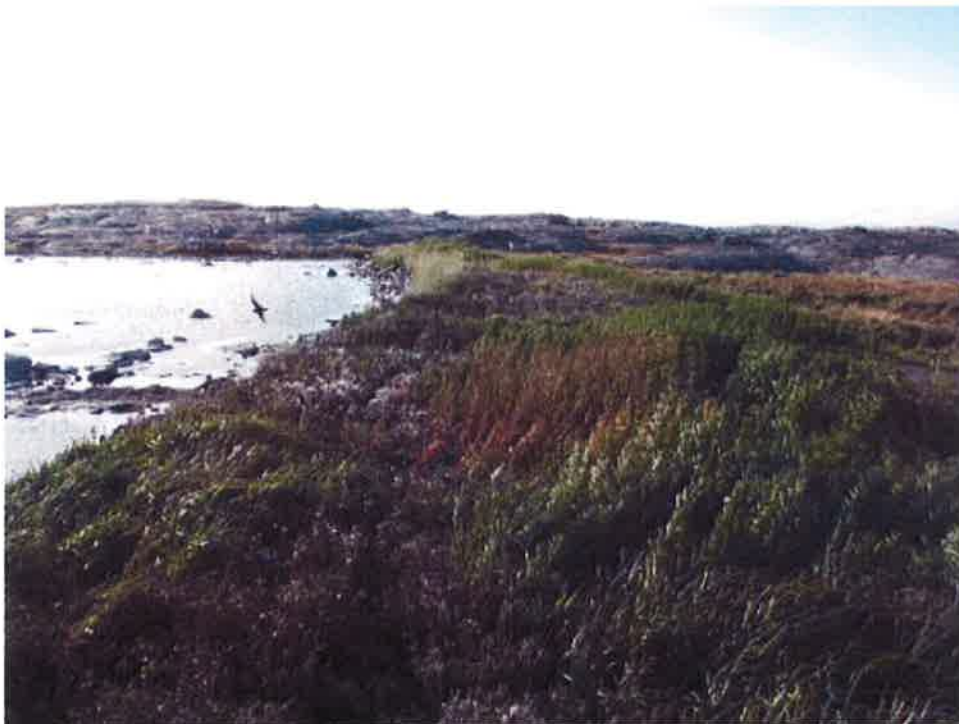
Photograph No. 14: Existing Outlet Berm (West Berm)

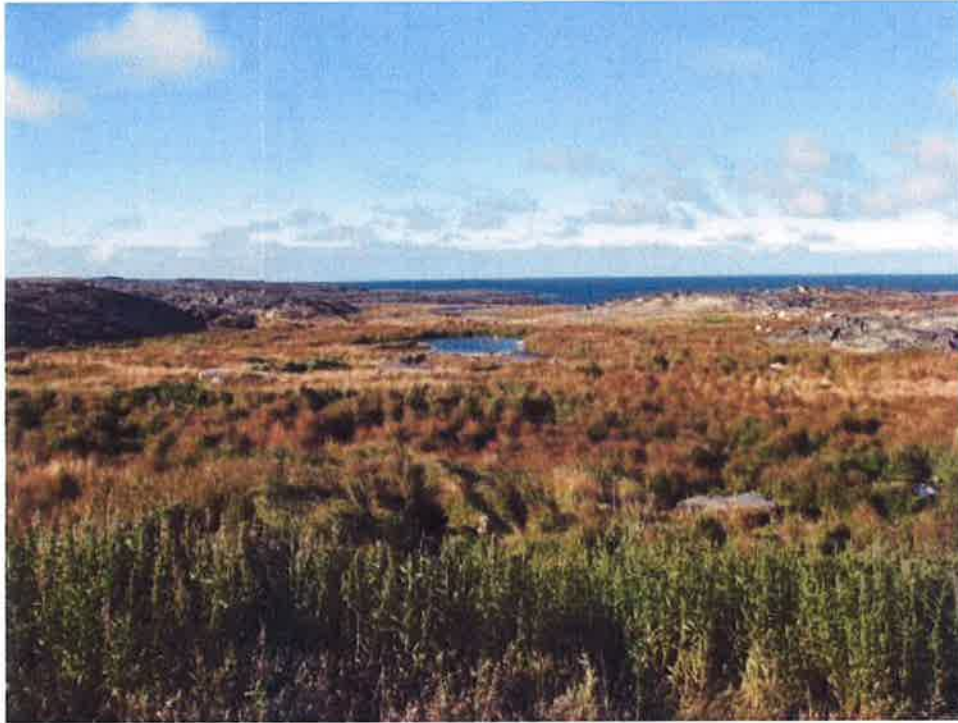
Photograph No. 15: View from the West Berm to the Downgradient Wetlands; Ocean in the Background (Looking West)

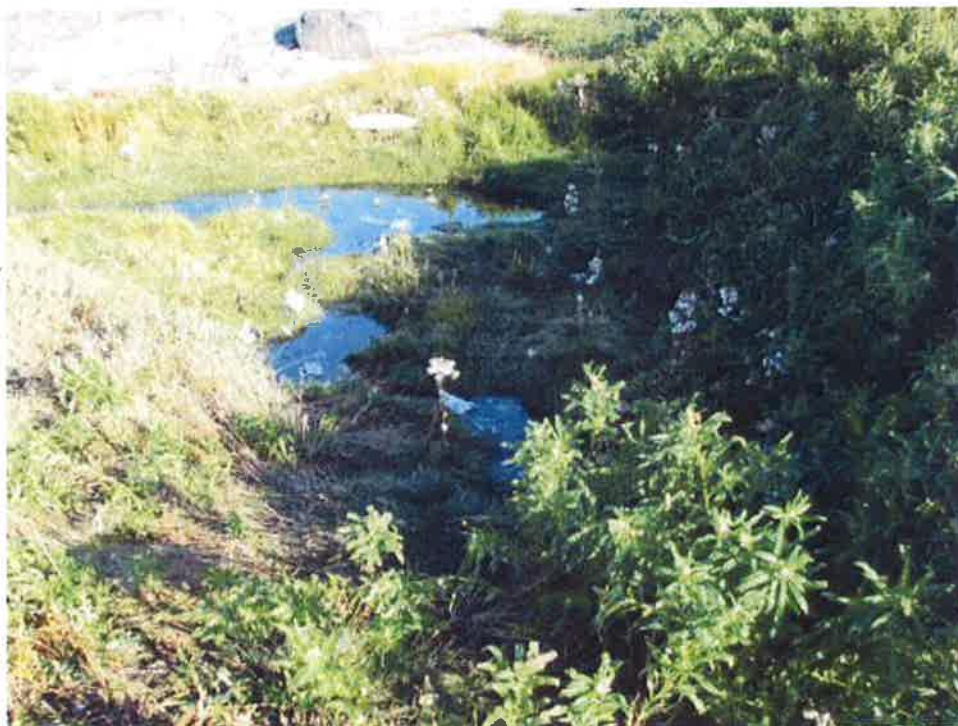
Photograph No. 16: Minor Berm Seepage (West Berm)

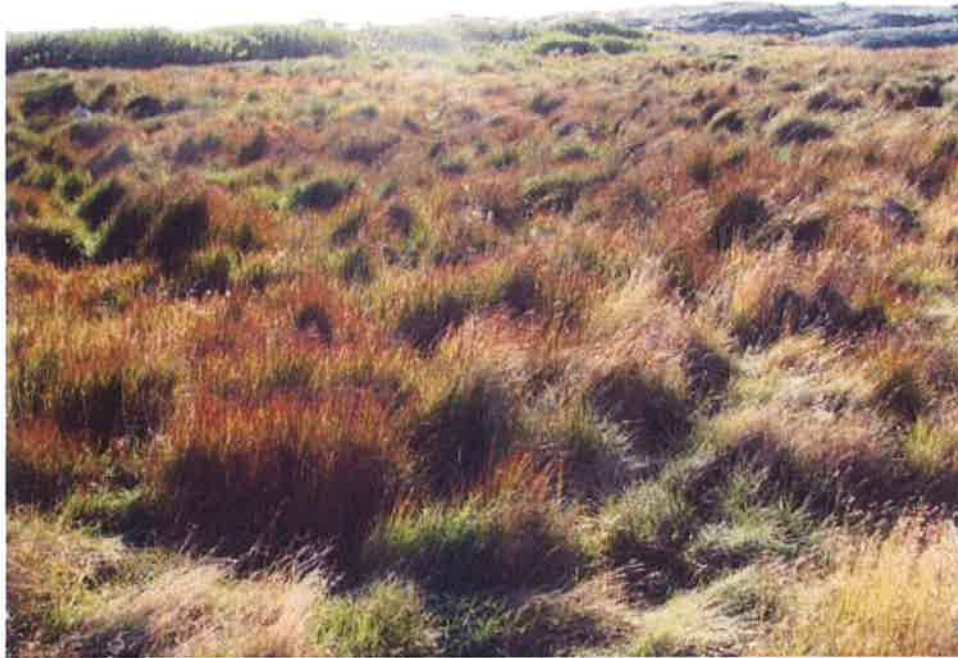
Photograph No. 17: Beginning of Wetlands (Adjacent to West Berm)

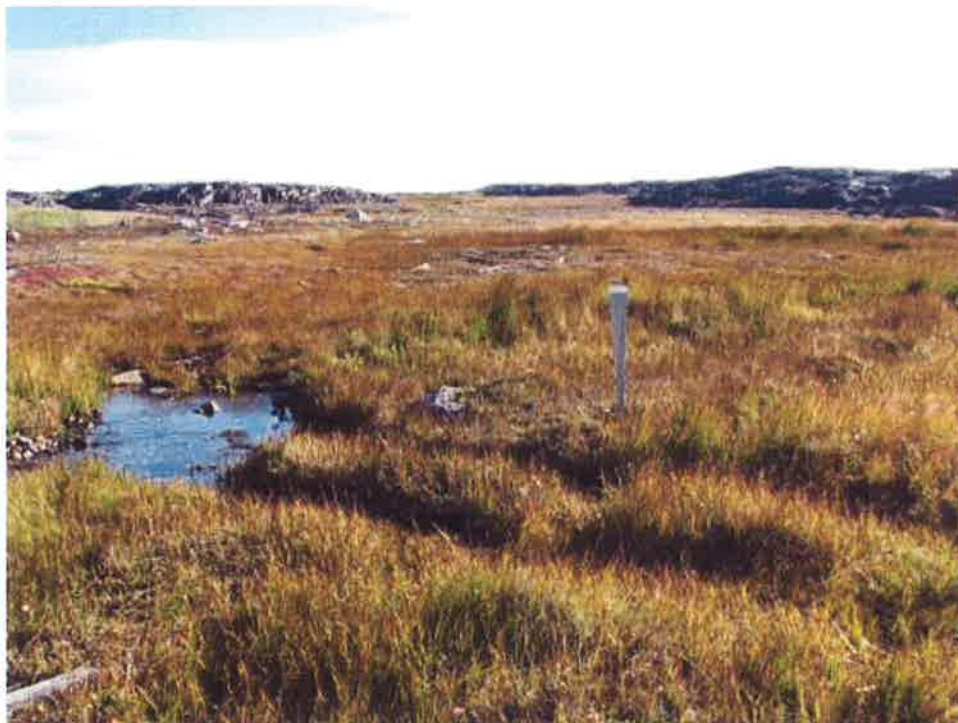
**Photograph No. 26: Downgradient Surface Water Sampling Point
(Facing East Toward Sewage Lagoon)**

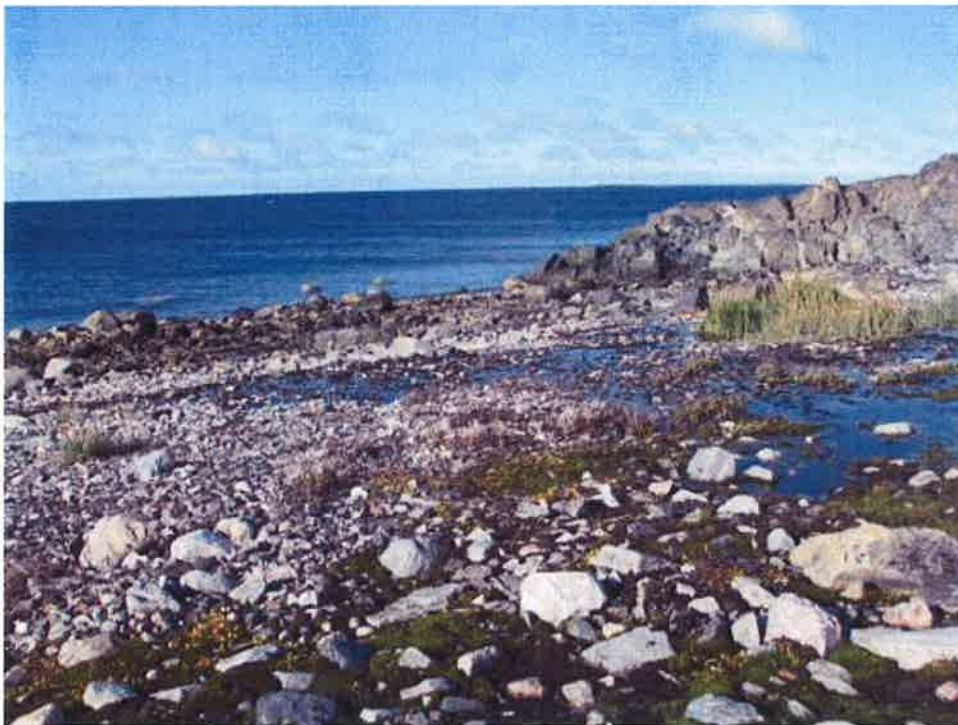
Photograph No. 28: Outlet to the Ocean
