WITHDRAWAL OF APPLICATION FOR WATER LICENCE AMENDMENT

References: A. Nunavut Water Licence 3BC-DYE0919, Type "B"
B. Application for Water Licence Amendment 3BC-DYE0919, Type "B", dated 09 Dec 2015

PROPOSED SITE WORK AT DYE-M

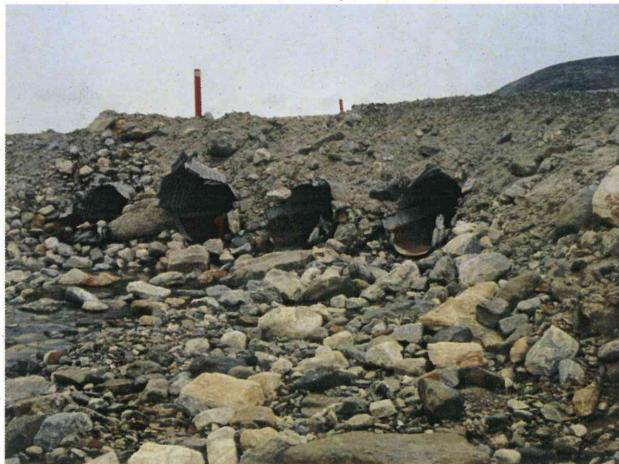
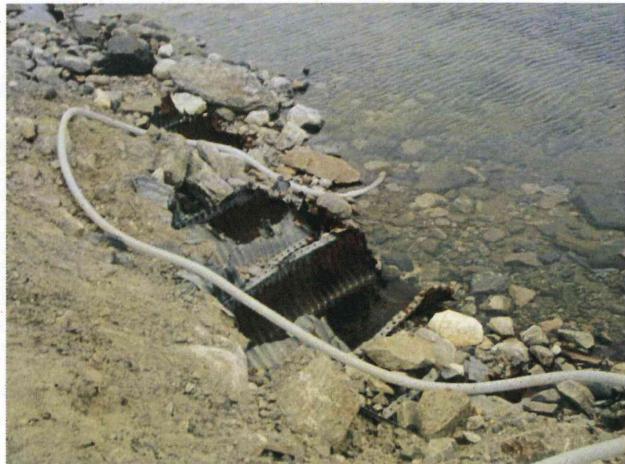
3. Over many years, several culverts have been damaged from ice dam removal operations. Furthermore, erosion at the glacier/spring melt crossing has reduced the road to one lane. Annual roadway maintenance and repair activities have not been able to address the damage to these culverts. The following photos show several of the damaged culverts at DYE-M.

4. During the summer of 2018, the NWS Office proposes to address the current drainage deficiencies by replacing damaged culverts with larger ones and by installing additional culverts. The roadway at the glacier/spring melt crossing will be restored to a two lanes. The work will be completed through our principle contractor, Raytheon Canada Ltd (RCL). Table 1 summarizes the proposed culvert sizes as determined by civil engineers at RCL.

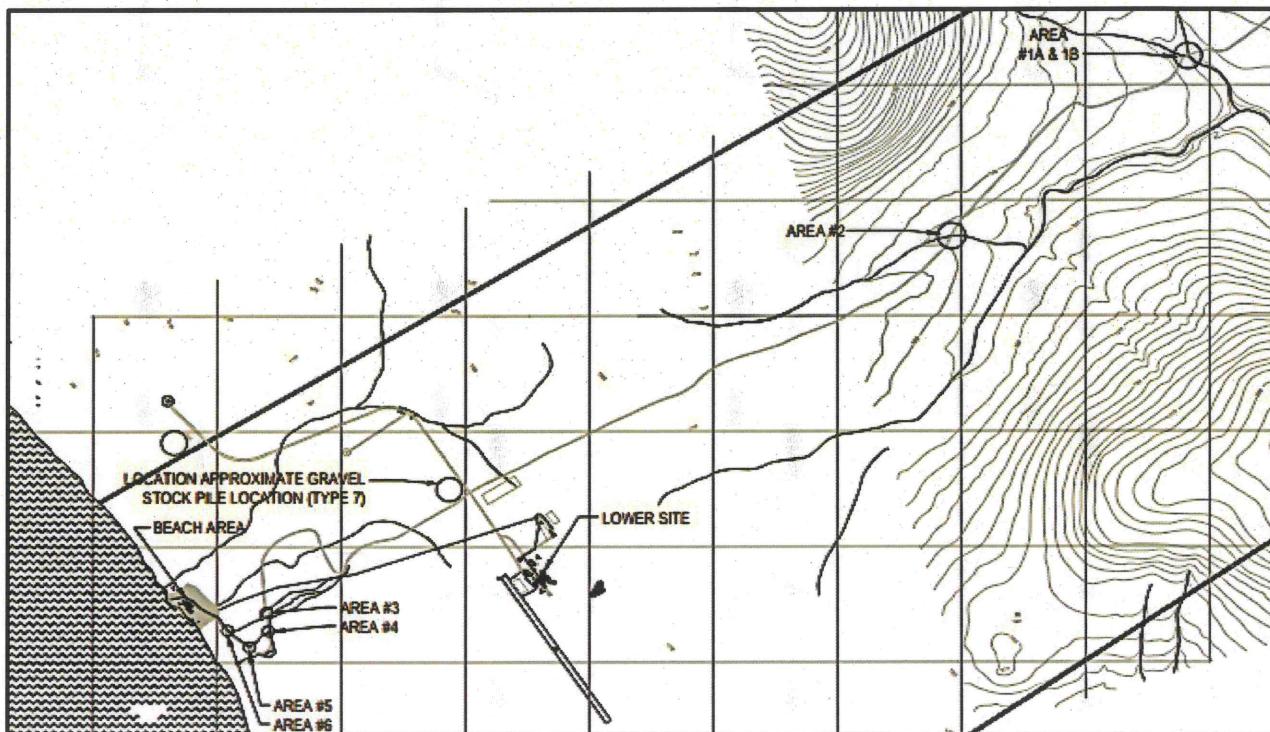
Figure 1

5. The cross-sectional area of culverts at locations 1A, 1B and 2 will be increased. New culverts will be added to locations 3, 4, 5, and 6 where the roadway has been washed out in the past due to the spring melt. Work areas are shown in Figure 1.

6. In addition to culvert work, the existing slopes and ditches along the road will be regraded to achieve proper drainage. Rip-rap and Gabion Baskets will be placed along the road embankments to stop erosion. No permanent diversion of water will occur. The water courses / runoff will be temporarily diverted during construction using a berm to re-direct the water past the work area. Check-dams and silt fencing will be installed to remove silt, sediment, and debris from the diverted water flow. Upon completion of the work, the temporary control measures will be removed in a manner that prevents the release of sediment or debris into nearby watercourses. More specifically, the area enclosed by check-dams will be cleaned of debris. Accumulated sediment will be removed prior to the removal of the silt fencing. No new roads will be created as part of this work.
