Re: New Application Acknowledgement for the Eureka Project

Implementation Schedule for Characterization of Contaminated Sites Final Report 2007/2008

Fort Eureka Sites

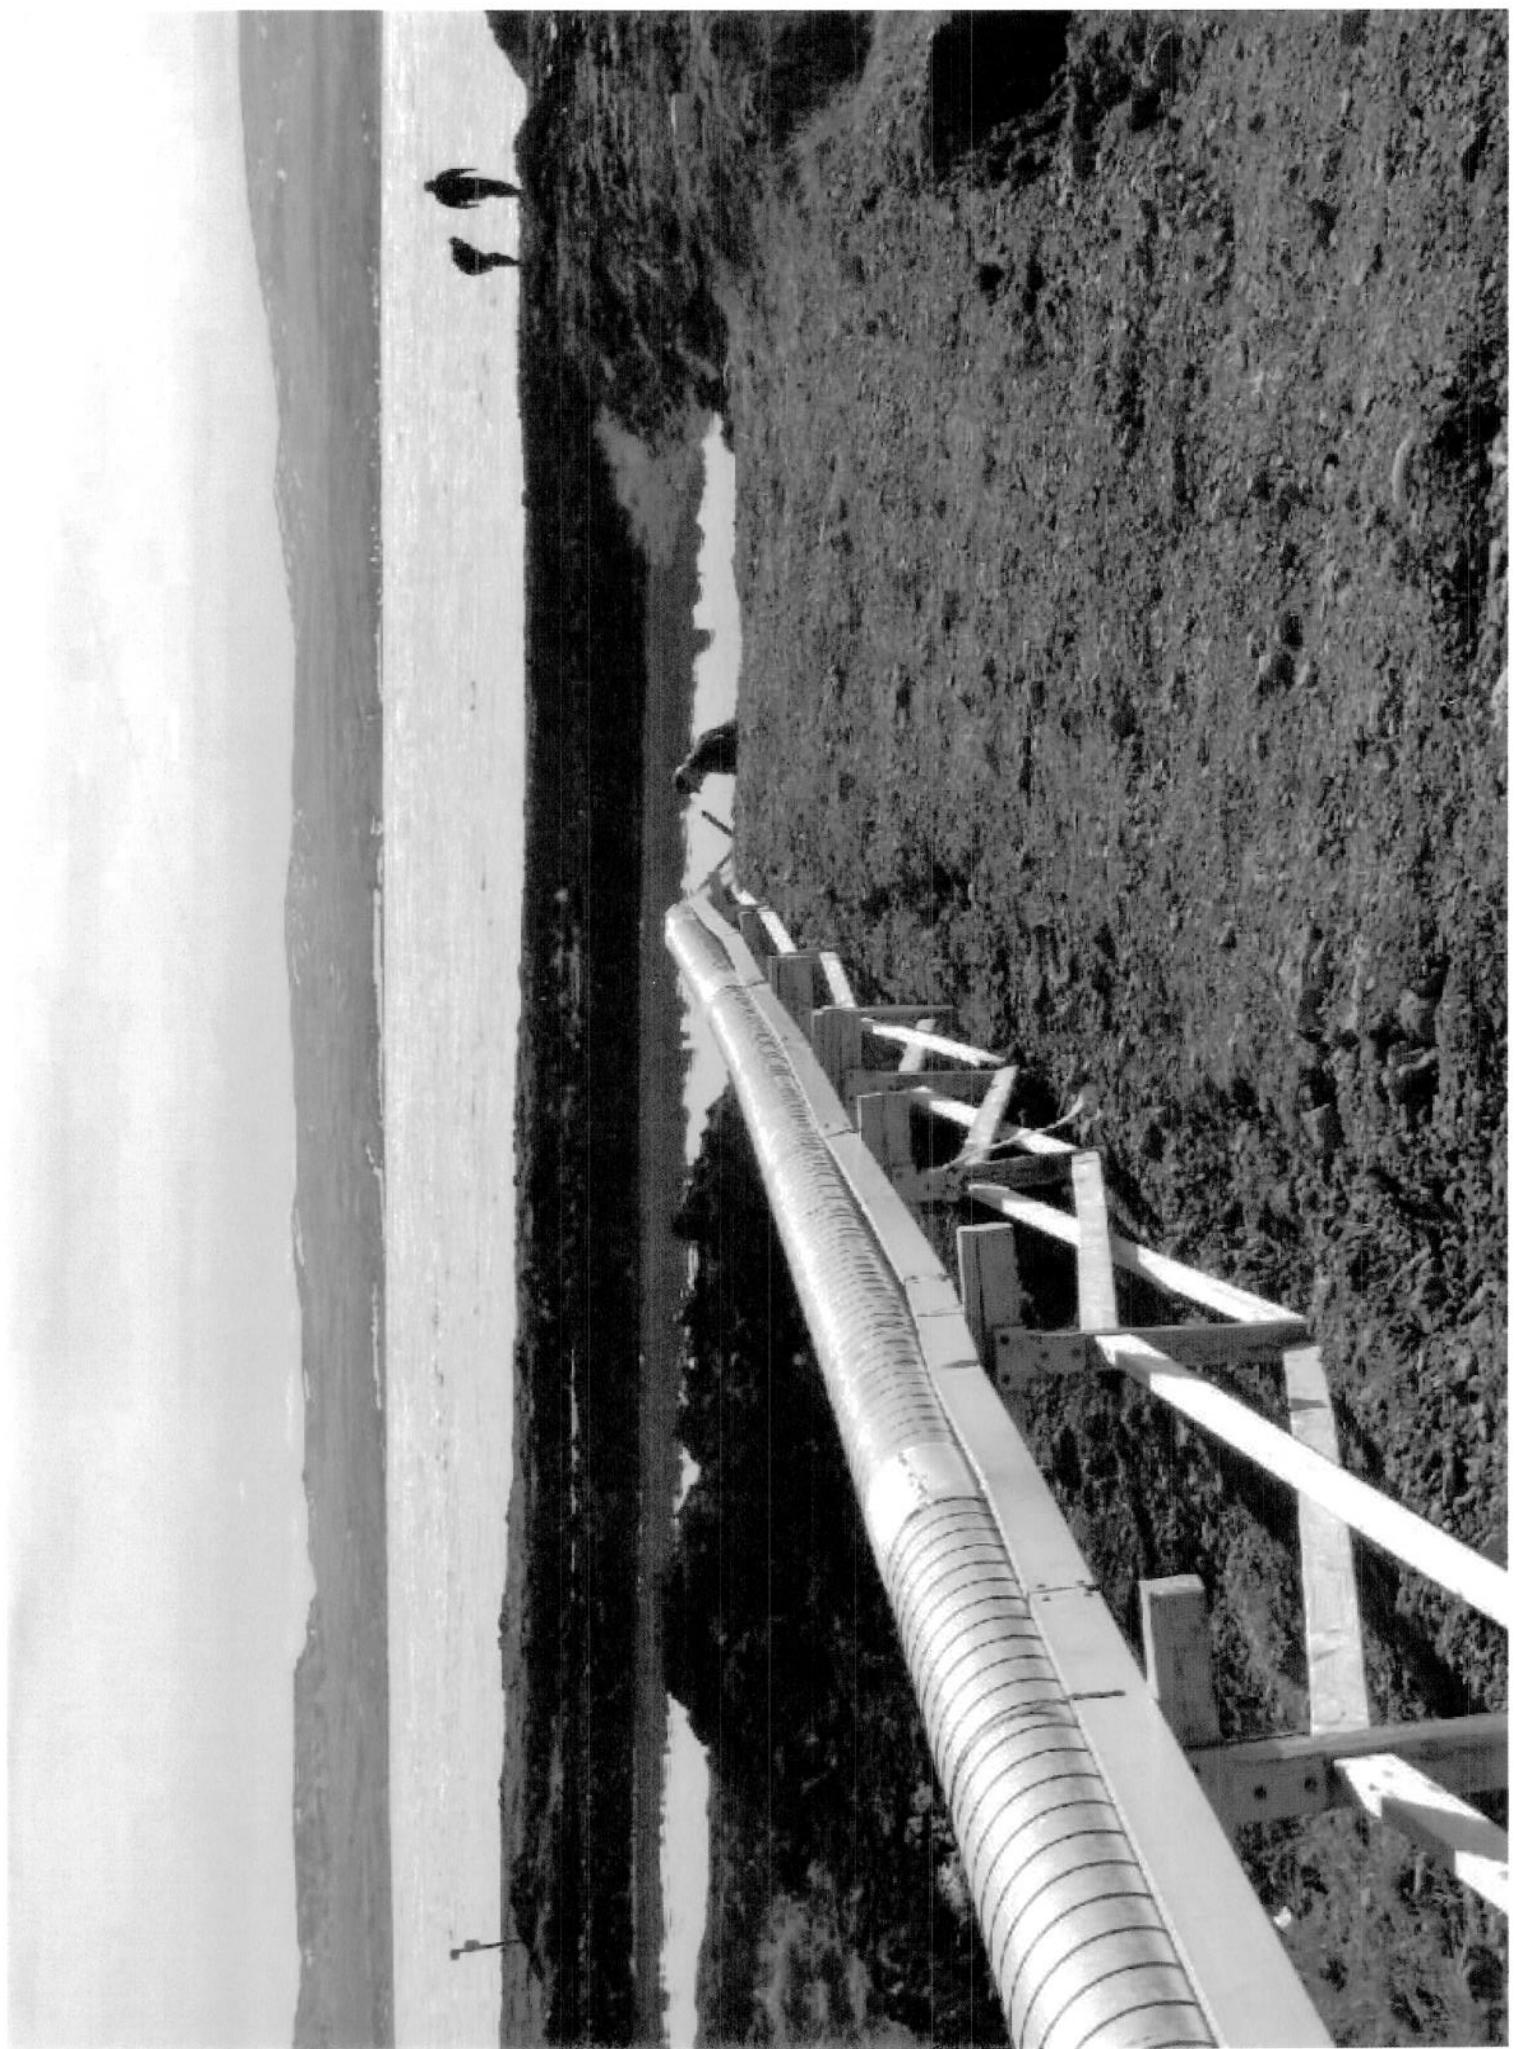
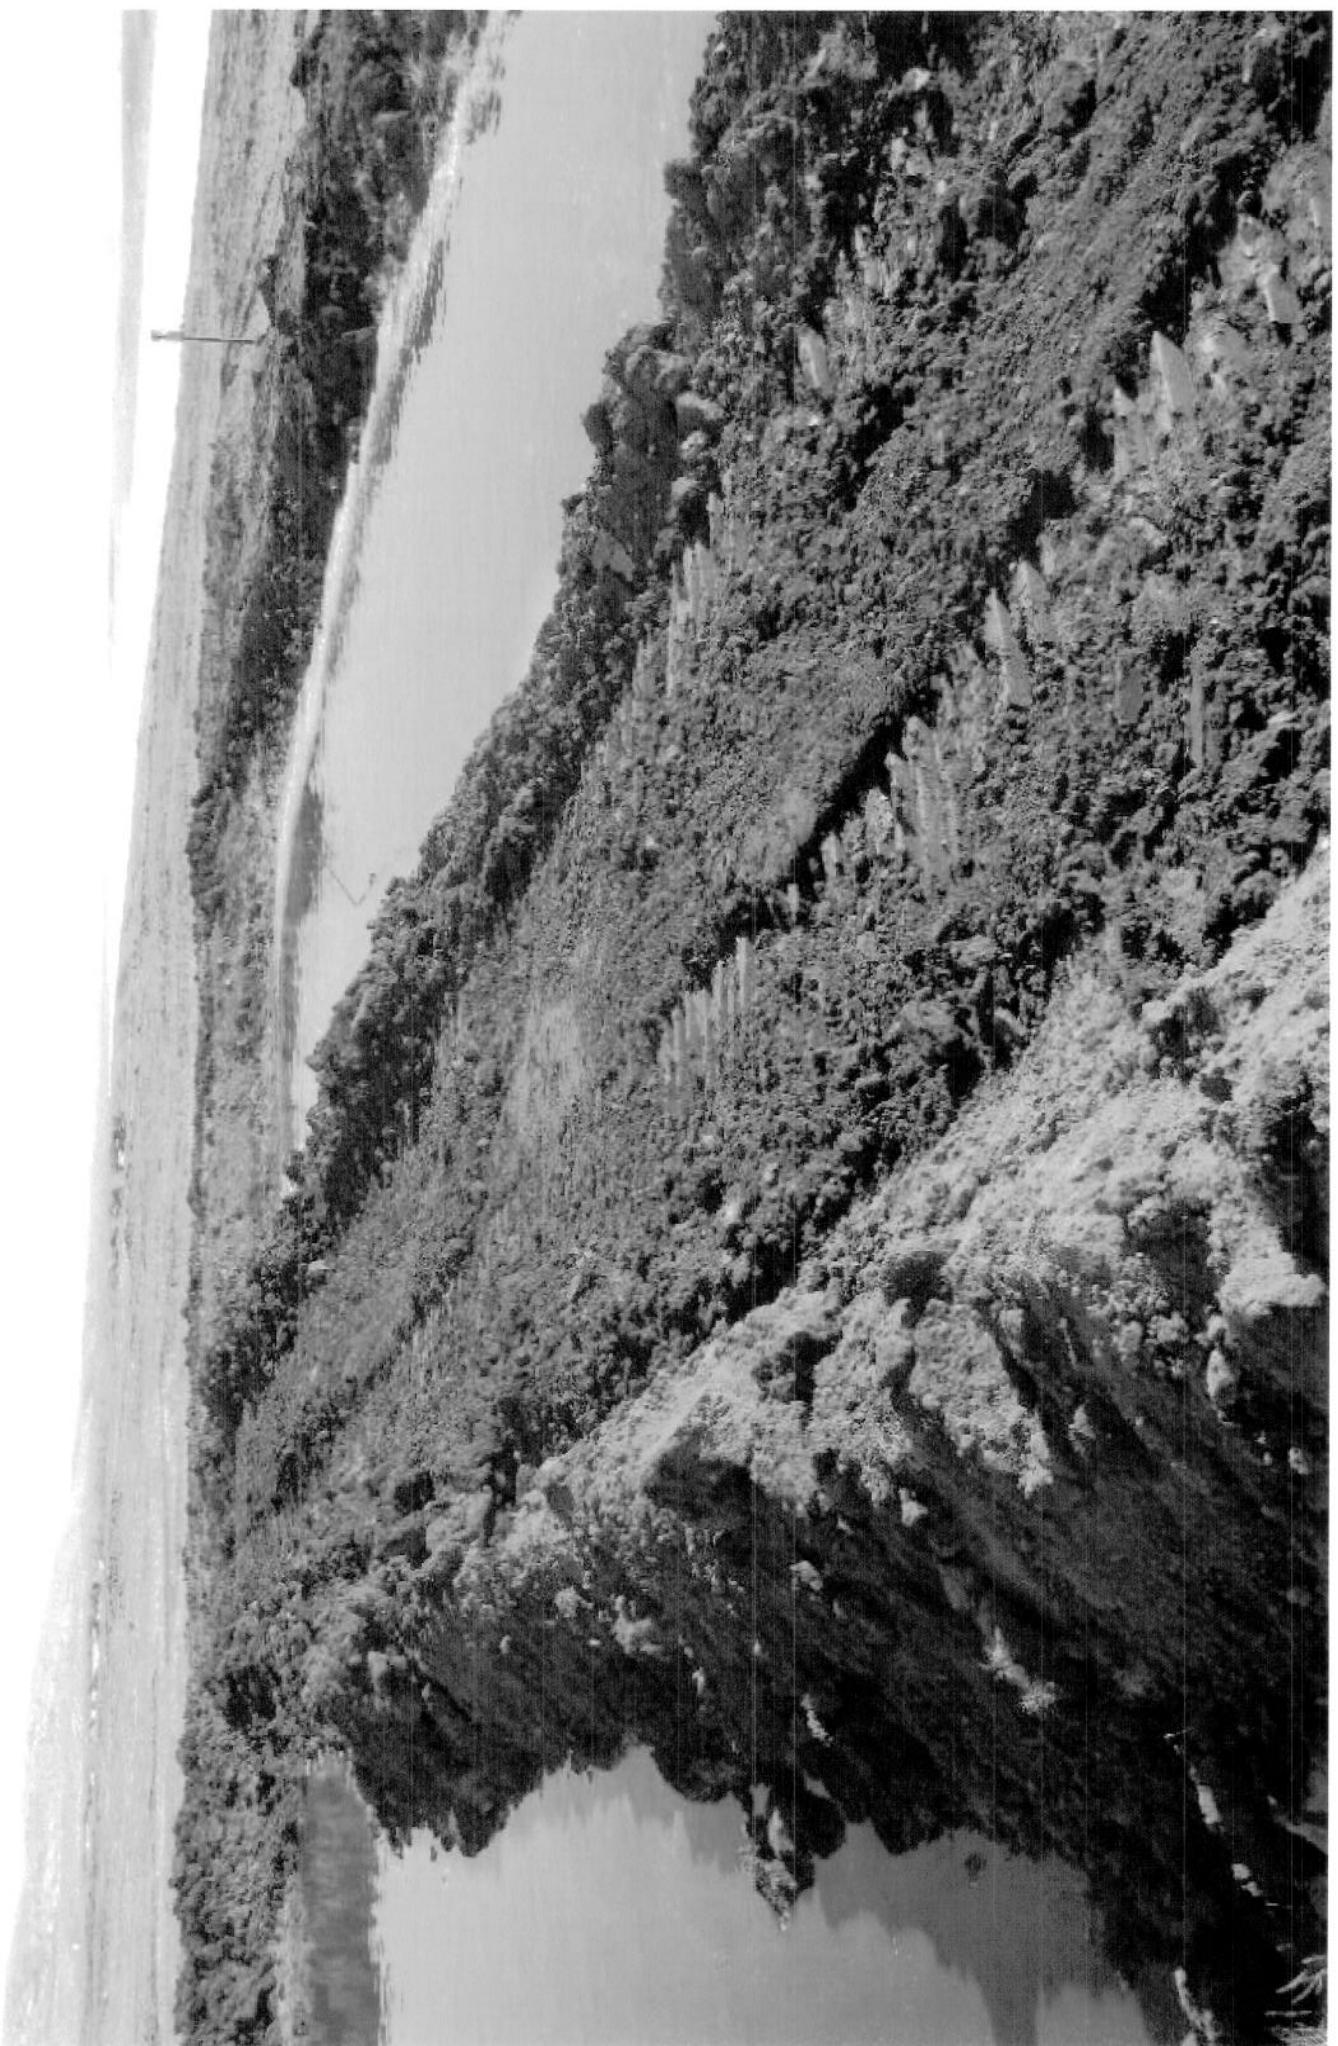
Water from the Sewage Lagoon was found to have concentrations of copper, lead, selenium and zinc above criteria (2180, 9, 5 and 320 mg/kg, respectively). When discharge criteria were

examined, chromium (20mg/L) and copper (2180 mg/L) exceed the guidelines (10 and 200 mg/L, respectively). A total of 9 soil samples were collected from around the lagoon. Three samples were slightly above guideline for arsenic (13.4, 14.8 and 12.5 mg/kg) and 1 sample was above criteria for copper (99 mg/kg). All other samples were below criteria for all measured parameters. Three sediment samples taken from within the lagoon were above guidelines for arsenic (16.2 and 6.1 mg/kg) and copper (121 mg/kg).

Please find following, photos of the sewage lagoon located to the south of the main quarters at Fort Eureka. DND does not have any "design drawings" on hand for said lagoon. However, following is the description of the work conducted forwarded by the military construction supervisor:

The outside perimeter walls of the lagoon were raised, widened, and reinforced using the clay and soil around the perimeter. The middle wall between the two lagoons was rebuilt and we installed an "L shape" 4" pvc pipe between the two lagoons so that when it reaches a certain level in the main lagoon, it will flow down to the secondary i.e. smaller lagoon. We also installed an overflow pipe should the secondary lagoon becomes full.

The improvements indicated above were made to facilitate improved settling within the lagoon and to allow transfer of liquids from the first cell to the second cell of the lagoon. Once the lagoon fills, removal of liquid from the second cell will be conducted via pump and any effluent will be allowed to flow overland toward Slidre Fiord.

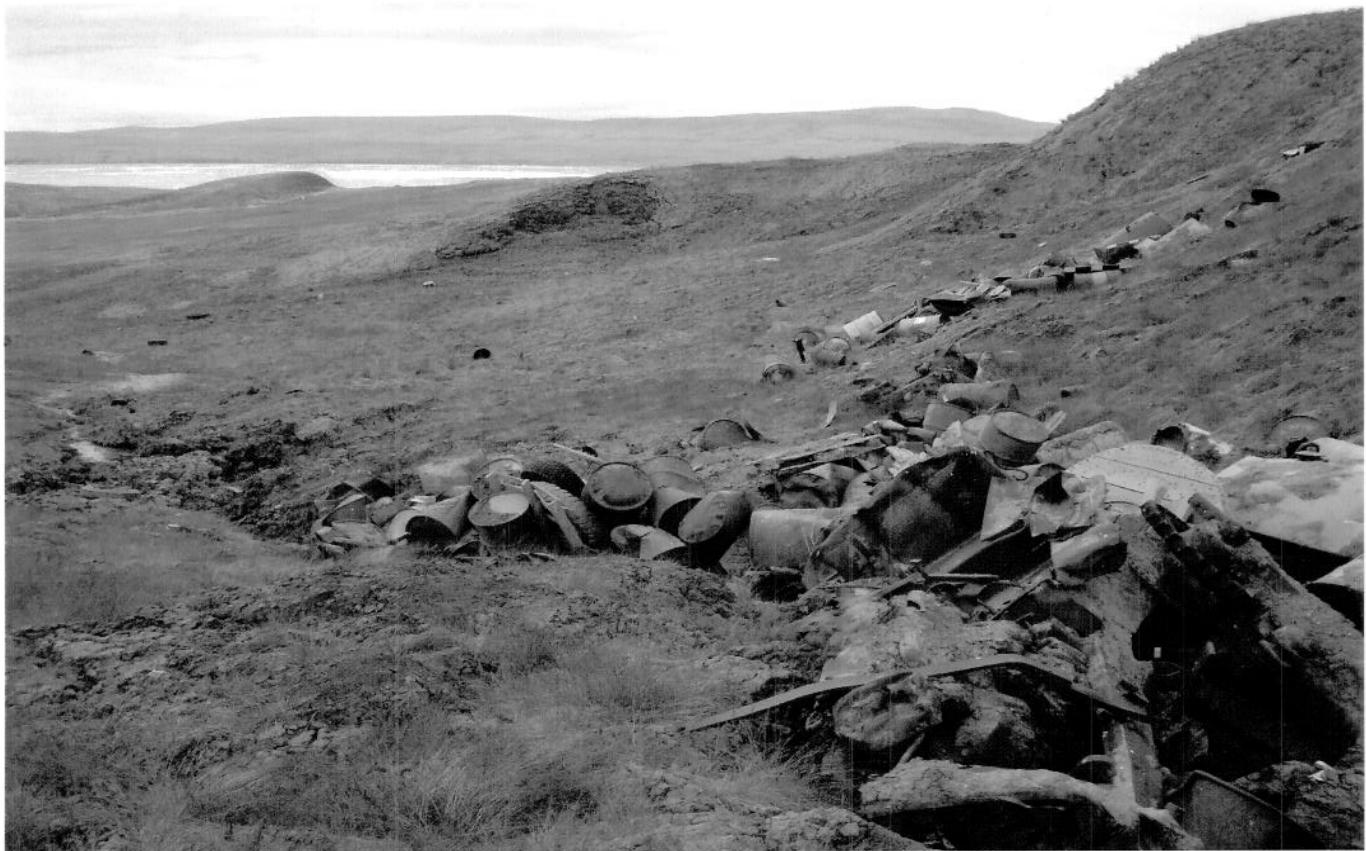
Photograph 3. (East Airstrip Landfill, S-10186). Refuse in the active landfill.

The landfill is active and as such cannot be closed. The areas immediately adjacent to and downgradient from the landfill should be regularly sampled (eg. every 2 years) to verify that leachable material is not migrating from the landfill. In particular, the drainage channels originating from the landfill and adjacent areas should be sampled regularly.

Response: Sampling and analytical testing of the drainage from the landfill will be conducted as recommended (on a bi-annual basis). It should be noted that the landfill is co-located with the landfill used by Environment Canada.

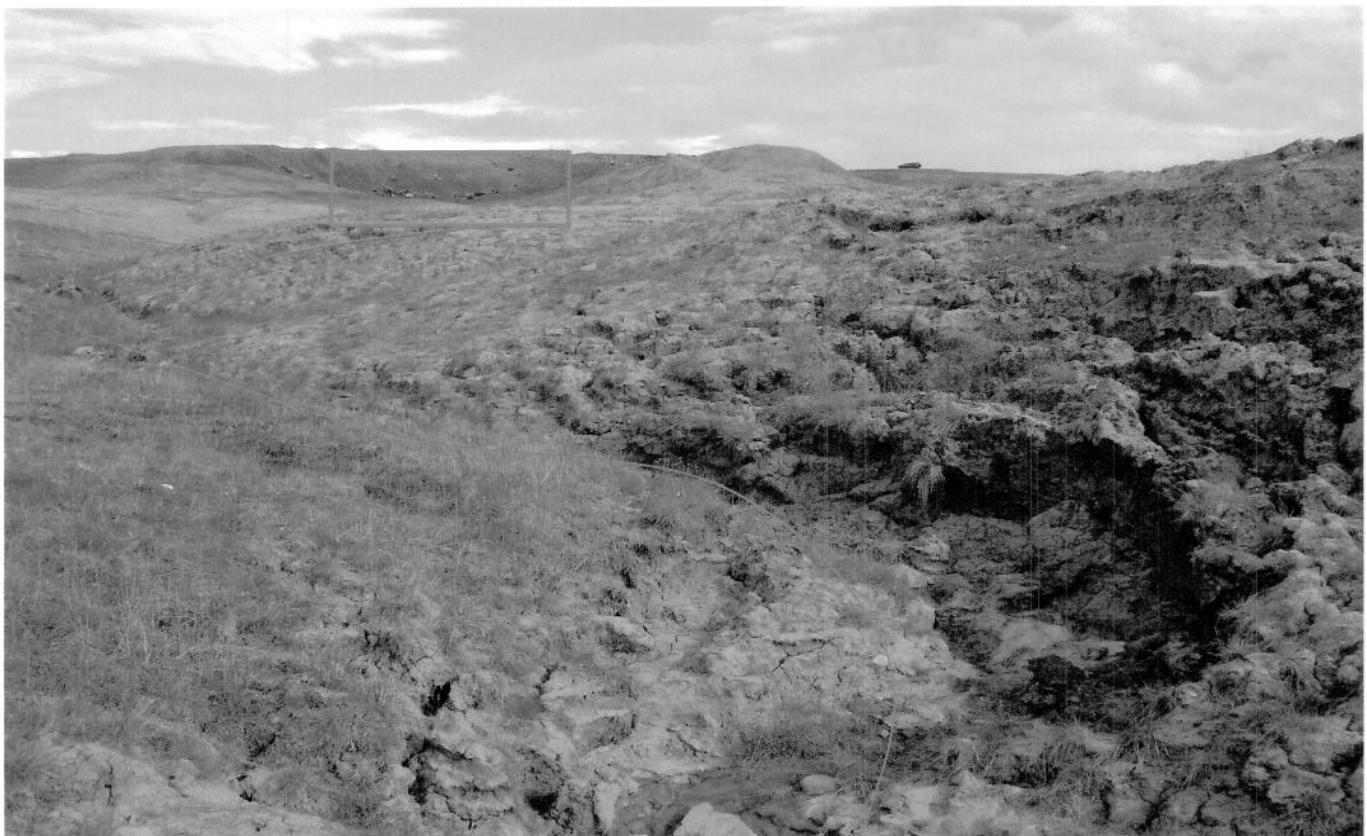
Photograph 4. (East Airstrip Landfill, S-10186) View of the drainage channel leading from the landfill to Slidre Fiord.
