2021 ANNUAL NUNAVUT WATER BOARD REPORT FOR CAM-3 FOR THE North Warning System

Document Number
NWB-C3-2021, Rev 2, 22-Mar-2022

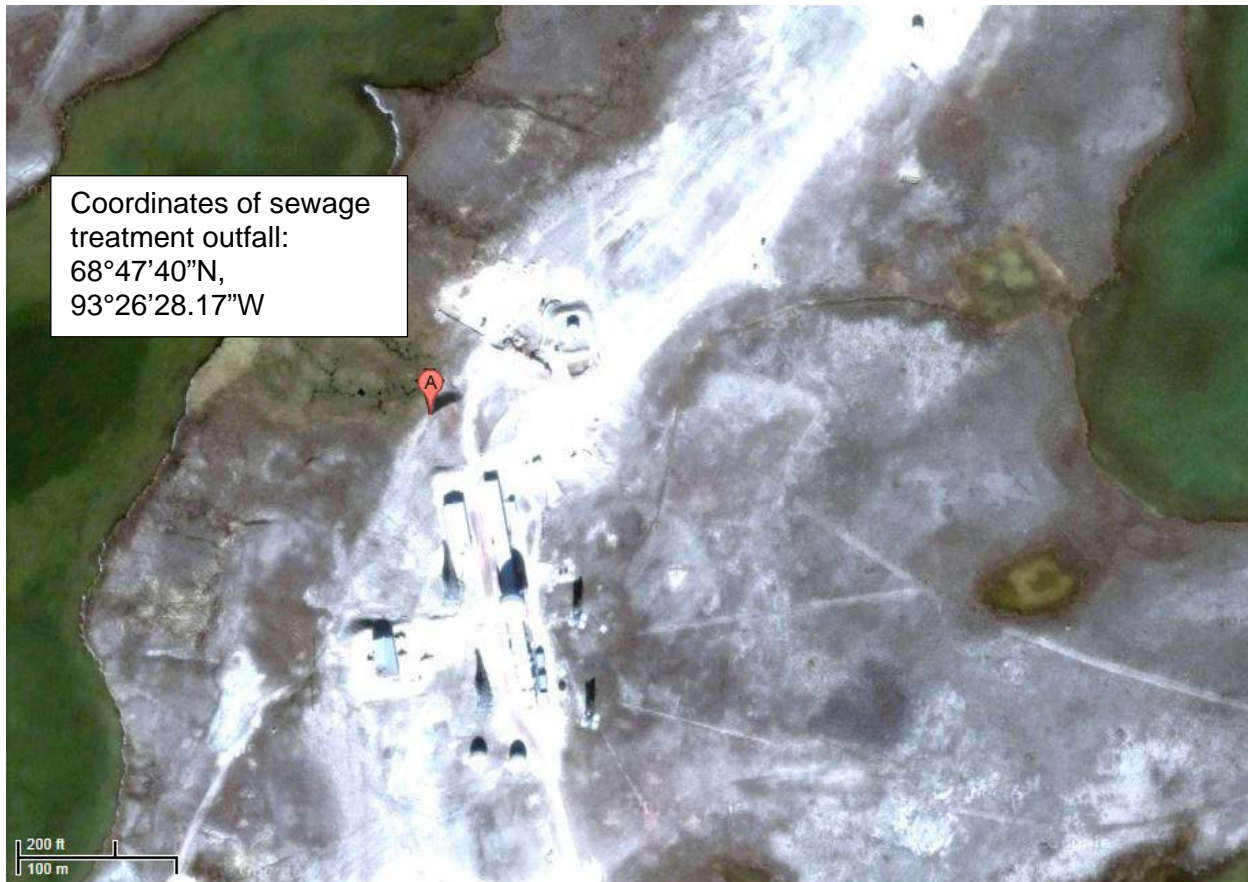
**Figure B-1: Coordinates of sewage outfall: 68°47'40"N, 93°26'28.17"W**

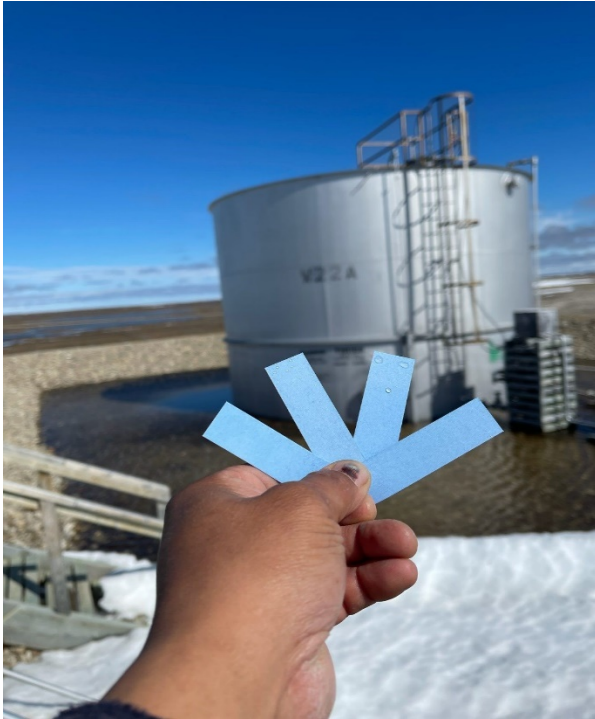
Photo E 1: Hydrocarbon test strips used in berm of tank W22A (12-Jul-2021)

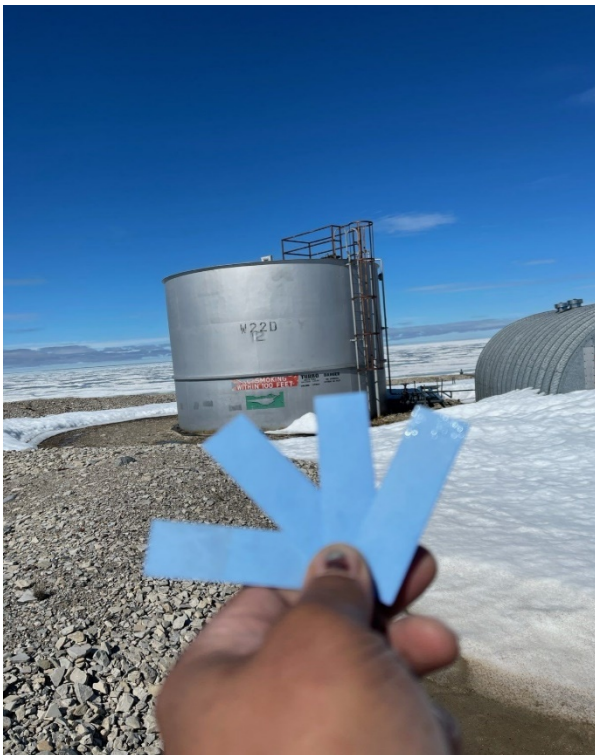
Photo E 2: Hydrocarbon test strips used in berm of tank W22D (12-Jul-2021)
