06 September 2019

RE: 8BC-SHE1929, Culvert Replacement CAM-3

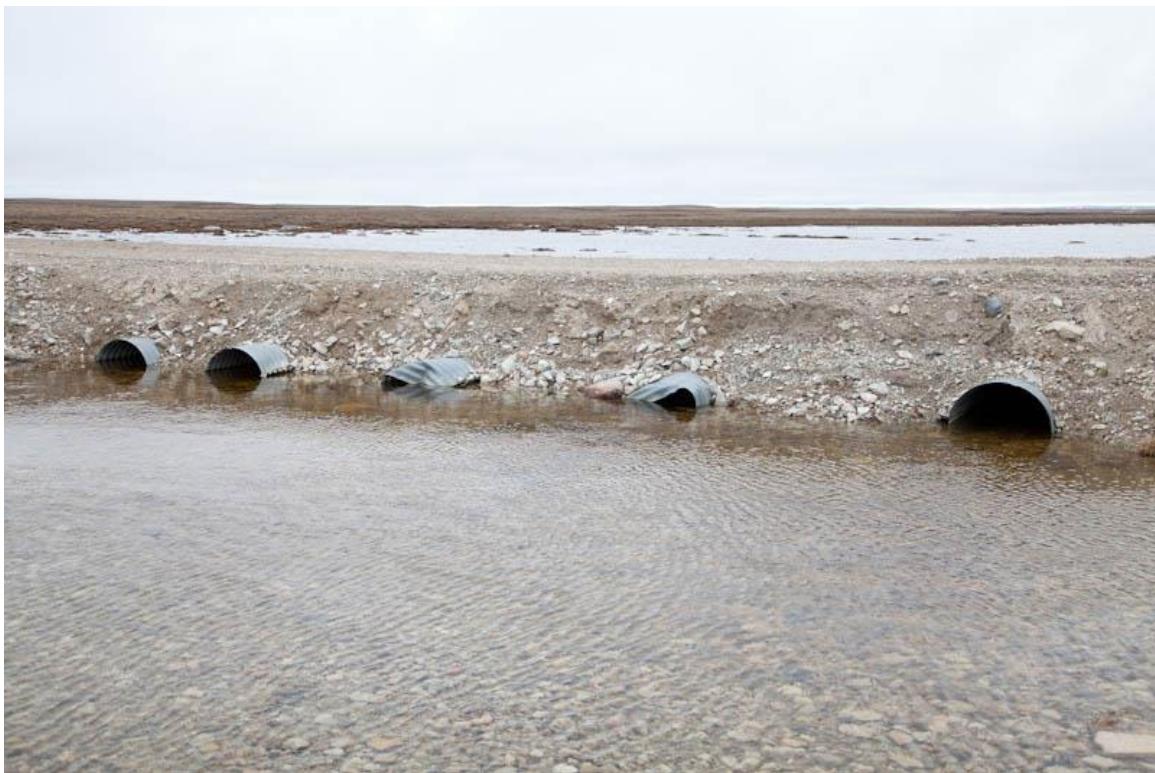
Figure 4: "Area #2" on Figure 1

The main access road at CAM-3 extends from the beach landing area to the summit site and continues to the airstrip and water lake. Over many years, some of the culverts in this road have been damaged (Figure 4) other culverts were made of drums laid end-to-end which have started to separate (Figure 5).

RCL and NWSO would like approval for a project that will include in-water work to replace culverts in four areas at CAM-3.

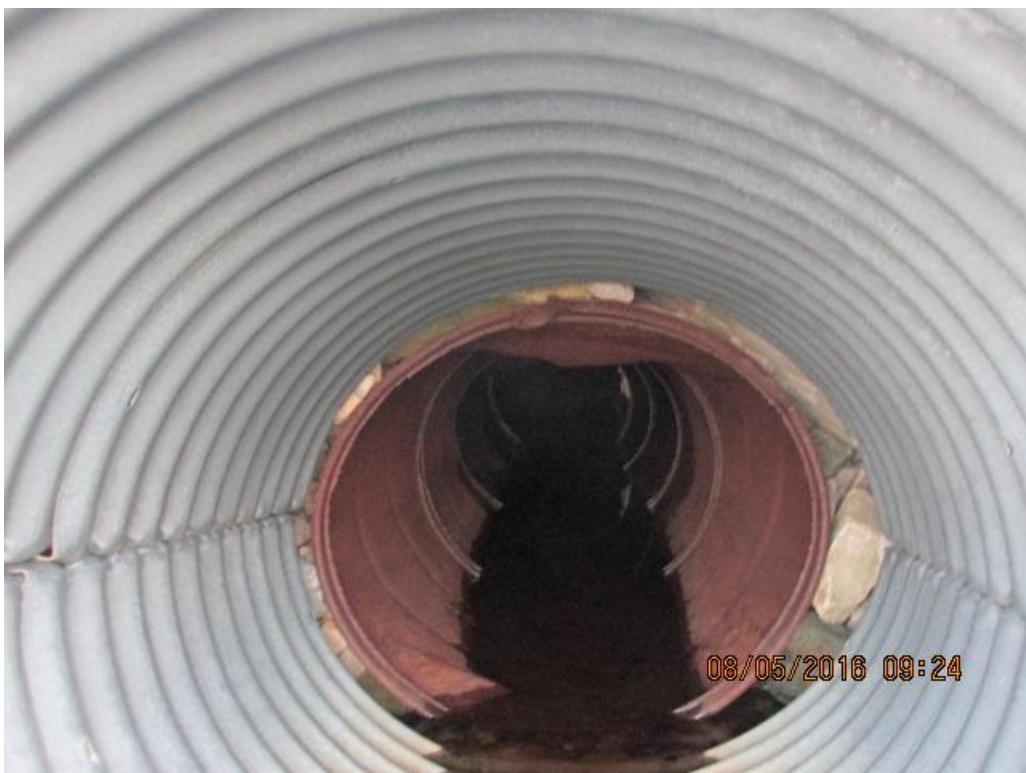
Figure 5: Example on condition of culvert to be replaced in "Area #2"
