Golder Associates Ltd.

**AIR PHOTO INTERPRETATION, SITE
RECONNAISSANCE, MAPPING, AND SAMPLING:
TEHEK LAKE ACCESS ROAD,
MEADOWBANK GOLD PROJECT
NUNAVUT**

September 13, 2005

05-1413-021/2000

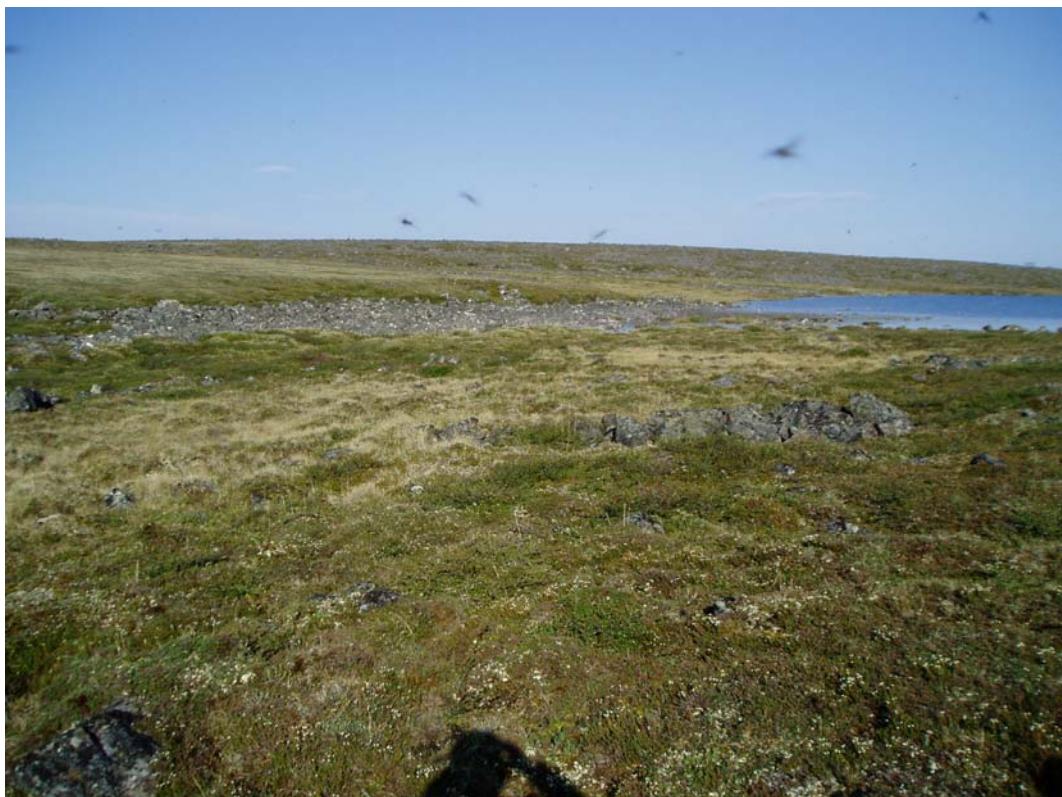
Photo 1: Example of type 0 terrain in an area of volcaniclastic bedrock at crossing R24 south of kilometre 105.

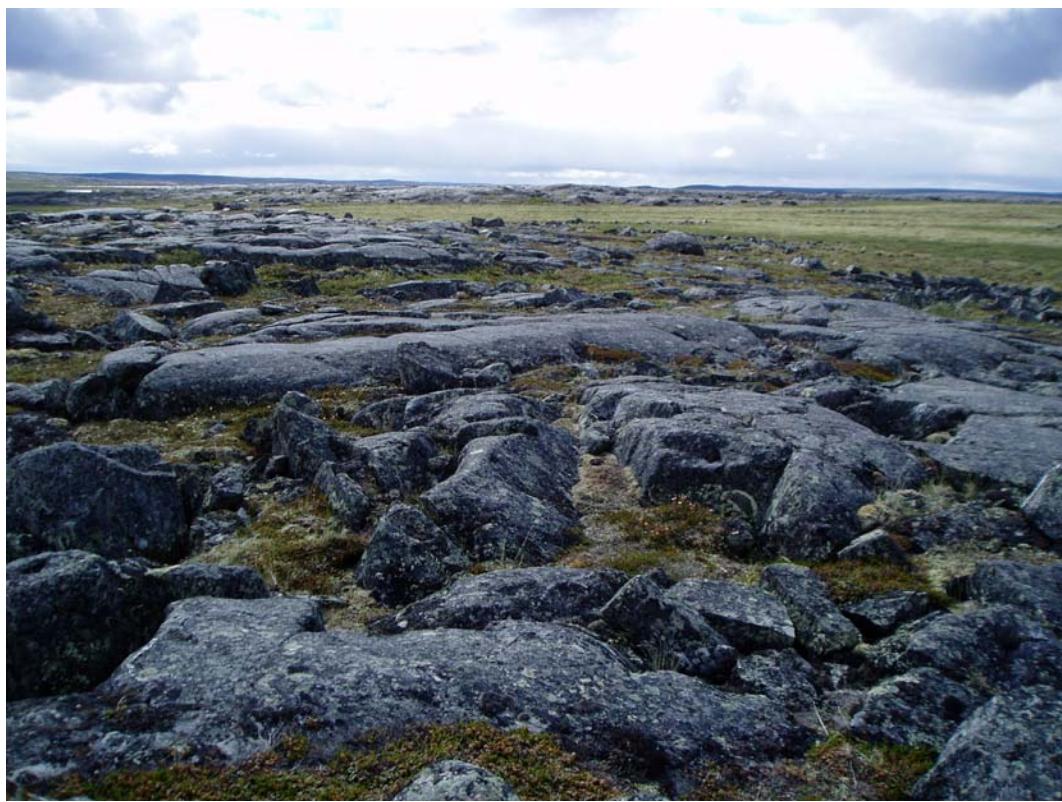
Photo 2: Terrain type 1 in granitic bedrock near kilometre 22.

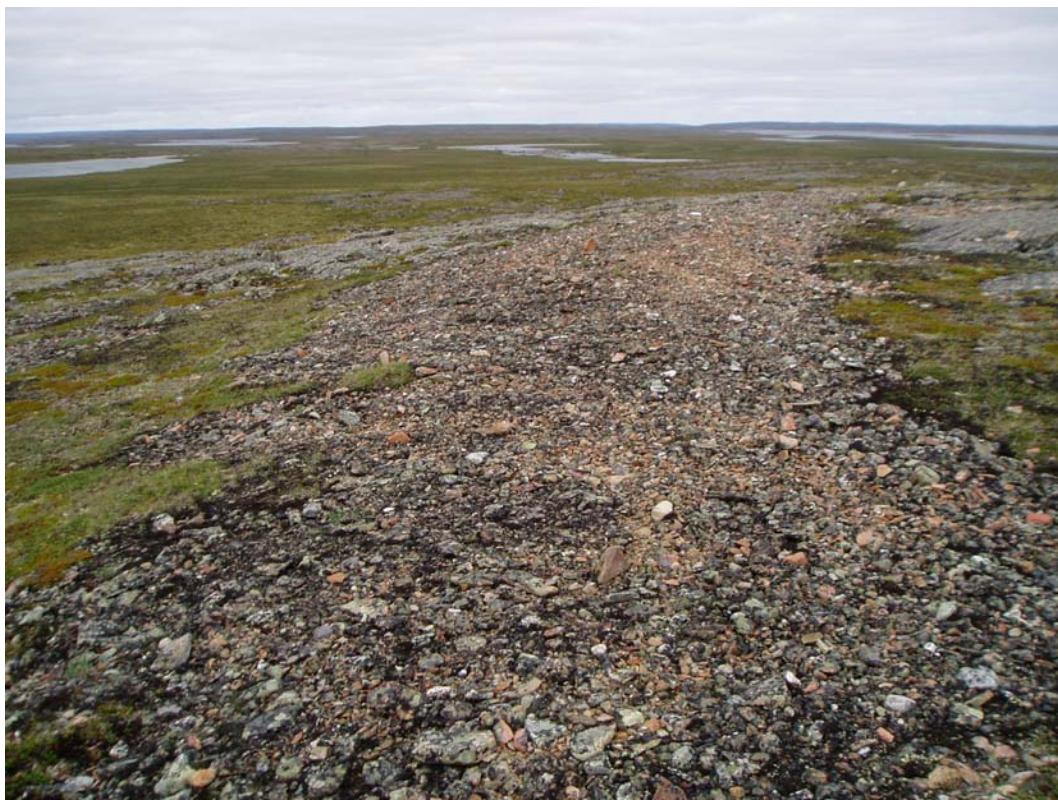
Photo 9: Small beach deposit on a bedrock ridge southeast of kilometre 9.

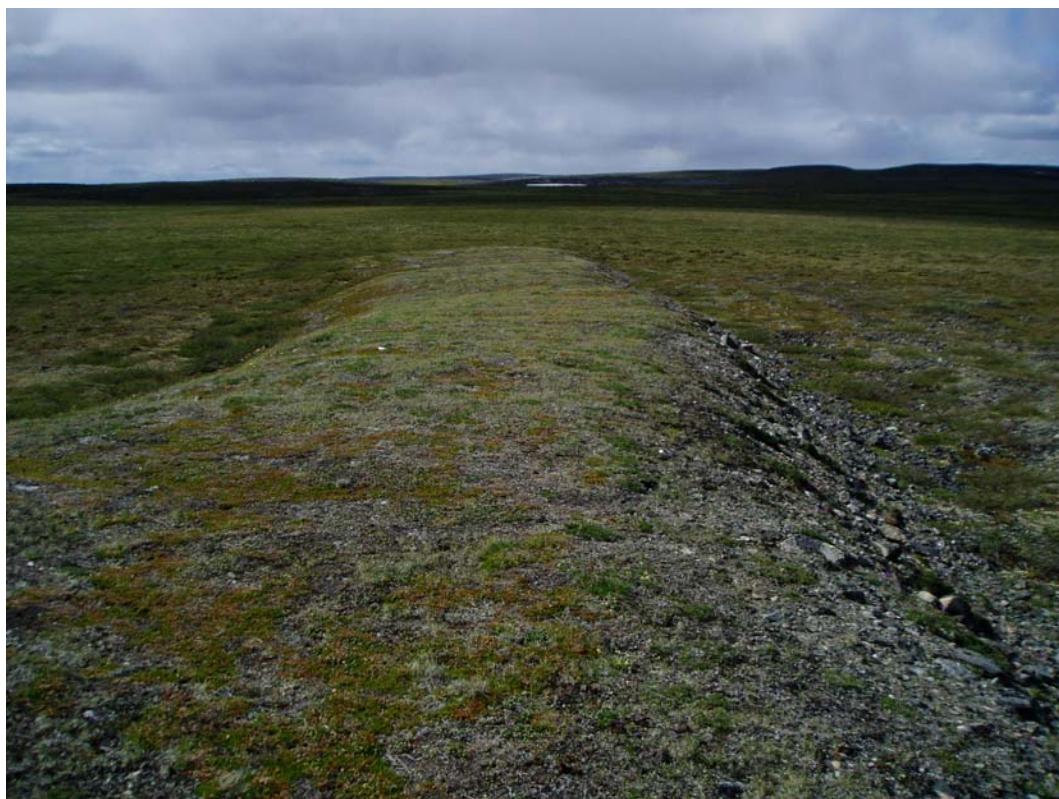
Photo 11: Small esker about 600 metres east of kilometre 33.

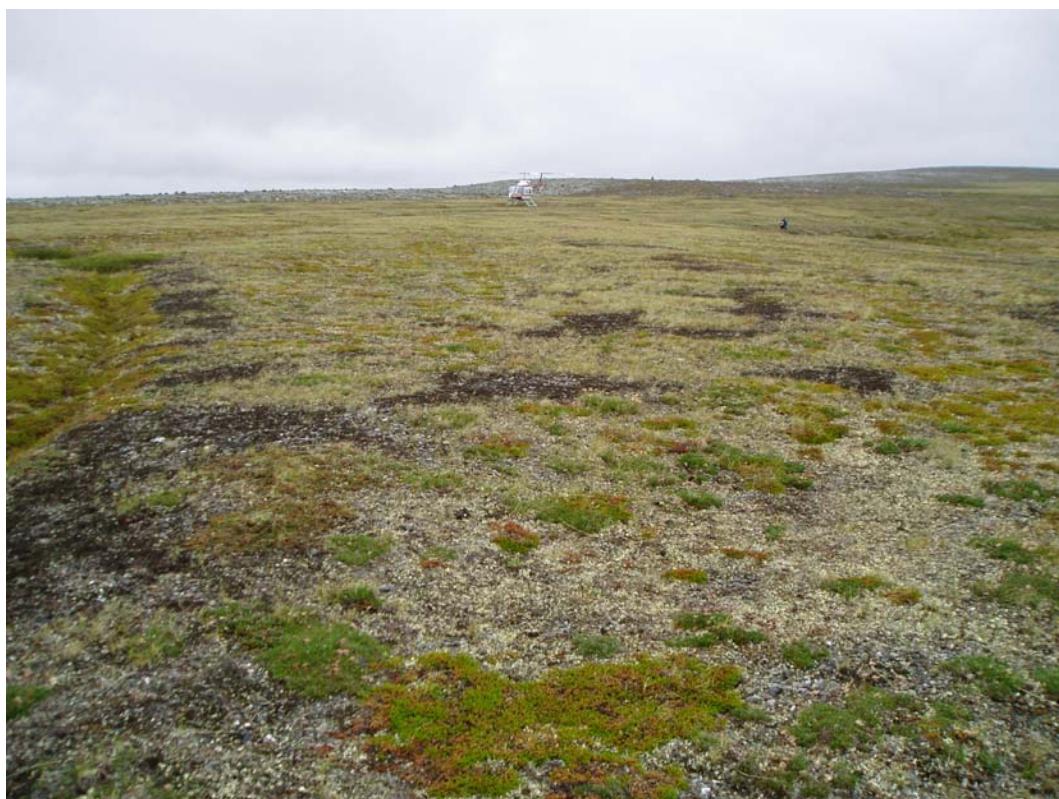
Photo 12: Shallow ice-marginal glacio-fluvial deposit north of kilometre 34.
