Sanikiluaq Wind Project

Site Visit Report

Document Name:	Sanikiluaq Wind Project Site Visit Report (October 14, 2021)		
Document Number:	SAN-PDG-RP-002

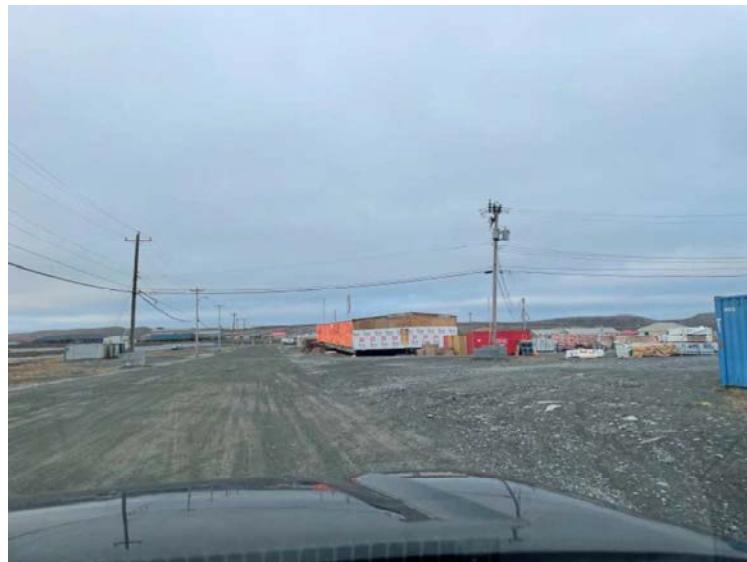
- The hotel is being repaired following the recent storm damage. Information from the guide indicates that when reopened, the hotel will have more rooms than the original hotel and a dining area/restaurant.

Figure 2: Co-Op Hotel Sanikiluaq

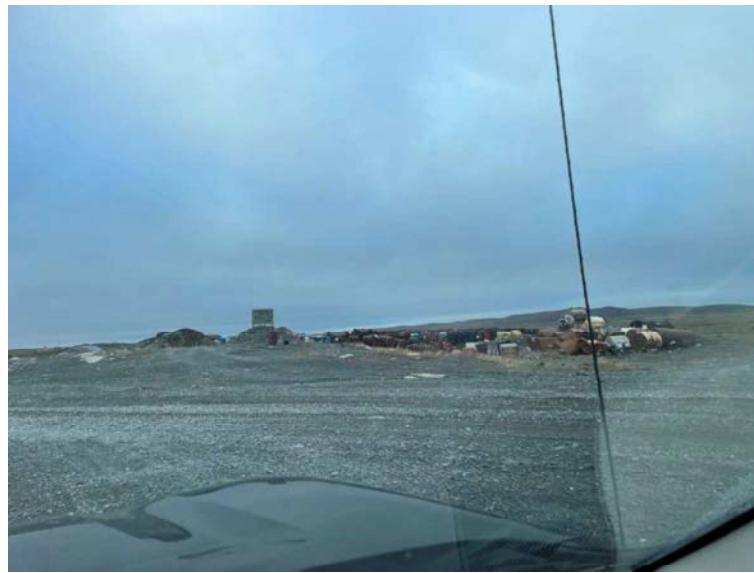
- Roads in the hamlet are in relatively poor condition and would benefit considerably from additional gravel and grading. This is particularly evident in the road from the airport to the community.
- There is a sizable Co-op grocery store for food/amenities. The team did not enter the store this visit however a team member was in the store in October 2020 and confirmed it is fully-stocked.
- The hamlet avails of an open landfill for disposal of all community wastes, including, recyclables, organics, metals, and hazardous wastes. The project will need to consider disposal of wastes (including waste oil) in a more environmentally friendly manner. This could involve removal of the wastes on sealift and disposal in the south.

Figure 4: Hazardous Waste Stored at Landfill

- Consideration is required for waste disposal (including waste oil). The team feels it is irresponsible to dispose of project wastes in an open landfill. This goes against the overall values of a community-led renewable energy initiative.

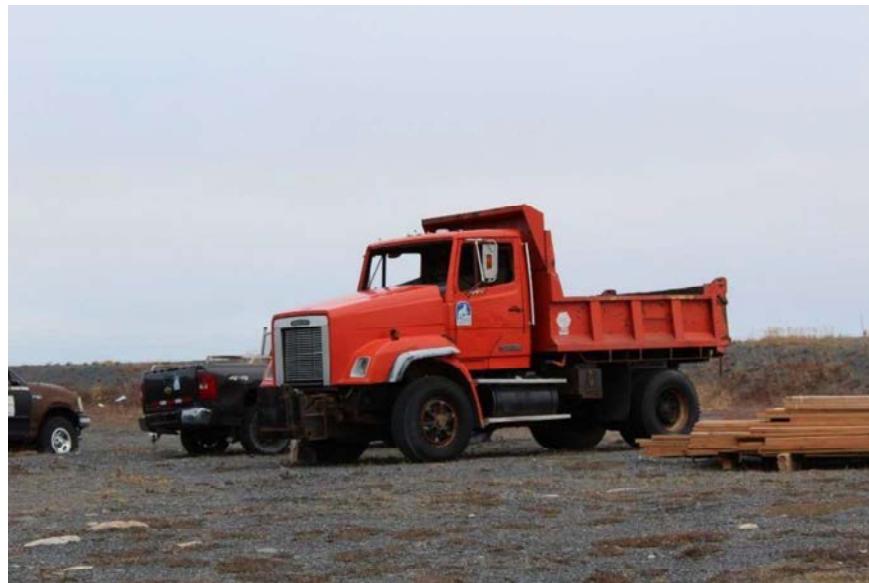
- Reports from the community and discussions with the guide indicate that vandalism is a major concern in the community. The project will need to be cautious leaving equipment unattended for extended periods of time.

Figure 7: Truck with Windows Vandalized

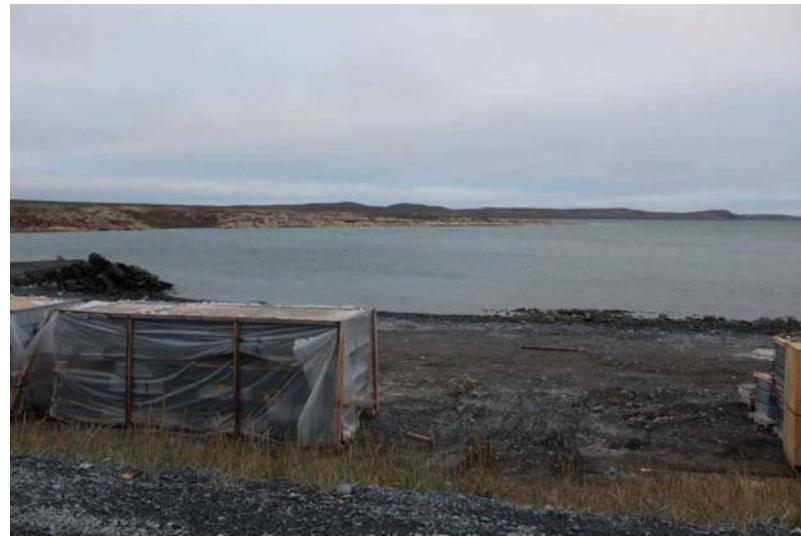
- The team viewed the sealift landing location. Consensus is that equipment shipped in containers as the only facility is a beach for landing the sealift barge. It is believed that the sealift landing location will be sufficient, however, there is no deep-water port capabilities in the hamlet. The sealift ship takes anchorage approximately one mile offshore according to the guide. This should be validated by the project team.

Figure 8: Sealift Landing Location

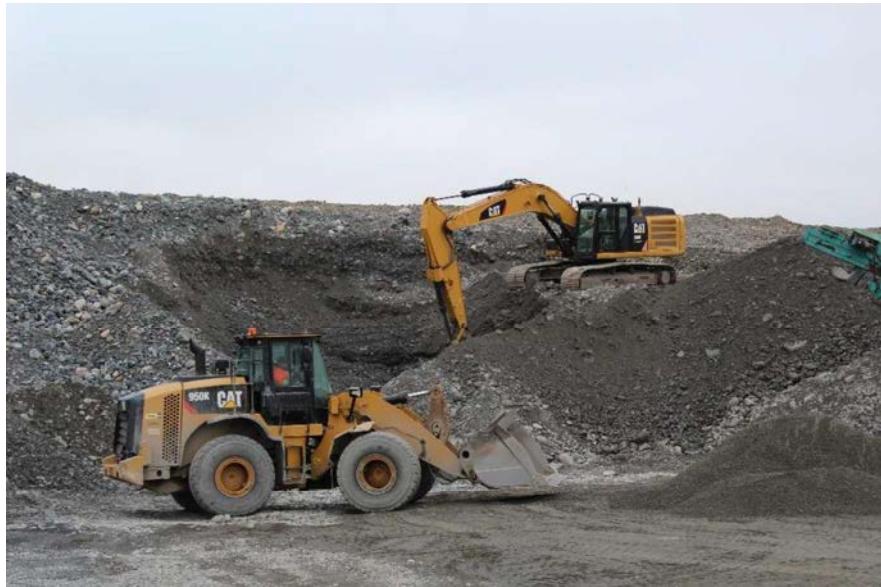
- There is a hamlet owned gravel pit/borrow source. It appears that considerable quantities of material are available, but discussions with community personnel indicate that there is

a long lead time for crushed material due to a backlog from ongoing construction projects in the hamlet. Information indicates that class A material costs \$60 per cubic yard.

Figure 9: Hamlet Pit

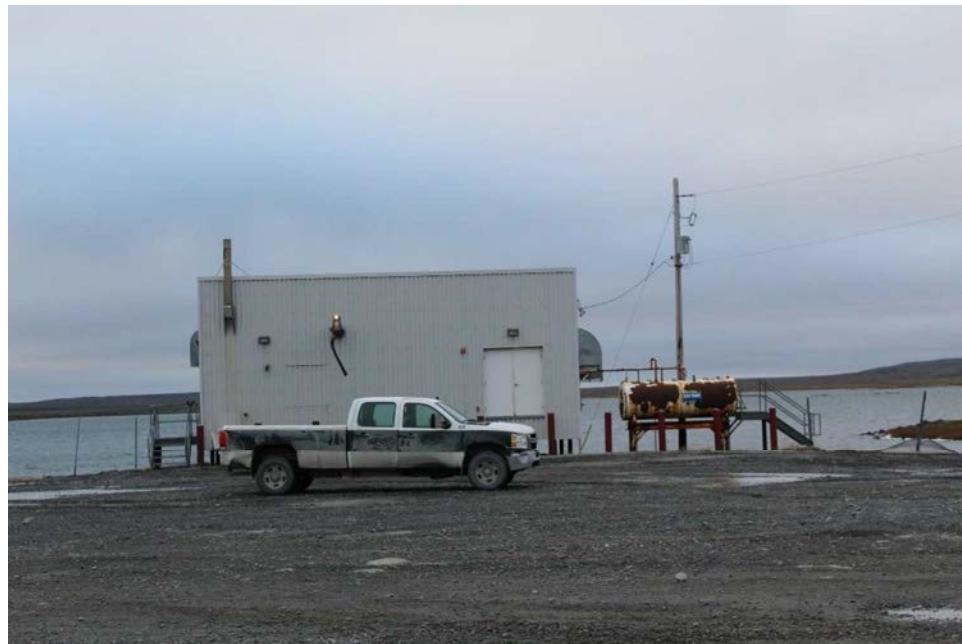
- There are plans to install a new water treatment facility. Surveying has taken place recently, but there are no indications on timelines or a specific location for the new facility. The current water station was viewed by the project team. Discussions with the guide indicate that there are considerable challenges pertaining to clean water in the community. Encouraging information from a Government of Nunavut employee indicates that there are reverse osmosis units installed in every house in the hamlet. It is therefore assumed that the potable water in the hamlet is sufficient for housing employees during construction. Any future water treatment facilities constructed in the community will benefit the wind/BESS project through load growth and potential for additional renewable energy generation.

Figure 10: Existing Water Treatment Facility

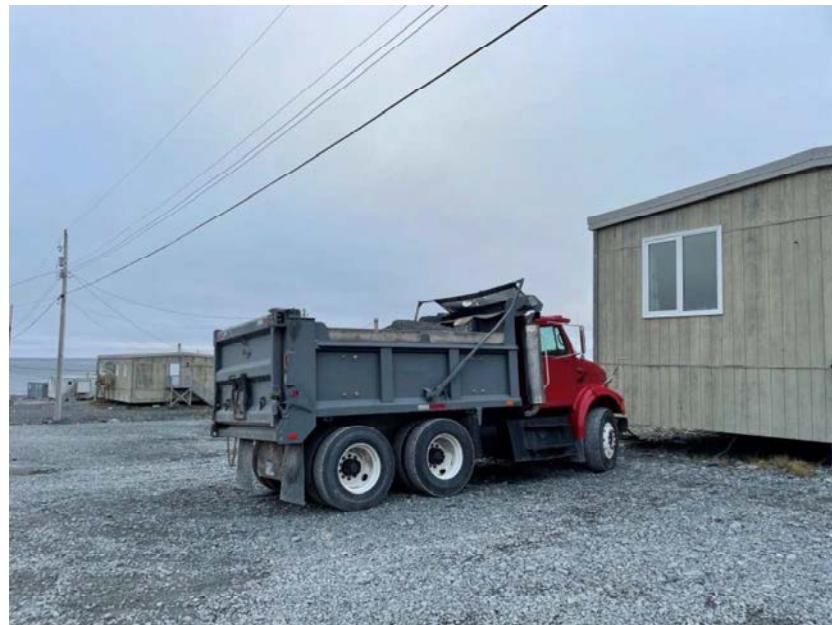
- 2001 International Dump Truck owned by Gary Rumbolt. Discussions with Allan Rumbolt indicate that the truck currently has transmission that are being investigated and repaired.

Figure 12: 2001 International Dump Truck

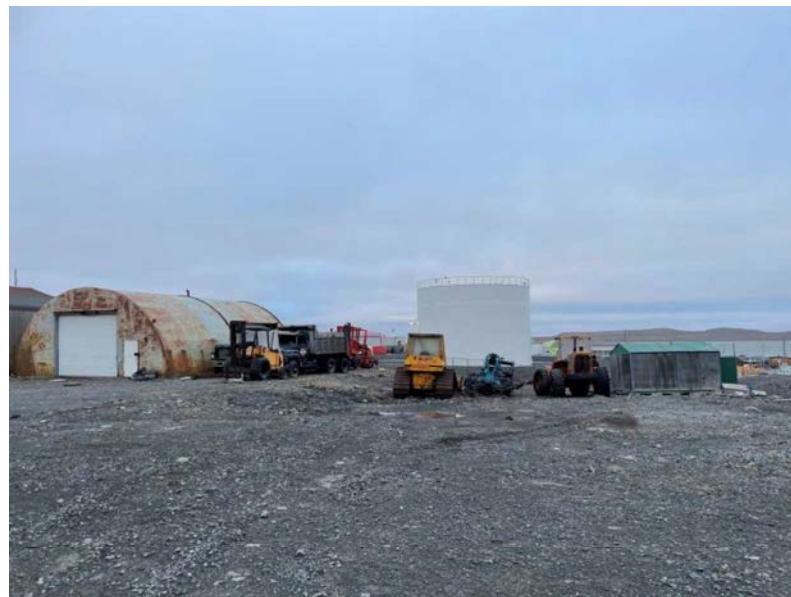
- Miscellaneous heavy equipment owned by Kawtaq Construction (majority shareholder is Gary Rumbolt). Stock was not taken of specific model numbers, however, all equipment at Kawtaq yard appears to be non-functional and in need of considerable repairs.

Figure 14: Kawtaq Equipment in Need of Repairs

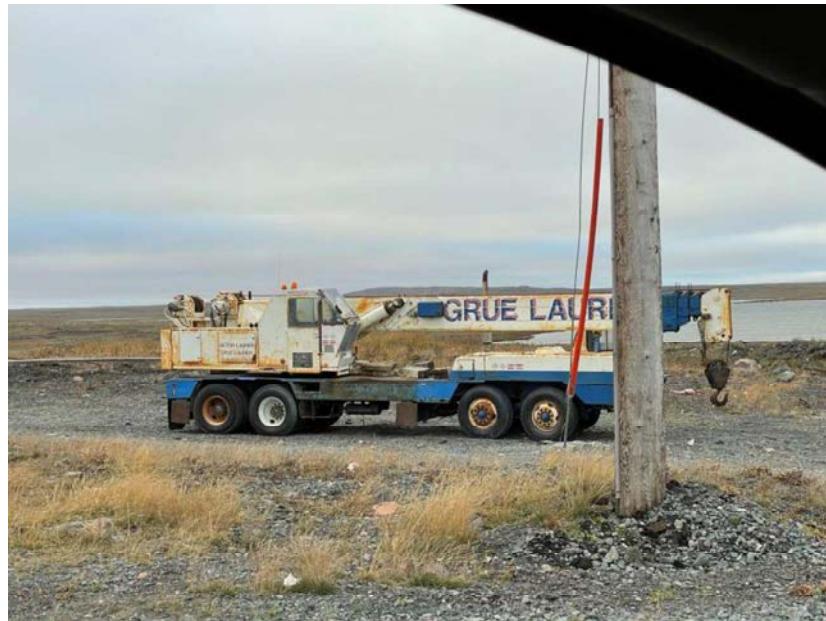
- Crane (unknown model number) owned by another construction company operating in the hamlet. Information indicates that crane may be operational but is not road worthy and appears to be in poor condition. Certification status is unknown, but it is unlikely that the crane meets the required certifications for lifting devices. Team will not use uncertified equipment for construction.

Figure 16: Crane Owned by Other Construction Company

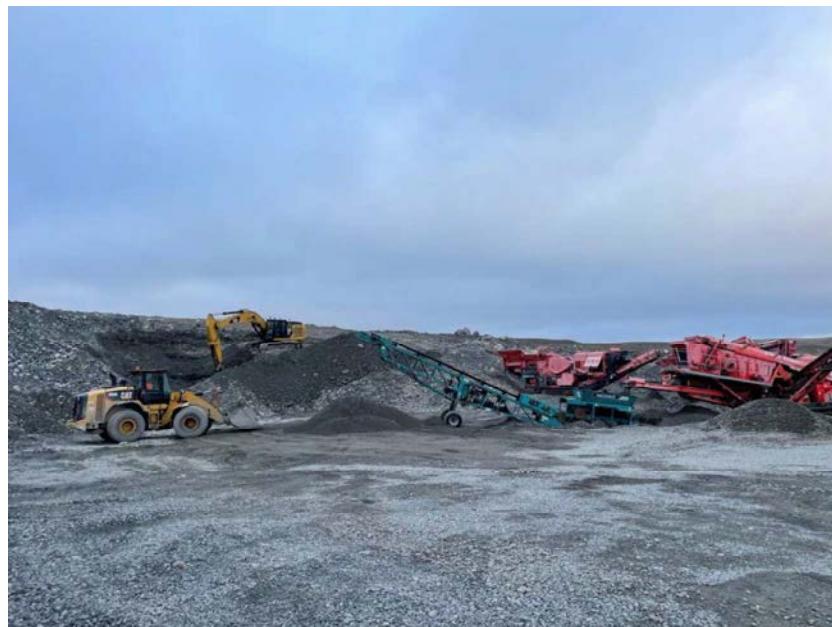
- Dump truck owned by hamlet and in process of being purchased by Gary Rumbolt. Information indicates that paperwork for dump truck is not in order. Dump truck was vandalized and does not have any windows currently (Figure 7).
- 330 CAT Excavator owned by Hamlet of Sanikiluaq.
- 950 CAT Loader owned by Hamlet of Sanikiluaq.
- Crusher owned by Hamlet of Sanikiluaq.

Figure 17: 330 Excavator, 950 Loader, and Crusher Owned by Hamlet of Sanikiluaq

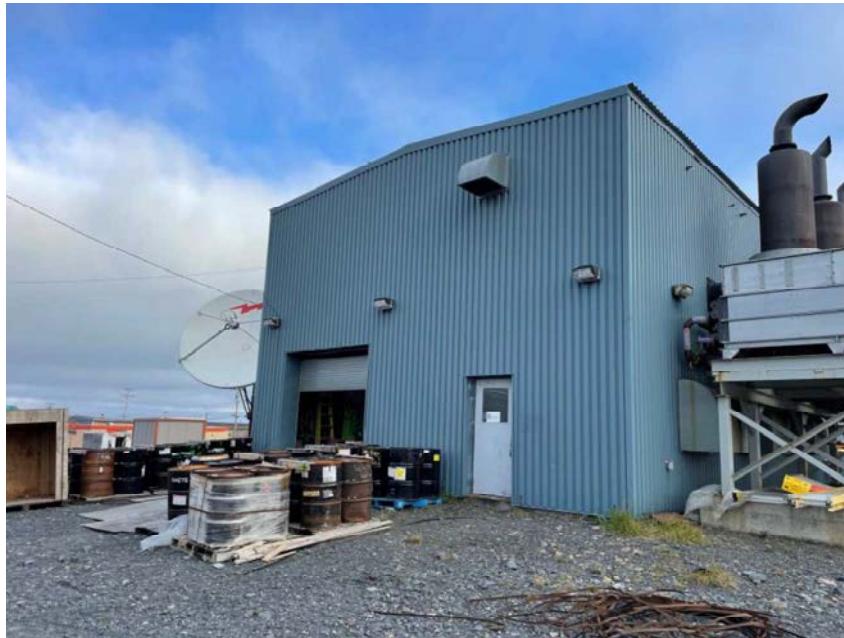
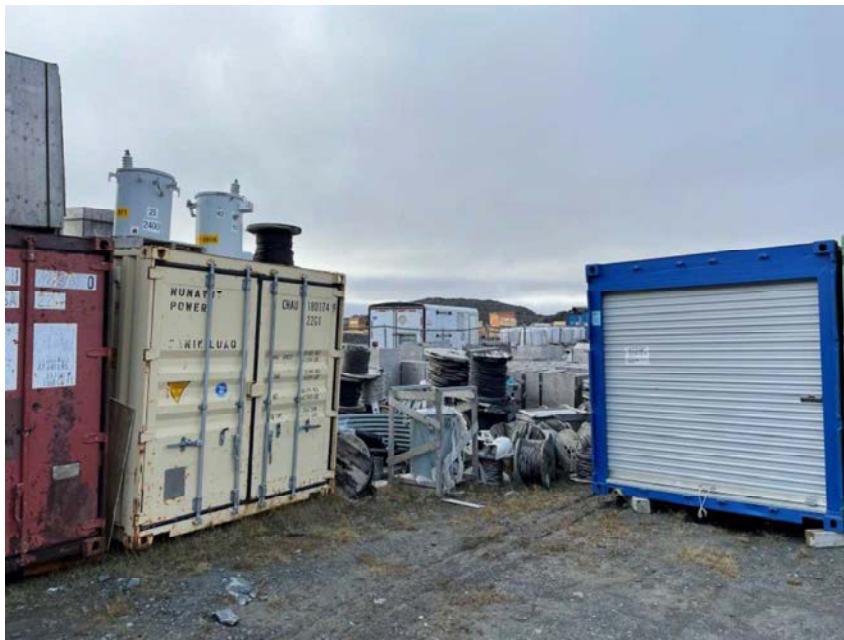
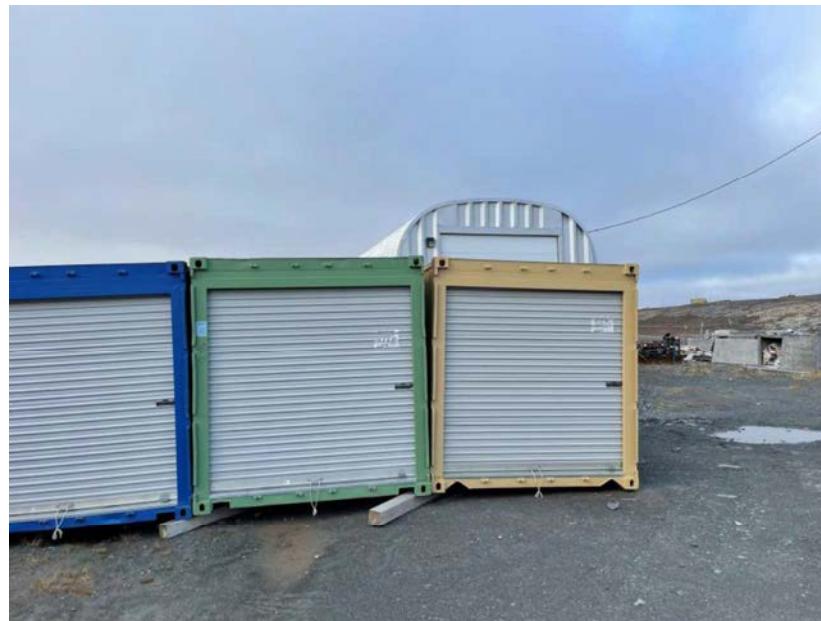
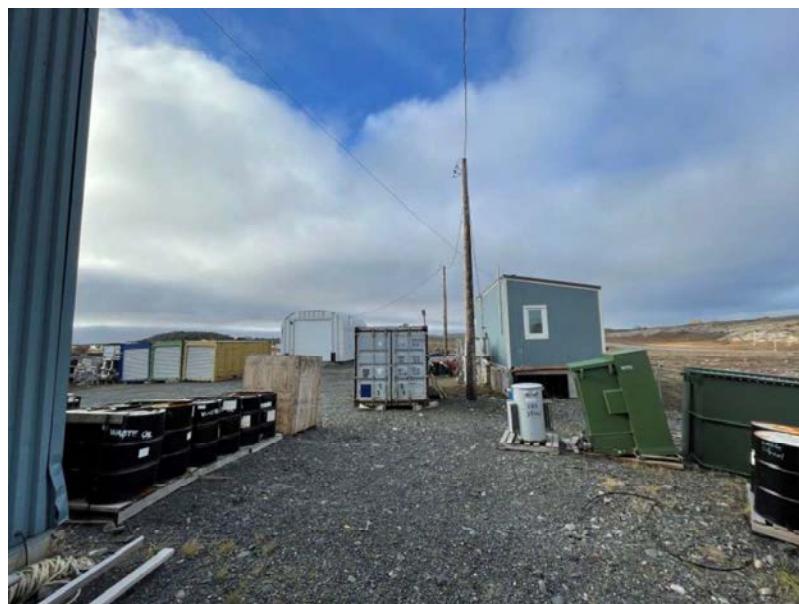
- There are some required changes to the current drawings because of impediments within the QEC yard. The project team feels it would be in the project's best interest for project-specific equipment to be installed beyond the boundaries of the current QEC yard.
- There is limited space for expansion within the current QEC facility. The project will need to collaborate closely with QEC for the installation of any equipment that needs to be installed in the facility.
- The Sanikiluaq district heating system was installed in the plant this past summer (2021).
- There will be transformer upgrades to the facility soon. There is a temporary 1,200 kW diesel generator in a trailer in the QEC yard to provide power to the hamlet during the upgrades.

Figure 21: Rear of QEC Plant

Figure 22: Miscellaneous Items in QEC Yard

Figure 23: New Storage Containers in QEC Yard

Figure 24: QEC Yard (North Side Looking West)

- Changes are required to the civil layout drawings concerning the QEC plant due to impediments within the QEC yard. The project team feels it would be best to place project-specific equipment beyond the bounds of the current QEC facility.

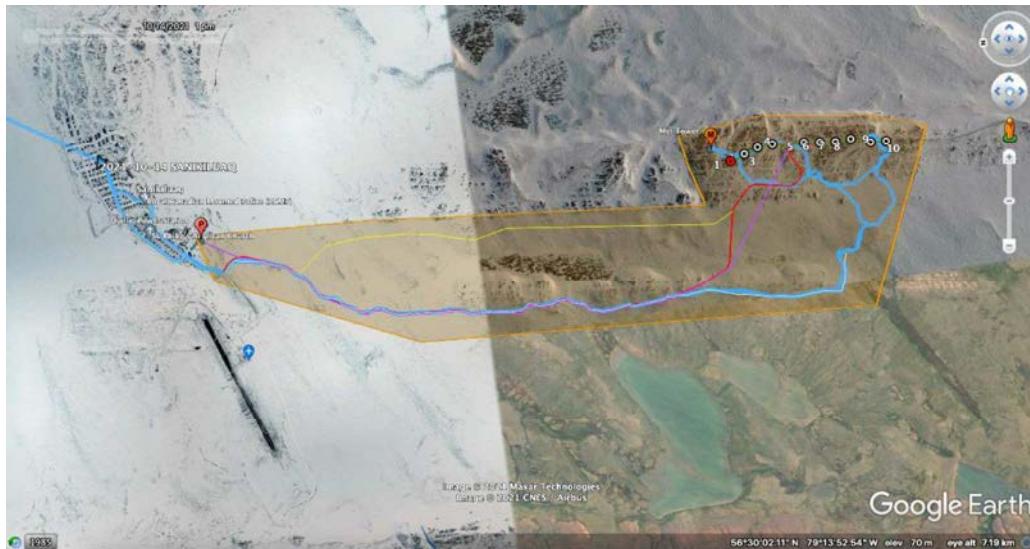
Figure 27: Sanikiluaq Site Visit Route

- The existing trail is rough, and it appears that there is limited use of the trail. Rocky sections were slow to traverse but should provide a solid foundation for road construction.

- Soft sections of the existing trail were difficult to cross, with no clear trail across some areas. Allan noted that areas around town that look OK to drive over, have seen large equipment sink and get stuck, requiring an excavator to retrieve. He mentioned that test drills went 12 m deep before reaching solid ground. It should be assumed that the soft sections along the trail may require more fill and an engineered solution like geotextiles between the fill and the existing ground.

- A fill-only road may be more advantageous than balancing cut fill along the route. This should be further assessed for productivity and investigating the price of the fill. Ability for a contractor to use their own equipment to remove material from the pit would be advantageous, rather than tying up the Hamlet's equipment. The pit appeared large enough for multiple operations to work simultaneously.

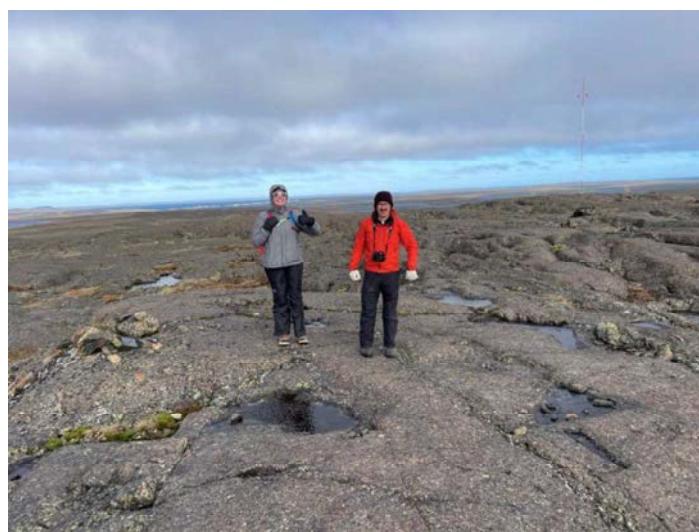
- All turbine locations were visited, no insurmountable barriers identified for construction. Additional fill may be required depending on the turbine supplier's requirements for tower erection.

Figure 29: Wind Turbine 1 Proposed Location
