Industrial Complex Area

Mill Foundation

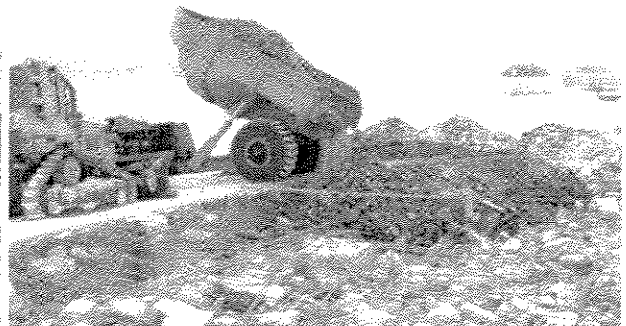
The infrastructure for this complex had been removed during the first quarter. The concrete floors and below ground crawl spaces were remediated during the 2nd quarter. A pneumatic hammer attachment was installed on our excavator and was utilized to break up the concrete and let it fall into the void below. Shale was then hauled and placed over the entire area.

Backfilling basement and broken concrete

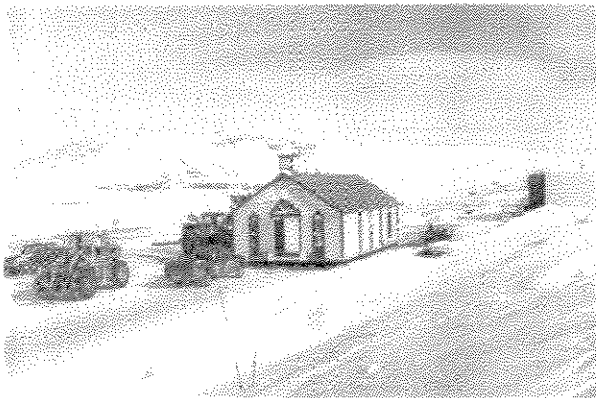
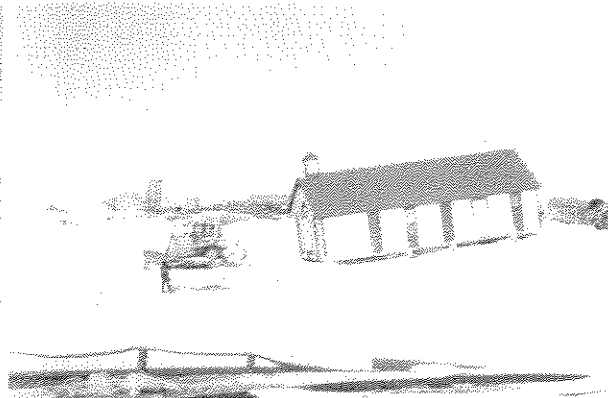
The Nanisivik church was originally a joint venture of the Anglican and Roman Catholic churches. The mine was approached early in the Spring to explore the possibility of moving the unit to Arctic Bay. This was accomplished by welding a steel frame and skid underneath the main section of the church and towing it to the Nanisivik Port and then along a makeshift ice road into the community of Arctic Bay.
